INITIAL EVENT INVESTIGATION REPORT  
EIR-2016-020

AOP-015 ENTRY AT AP-107 CORE SAMPLE PLATFORM

**Title AOP-015 Entry at AP-107 Core Sample Platform**  
**Event Investigation Report Number EIR-2016-020**

PER No. WRPS-PER-2016-0928

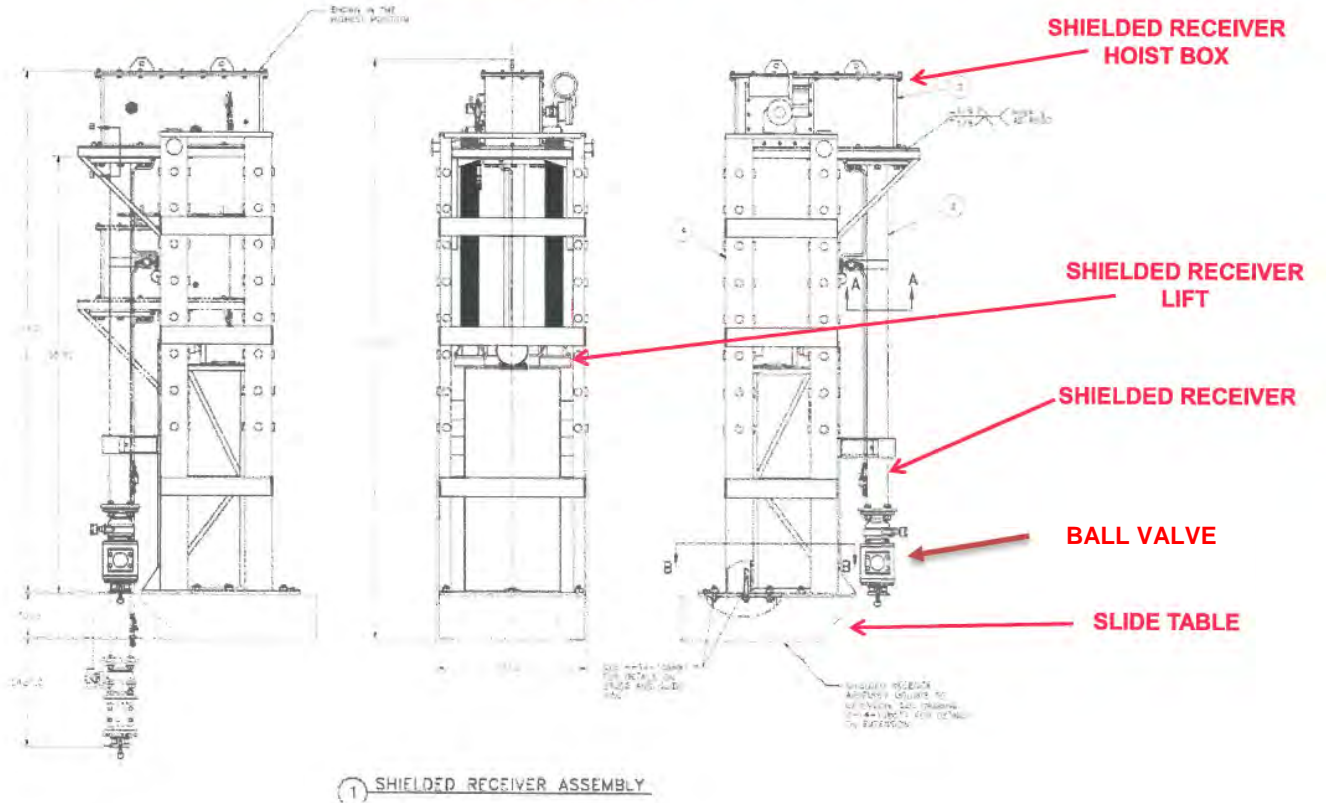
Attachment 1: Core Sampling System Drawing

A maintenance crew composed of four Instrument Technicians, two IHTs, two Health Physics Technicians (HPTs), five Nuclear Chemical Operators (NCO), one FWS, and a technical support staff member were performing WO# 172267 "Grapple and Sample Hoist Load Cell Loop Test and Calibration on AP-107." This scope included performing procedure 1-GENI-900, "Grapple and Sample Hoist Load Cell Loop Test and Calibration." The digital readout for the load cell required replacement and subsequent calibration which was a first time evolution since the platform has been deployed in the field (internally contaminated). See attachment 1, Core Sample System Drawing for system configuration.

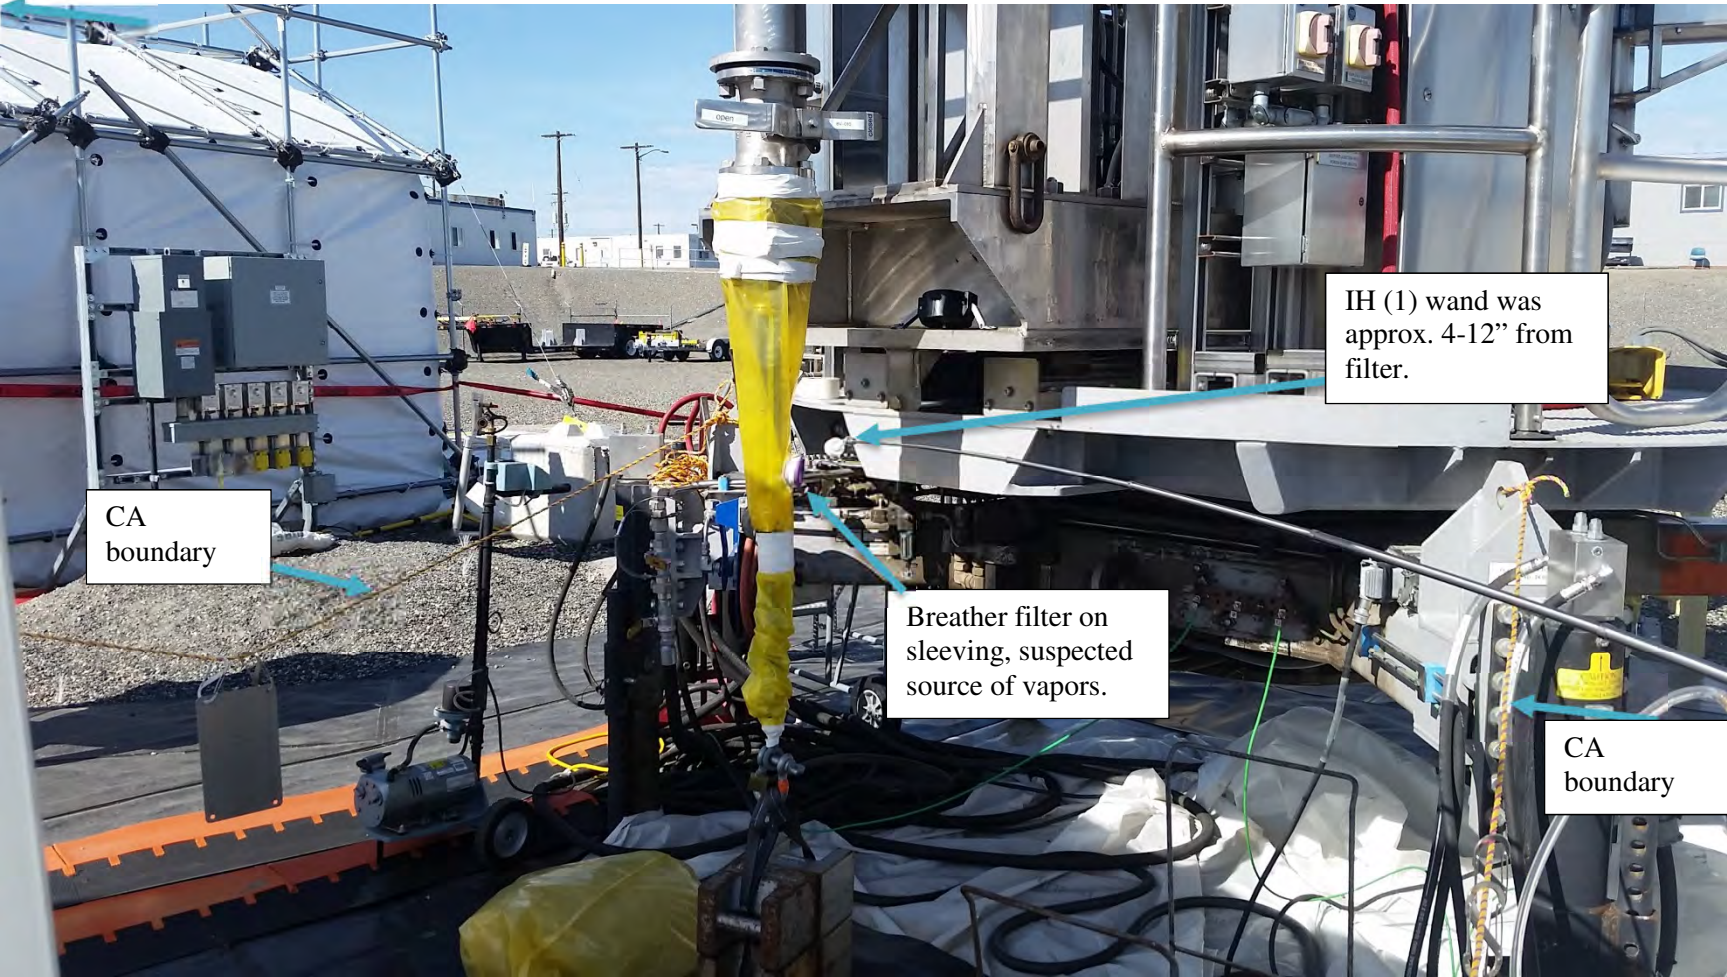
**Attachment 2: Field Configuration**

A CA was set up around the core sample platform, approx. 5ft by 10ft area. See Attachment 2, Field Configuration. Preparation for calibration included removal of the Camlock cap on the bottom of shielded receiver utilizing containment and a catch bag. The ball valve was opened and allowed to drain residual flush water out of the tower into the catch bag at approximately 0940am, (see Attachment 3, Preparing Shielded Receiver). Once the flush water was drained, the ball valve was closed, the bag horse tailed and removed for disposal. Next, contamination sleeving (e.g. polyurethane) was secured around the remote latch unit (RLU) and was pulled through and attached to the shielded receiver/ball valve using white tape, creating a seal. The sleeving included a High Efficiency Particulate Air (HEPA)/breather filter installed using white tape to seal the HEPA filter. The HEPA filter was in place to ensure the sleeving could breathe during the work evolution preventing the buildup of air in the sleeve. The installed HEPA filter was at a height of approximately 4 feet above ground level. After the sleeving was installed, the ball valve was opened and the RLU/shielded receiver was lowered down to allow the grapple connection to the d-ring. The instrument technicians installed approximately 100 pound increments of weight to the d-ring and began the load test. See Attachment 4, Set Up of RLU for Weight Calibration.

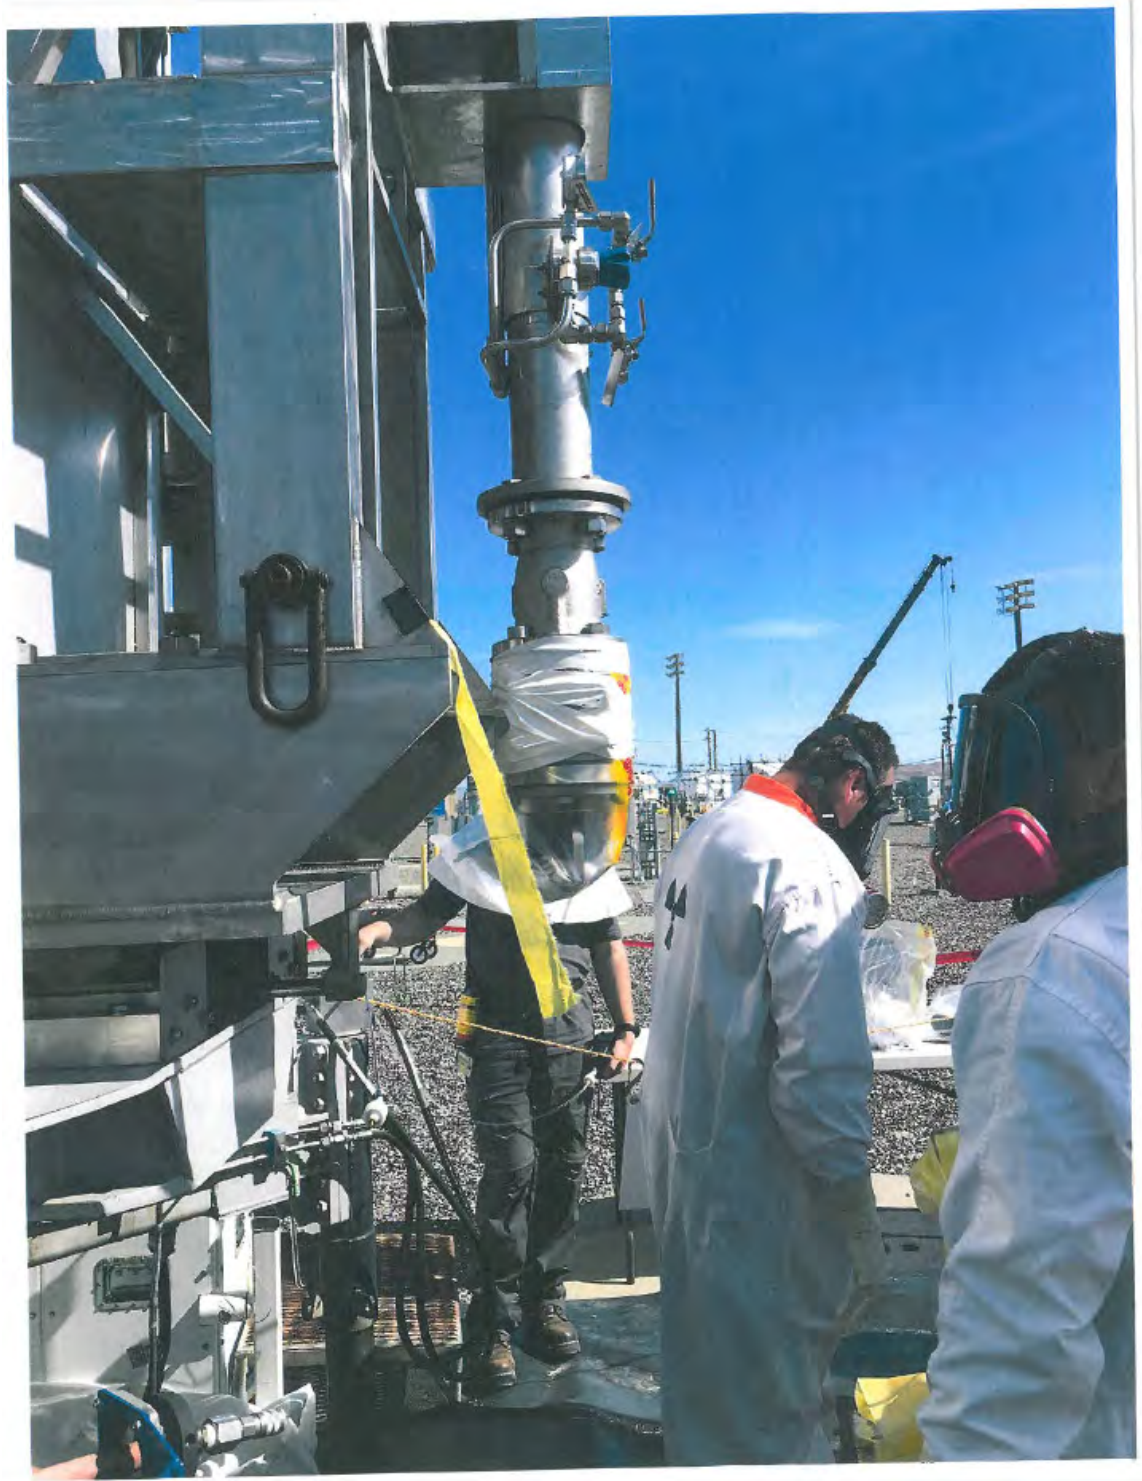
**Attachment 3: Preparing Shielded Receiver**

The most likely source is from the flush liquid being trapped in the sleeving where the HEPA filter was installed, and during the work evolution the ammonia vapors were trapped and exhausted. Some workers commented that AP farm and work around AP-107 have unique odors consistently. These odors are described as ammonia like, musty or onion. Other workers supporting WO# 172267 around AP-107 on May 2<sup>nd</sup> said they noticed the ammonia odor, however did not fill out Odor Response Cards, but it is also noted that not all workers smelled odors. Upon thorough review of the IH data, workers statements, and the onset of symptoms, it is determined that the liquid in the sleeving was the most likely source, and the venting of air/vapors through the breather filter was the most likely transport.

1. Tank Farm entry on the following day, Tuesday, to place area in safe configuration.
2. Made a procedure change to 1-GENI-900, to remove the breather filter from the sleeving, and making a modification to add a Nuc filter to a purge line off of the hoist boxes.
3. Added a respiratory protection boundary around work area until IH demonstrates the breather filter from the hoist boxes are working as intended
4. Updated Respiratory Protection Form to require Chemical Cartridge use.

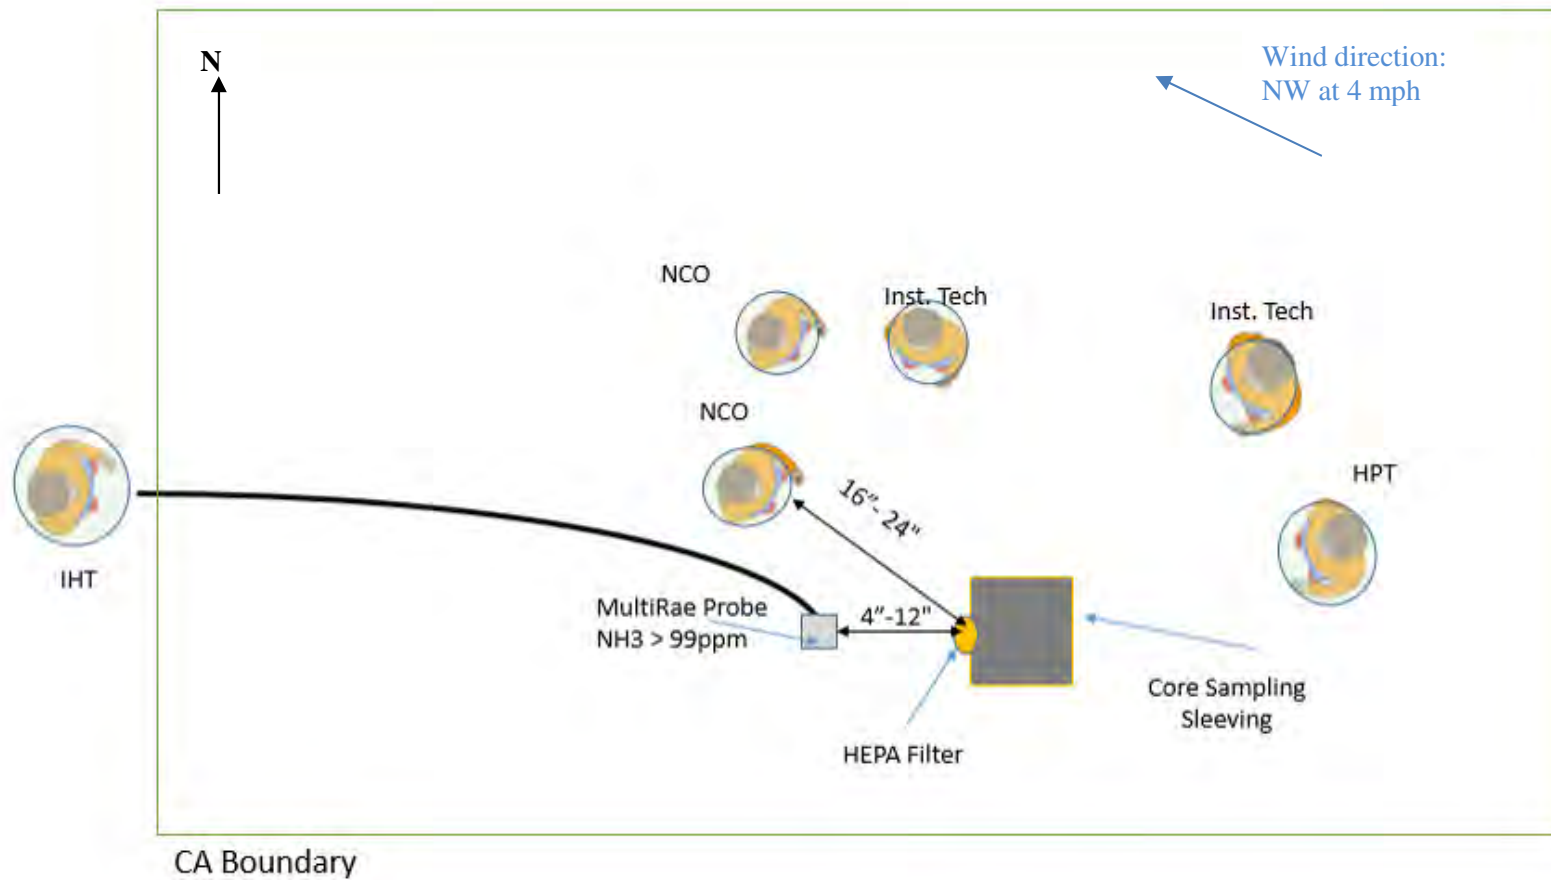
**Attachment 5: Field Personnel Positions**

There were five individuals located within the CA, including two NCOs, two Instrument Technicians, and one HPT. Due to the small area of the CA and ALARA considerations, the IHTs were located outside the CA. IHT (1) was monitoring inside the CA and had a wand approximately 4-12” from the sleeving filter on the west side of the workers, IHT (2) was located about 5’ southeast of the shielded receiver (SR). Both IHTs were performing continuous monitoring throughout the work evolution. See Attachment 5, Field Personnel Positions.

One of the employees experiencing symptoms was wearing a personal sample pump. The personal sample was analyzed at the laboratory with results indicating less than the analytical detection limitations for all analyzed constituents. It is expected that these results would not show exposure from this brief event. At the onset of the odor, the employees moved away from the suspected source. At the time of the alarm, NCO (1) was located closest to the HEPA filter at approximately 24" away.
