EVENT INVESTIGATION REPORT

C-Farm AOP-015 Event of July 18, 2014
Event Investigation Report Number EIR-2014-025

PER No. WRPS-PER-2014-1317 (Trend only as a roll-up to Significant PER WRPS-PER-2014-0602)

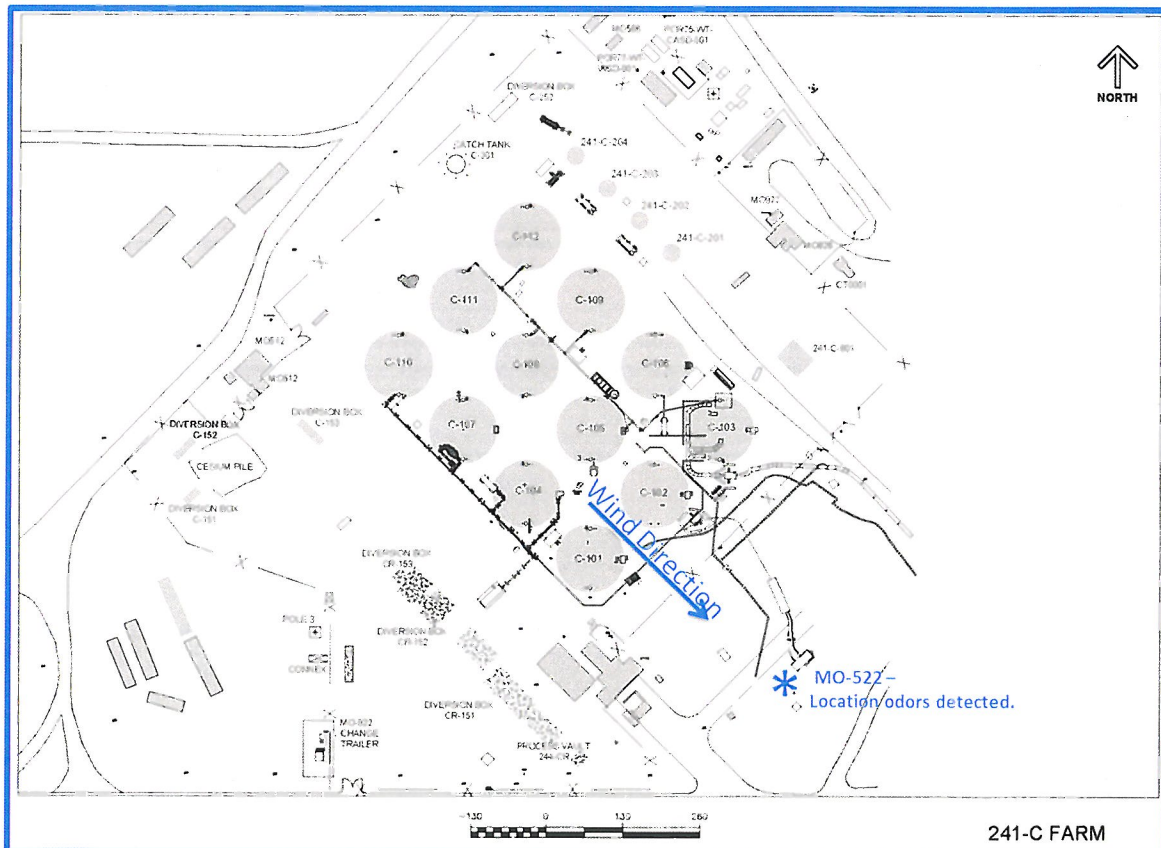
Attachment 1 – C Farm and location of detected odors
