**EVENT INVESTIGATION REPORT**

**TF-AOP-015 Response at AZ-102 Leak Detection Pit  
EIR-2015-024**

PER No. WRPS-PER-2015-1136

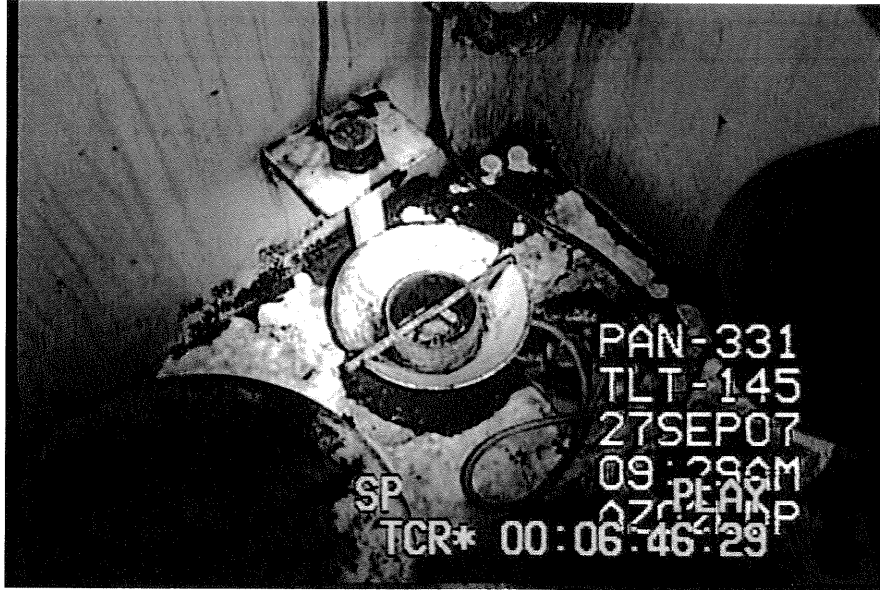
**Figure 2. Drain in the AZ-102 LDP**

Engineering confirmed that the drain in the AZ-102 LDP is in the closed position. [The video reviewed (from 9/27/07) was after the handle was removed, so this is believed to be the current state today.]

Confirmed LDP drain plug position (closed). [LDP isolated from primary tank.]

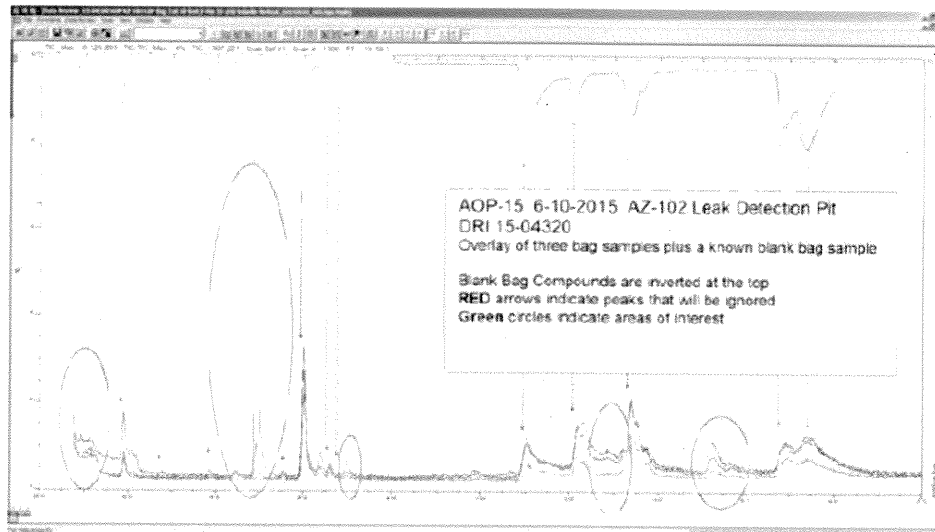
The first of these 15-04320 AZ-102 LDP 6-10-2015.jpg, is a very large overlay showing the bag samples compared to a known blank bag sample.

This permits the materials arising from the bag composition to be ignored. Several unique peaks were circled in green.

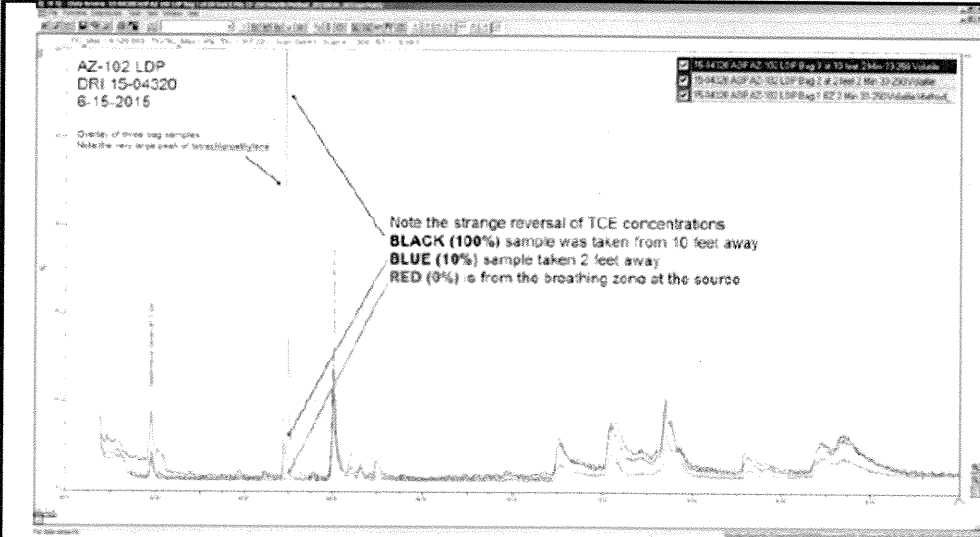
The second JPG image labeled Overlay Full Scale.jpg, is another overlay, this time only describing the large compound of interest

The very large peak of trichloroethylene has a completely different odor profile.

There is no possible way that this compound could have been responsible for the odor described.

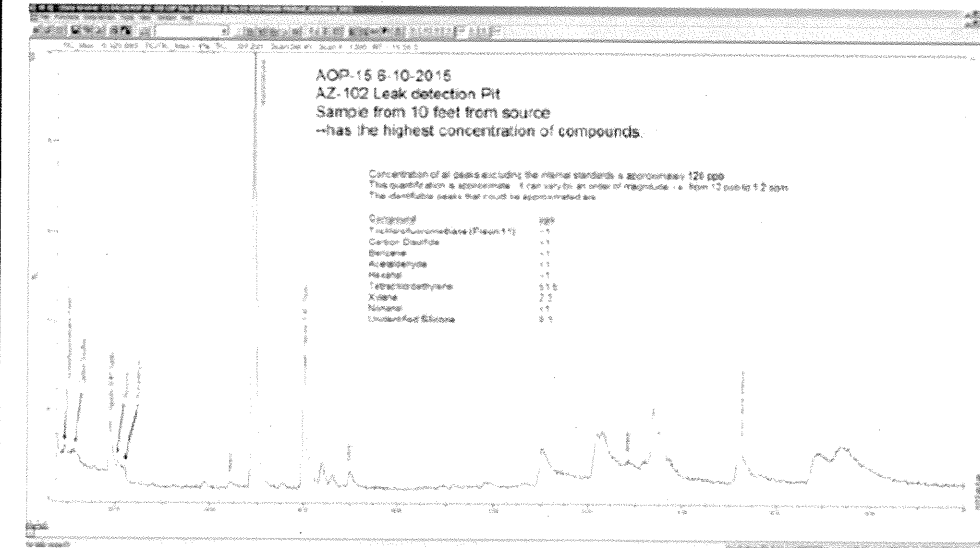
The final JPG image, labeled AZ-102 LDP 10 ft sample Annotated.jpg, is an identified and quantified chromatogram of the sample with the largest concentrations of unique, non-bag related compounds.

The only compound identified with a known odor was a barely identifiable, but not really quantifiable, amount of Carbon Disulfide.
