# EVENT INVESTIGATION REPORT

EIR-2016-024

Investigation of 702-AZ Room 105 AOP-015 Entry

PER No. WRPS-PER-2016-0908

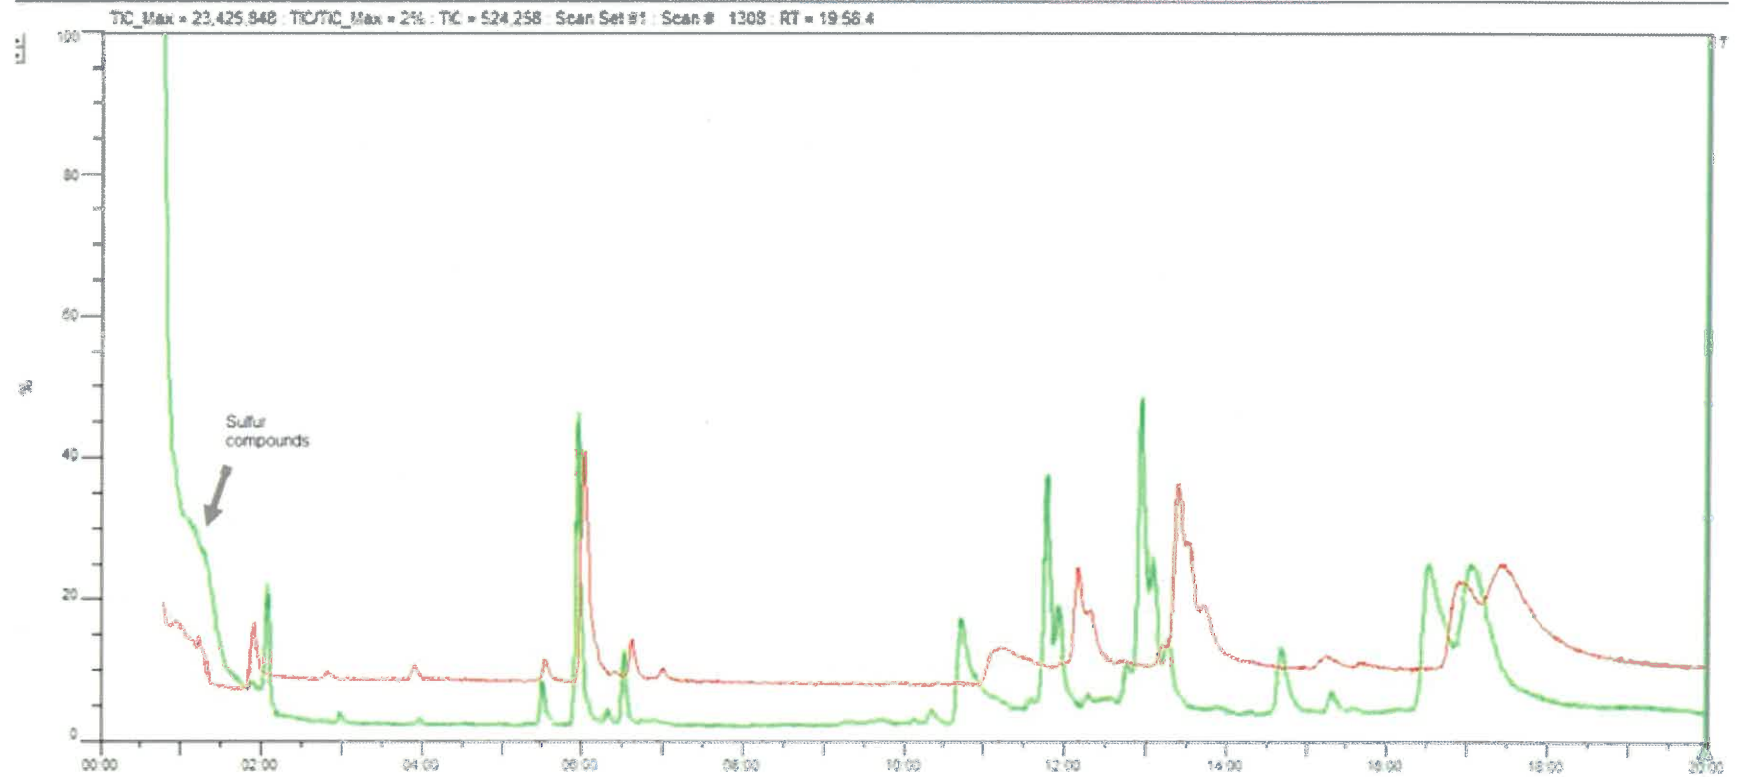
**b. GCMS Sample Results:**

No concerns were identified. Sulfur compounds were noted that may cause odors.
