INITIAL EVENT INVESTIGATION REPORT
EIR-2016-039

“EVENT INVESTIGATION REPORT, EIR-2016-039, AOP-015 FOR ODORS
REPORTED OUTSIDE AY-1 CHANGE TRAILER”

PER No. WRPS-PER-2016-1568

AOP-015 for Odors Reported Outside AY-1 Change Trailer

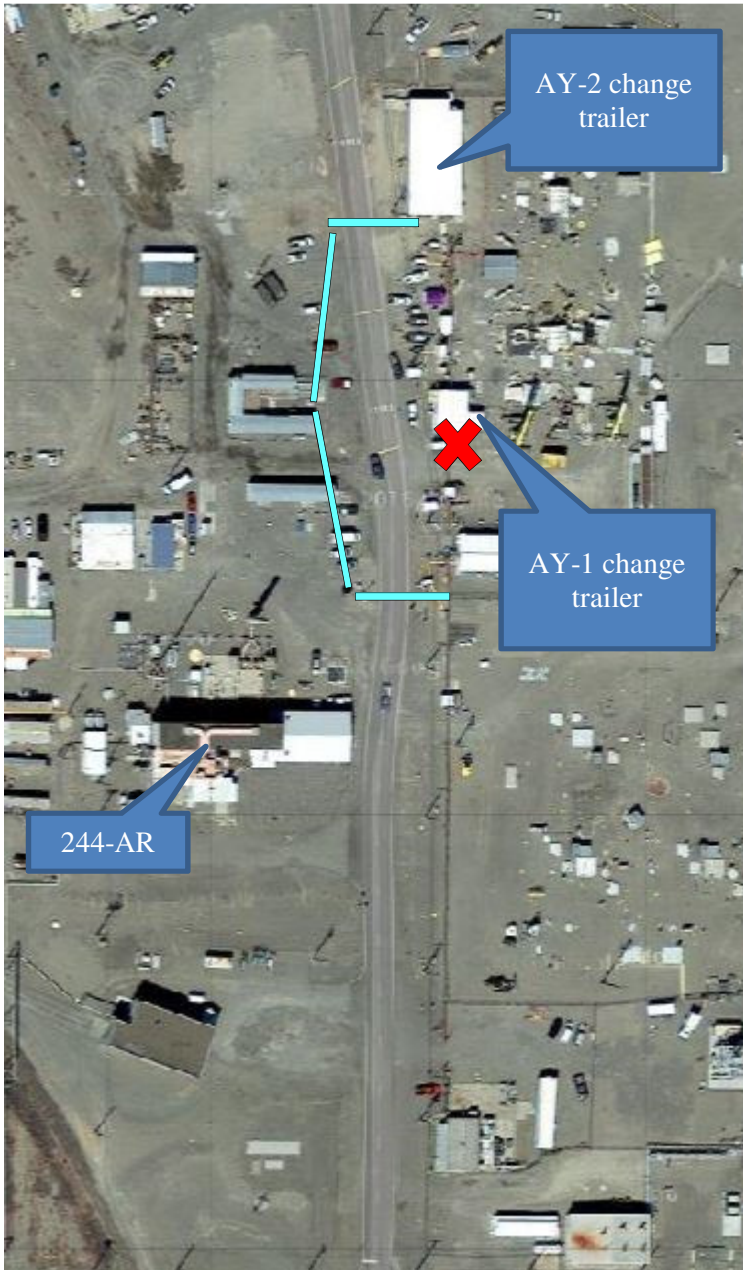
Figure 1 - AOP-015 for Odors Reported Outside AY-1 Change Trailer

* Odors detected between 0800 and 0815 hours and then at ~0900

Location where Pipefitters and MSA Teamster experienced odors

Temporary barricades; restricted area

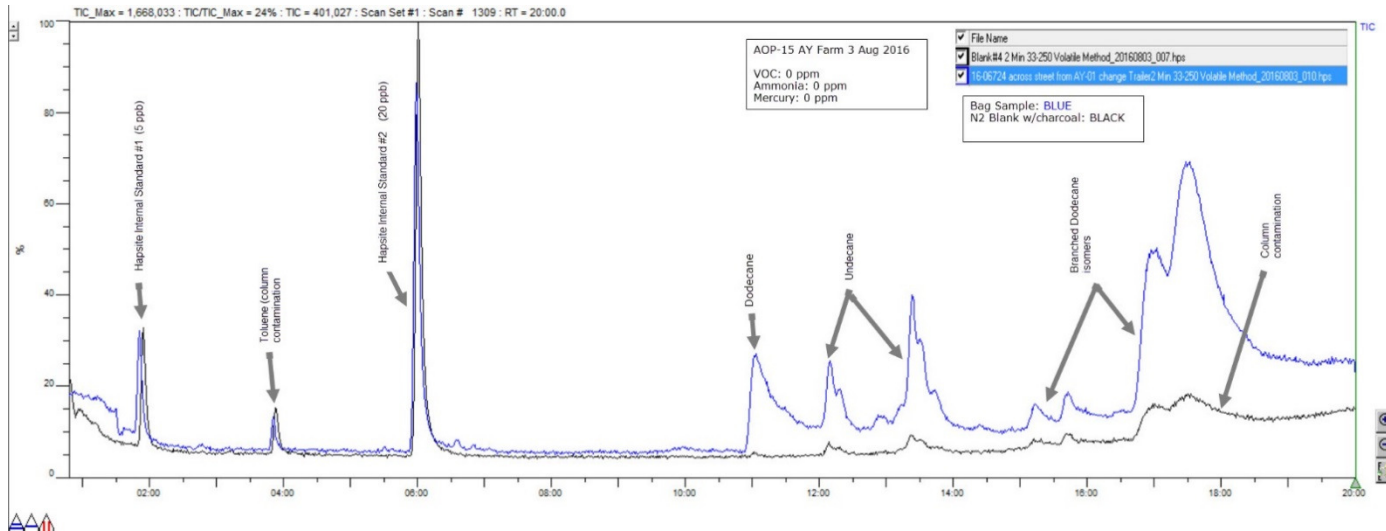
b. GCMS Sample Results:

No monitoring data available at time of odor event. No known source has been identified for this known odor location. Refer to above surveys for additional information.
