Subject: EVENT INVESTIGATION REPORT, "AOP-015 ENTRY WITH ODORS NEAR EXHAUSTER AND TANK AP-107," EIR-2016-014

EVENT INVESTIGATION REPORT

AOP-015 Entry with Odors near Exhauster and Tank AP-107

Event Investigation Report Number: EIR-2016-014

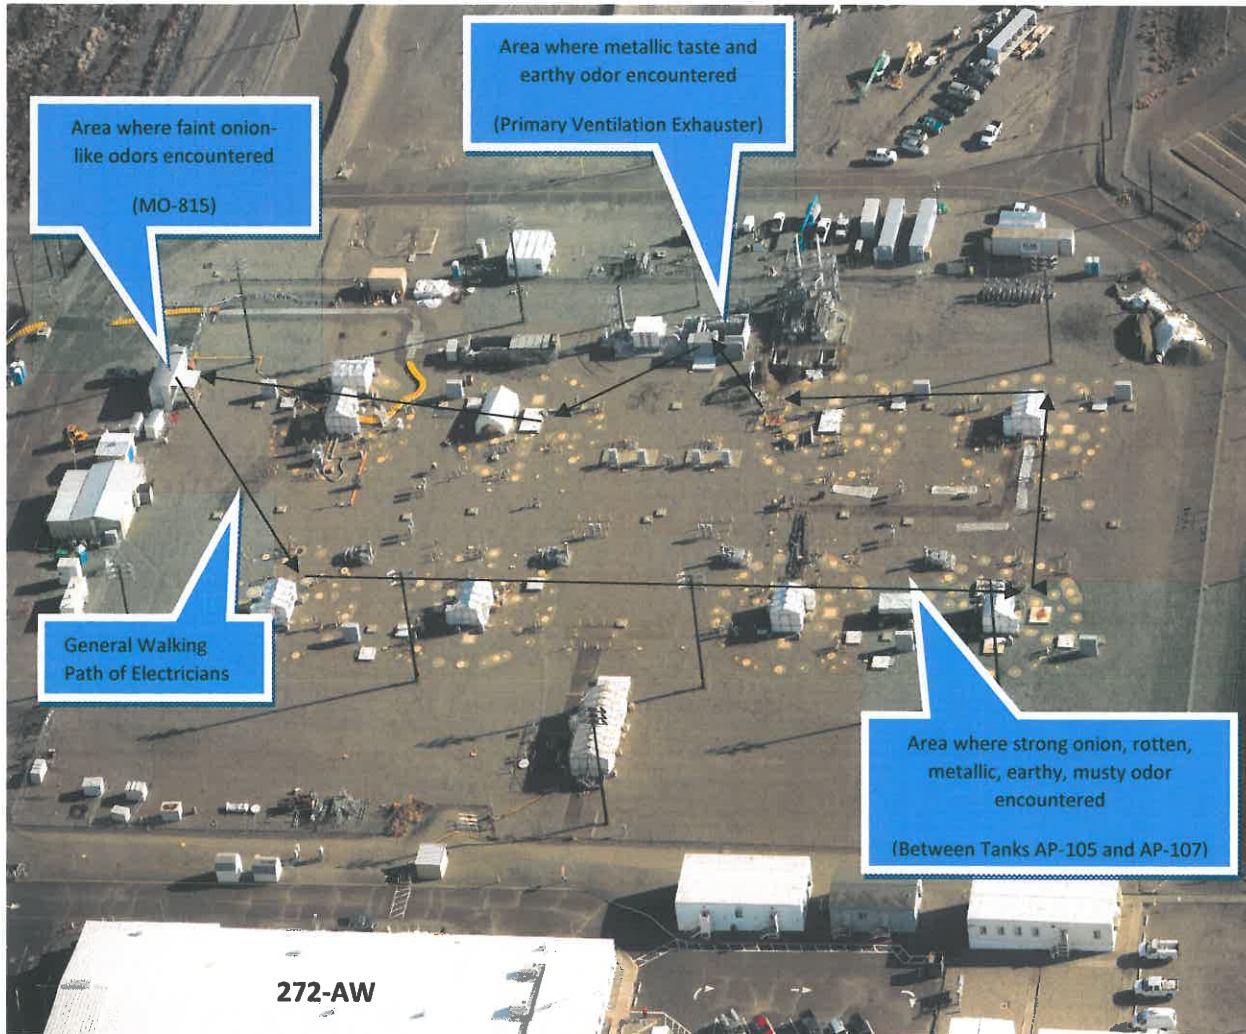
Photo of Area

241-AP Farm and Areas Where Odors Encountered

The AOP-015 entry was specific to the areas near Tank AP-107 and the Primary Ventilation Exhauster. However, odors, depending on wind direction and speed, have the potential to be detected near any tank and/or ventilation system.

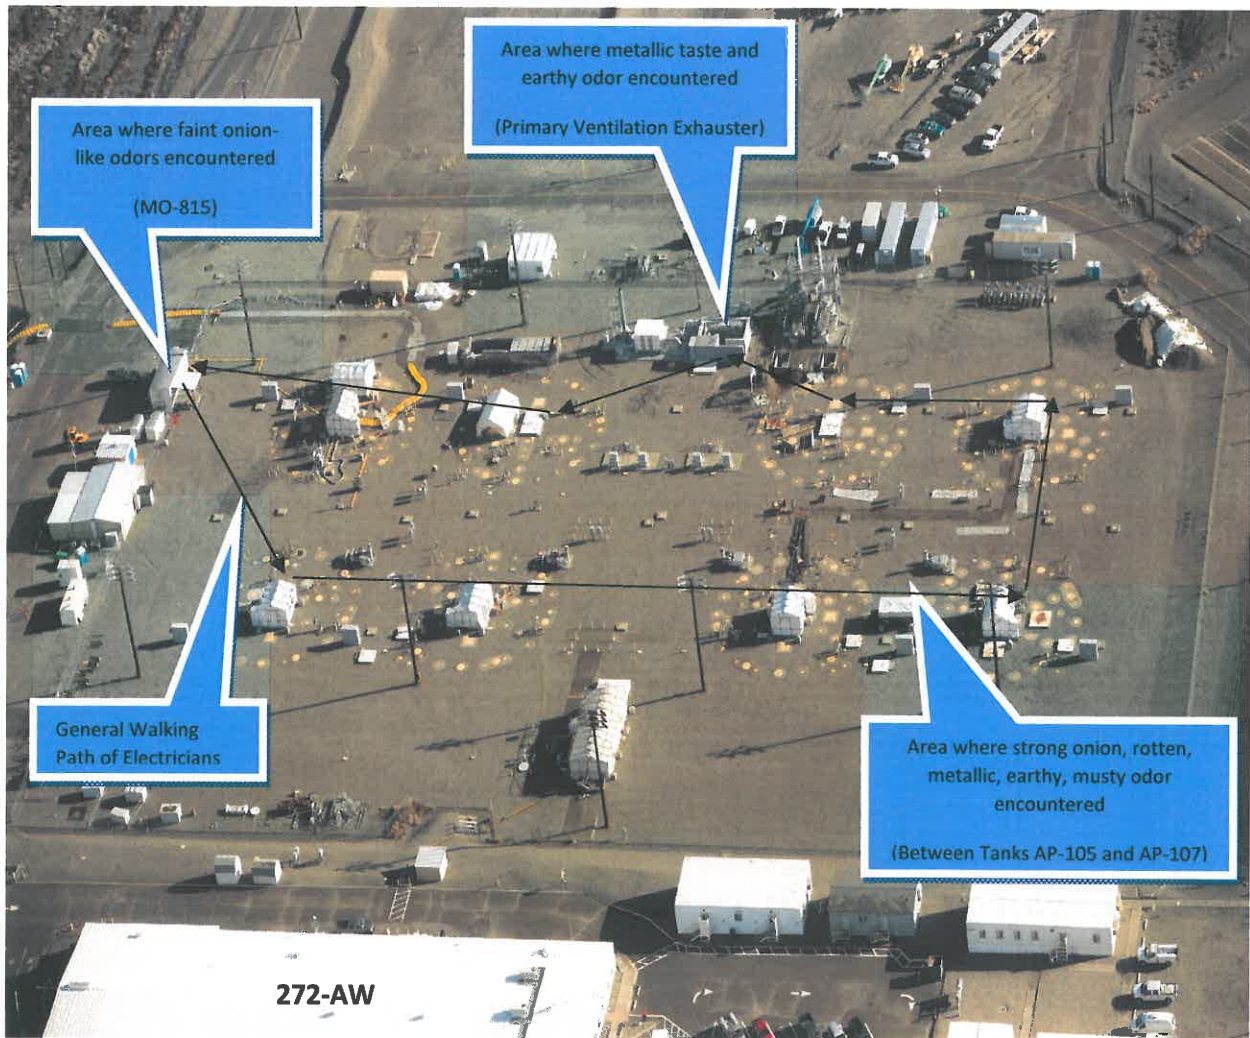
Attachment 1
Photos

241-AP Farm and Areas Where Odors Encountered

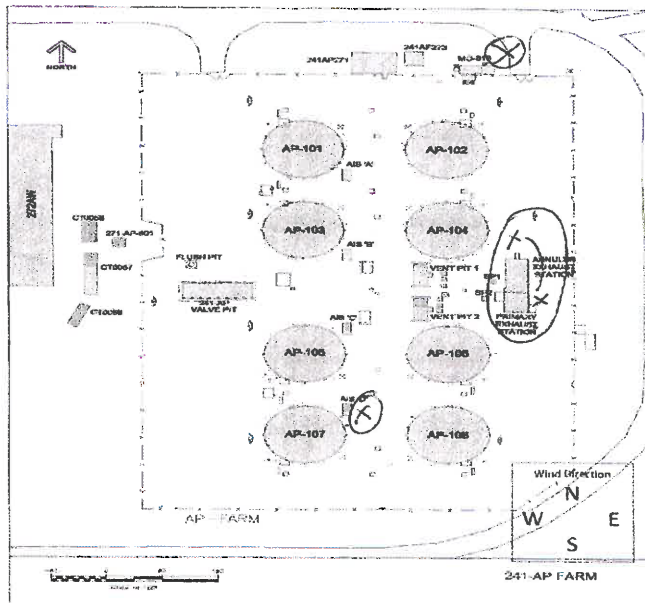
- Date and time odor was noticed 9:00 am
- Your name and the work you were performing de winterization
- Location of odors (mark area on map and wind direction) _____
- Name of others in or near the affected area [REDACTED]
- Was an IHT present? No
- Describe the odor Sweet Sour Musty Earthy Metallic Smoky Rotten Onion
 Cleaning Solution Ammonia Other _____
- Possible source _____
- Your symptoms (if any) Headache Dizziness/Light-Headed Nausea Cough
 Fatigue/Drowsiness/Weakness Sore/Burning Throat Difficulty Breathing Watery/Irritated
Eyes/Trouble with Vision Tingling/Numbness/Paralysis Rash/itching
 Other _____

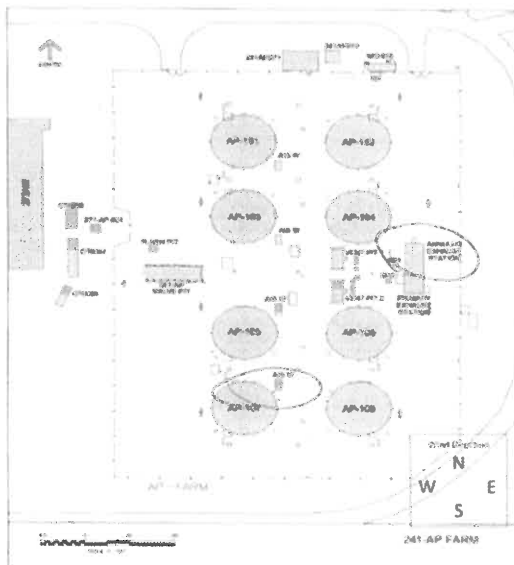
- Date and time odor was noticed 4-6-16 9:00 AM
- Your name and the work you were performing [redacted] electrical testing
- Location of odors (mark area on map and wind direction) AP Tank
- Name of others in or near the affected area [redacted]
- Was an IHT present? NO
- Describe the odor Sweet Sour Musty Earthy Metallic Smoky Rotten Onion
 Cleaning Solution Ammonia Other _____
- Possible source exhausters
- Your symptoms (if any) Headache Dizziness/Light-Headed Nausea Cough
 Fatigue/Drowsiness/Weakness Sore/Burning Throat Difficulty Breathing Watery/Irritated Eyes/Trouble with Vision Tingling/Numbness/Paralysis Rash/Itching
Other metallic taste in mouth

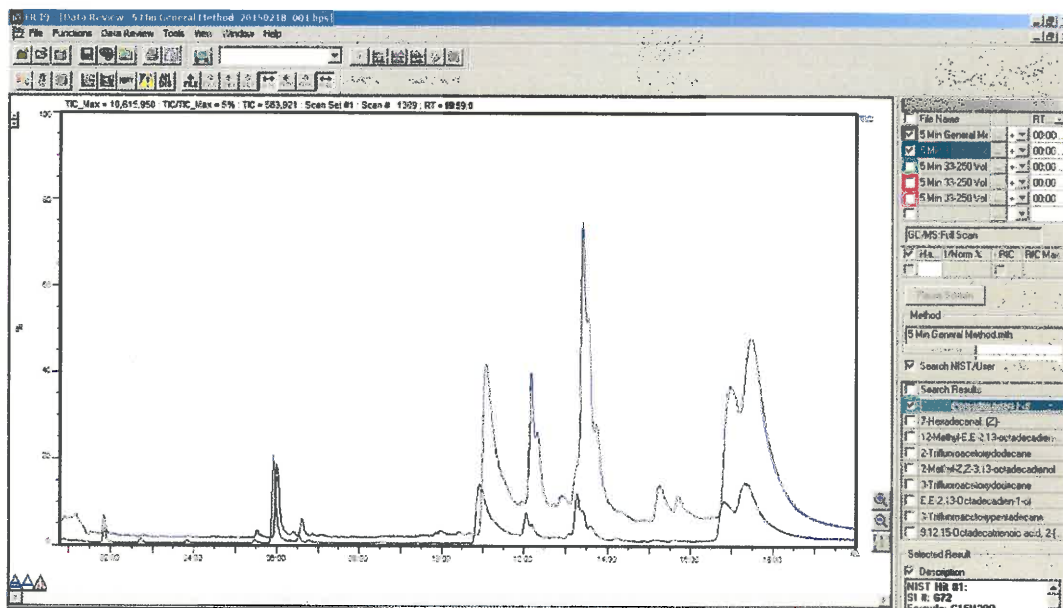
Bag 1 – Change trailer to exhauster. In this picture the blank is black and the sample is blue. Basically the sample is a match to the blank. The higher peaks past to 10:00 mark are due to the extended sample time. The high peaks before 10:00 mark are internal standards.

Bottom line: All 4 bags closely align with the blank sample.

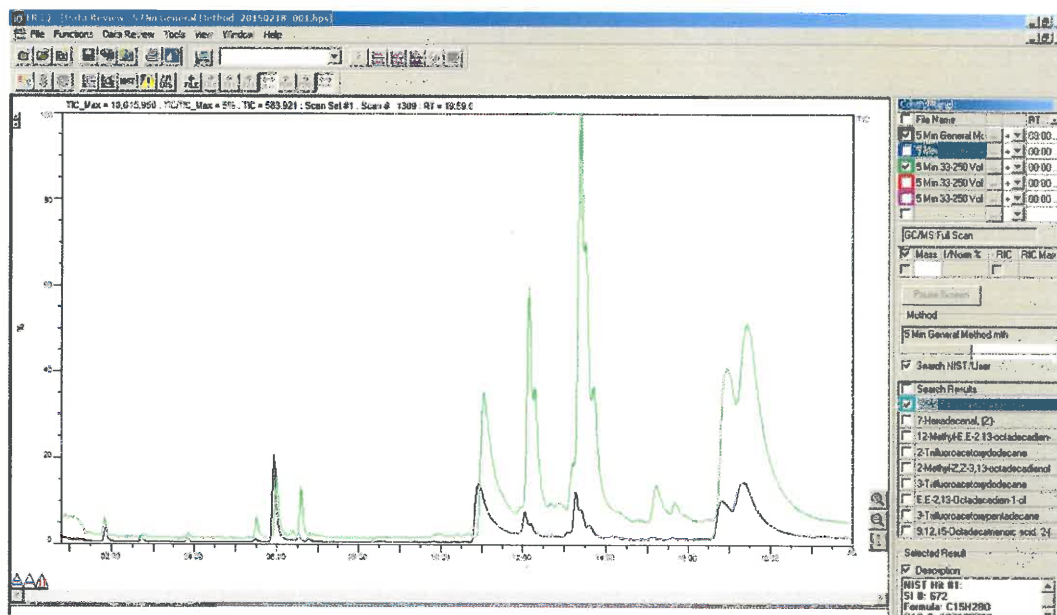
Bag 2 – Exhauster to AP-107. The blank is in black, the sample is green. Again, the sample is a basic match with higher peaks due to extended sample time.

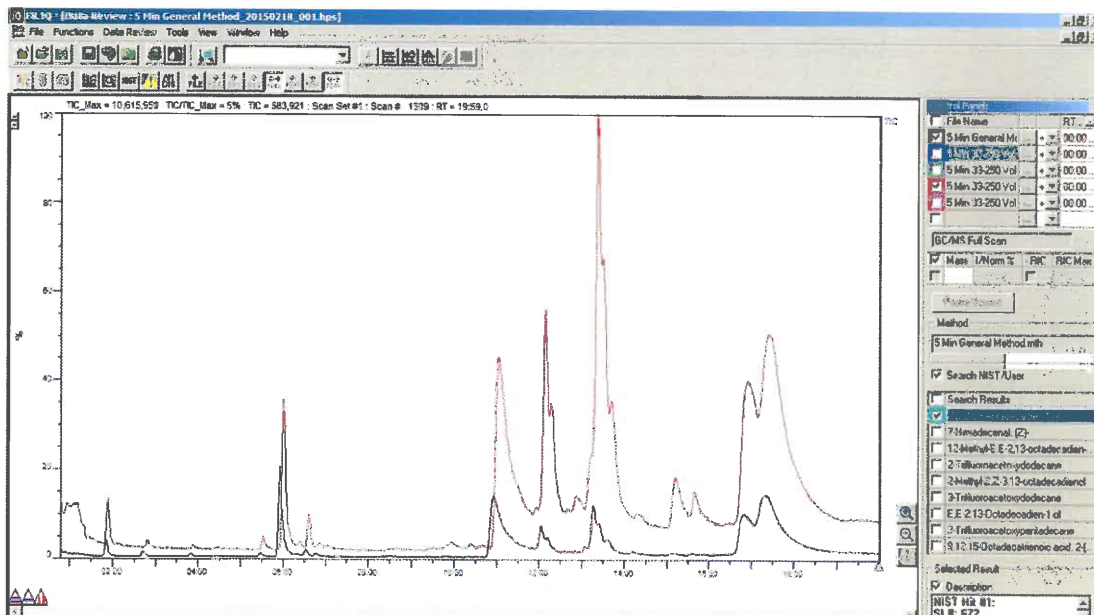
Bag 3 – AP-107 crane and AP-107. The same explanation as above applies to this sample as well.

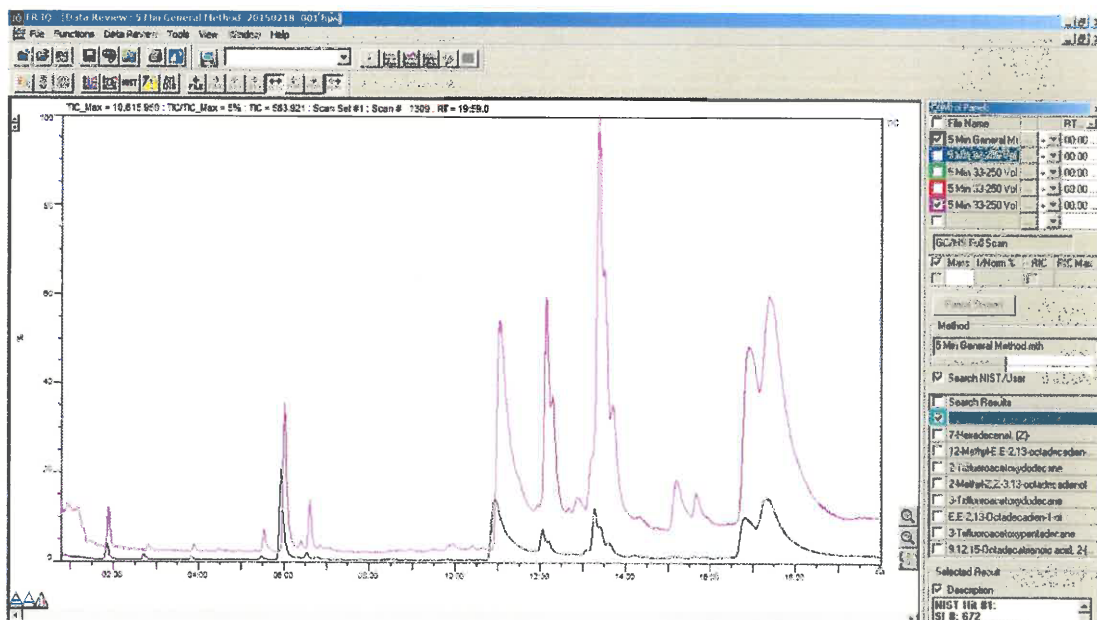
Bag 4 – AP-107 to change trailer. The same explanation as above applies to this sample as well.
