EVENT INVESTIGATION REPORT

241-T-201 Primary Tank Video Vapor Event EIR-2014-008

PER No. WRPS-PER-2014-0554

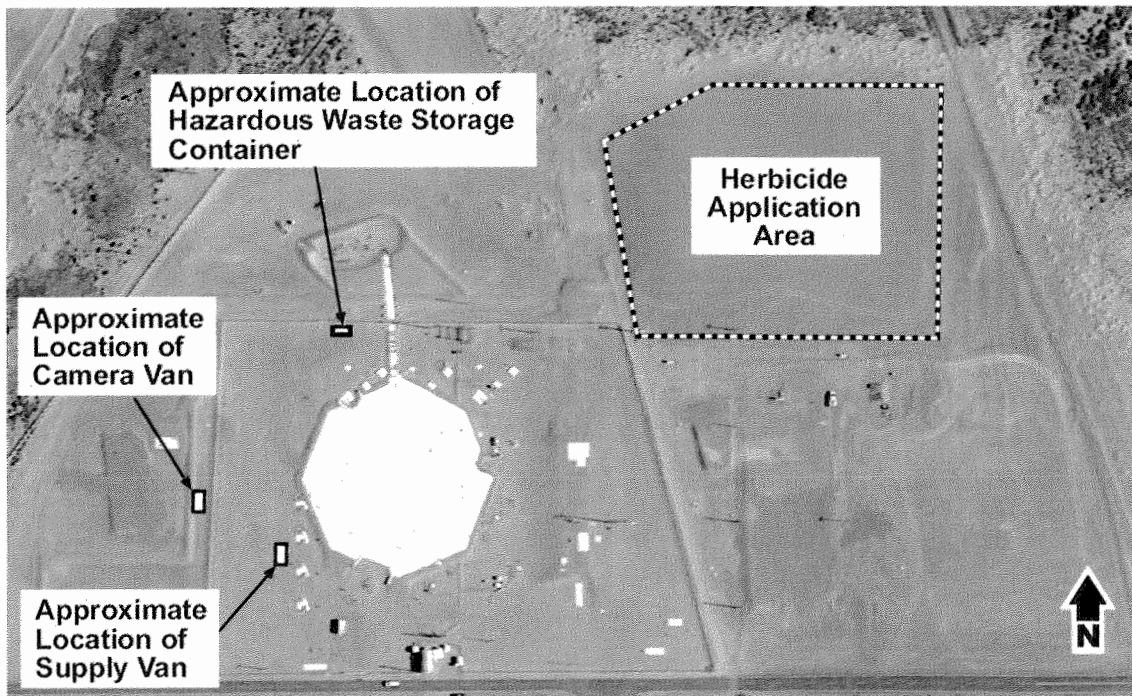
[See the sketch of the 241-T-201 work area. The waste box was located to the north of the T-201 primary video work area and herbicide was being applied to an area northwest of the work location.]
