EVENT INVESTIGATION REPORT

EIR-2018-043 "TF-AOP-015 Event Southeast of AW Farm"

(WRPS-PER-2018-2932)

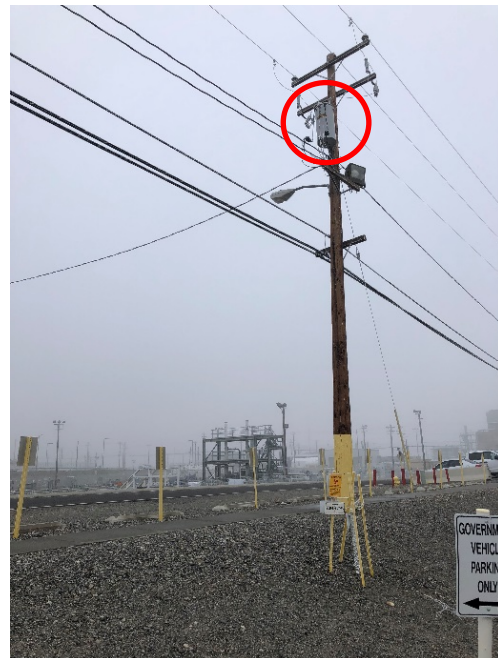
Utility Pole and Transformer C6692L

In order for the MSA work crew to conduct the outage, a “Bucket Truck” was required to access Transformer C6692L, which is mounted on a utility pole located between the southeast corner of AW Farm and Building 272-AW (see photos below).

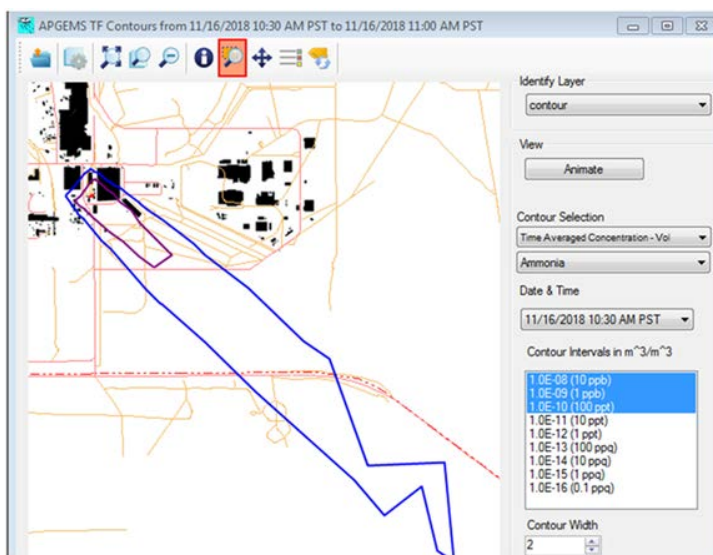
The met data for that time (as indicated in the EIR as well) had winds out of WNW (going toward ESE). The atmospheric mixing height was 60 ft., and stability was neutral. Since the stack was lower than the mixing height, and the temperature profile was neutral, one would expect limited vertical mixing (i.e., the emission would disperse horizontally).

The screen shot from the APGEMS model of the 10:00-10:30 plume from the AW stack, just showing the three highest concentration contour levels. The plume went directly to the SE, so from a lateral perspective, the workers were in the line of the plume. However, from the vertical perspective, they were probably below the centerline of the plume. Based on the analysis of the model output, it's likely that the short-duration concentration was less than 1 ppm, and perhaps less than 0.1 ppm. (The highest concentration here is 10 ppb = 0.01 ppm, so going an order of magnitude higher for shorter duration makes sense.) The OEL for ammonia is 25 ppm; the action level for Ammonia is 12.5 ppm. The modeled concentrations are well below these regulatory thresholds. The odor threshold is noted to be as low as 0.037 ppm (37 ppb). Modeling results are consistent with direct reading instrument readings taken by IH during the AOP-015 response and would be consistent with the workers smelling the odors at the ppb concentrations.
