EVENT INVESTIGATION REPORT

**Investigation of TY Farm AOP-015 Entry
Event Investigation Report 2019-013**

4/9/2019

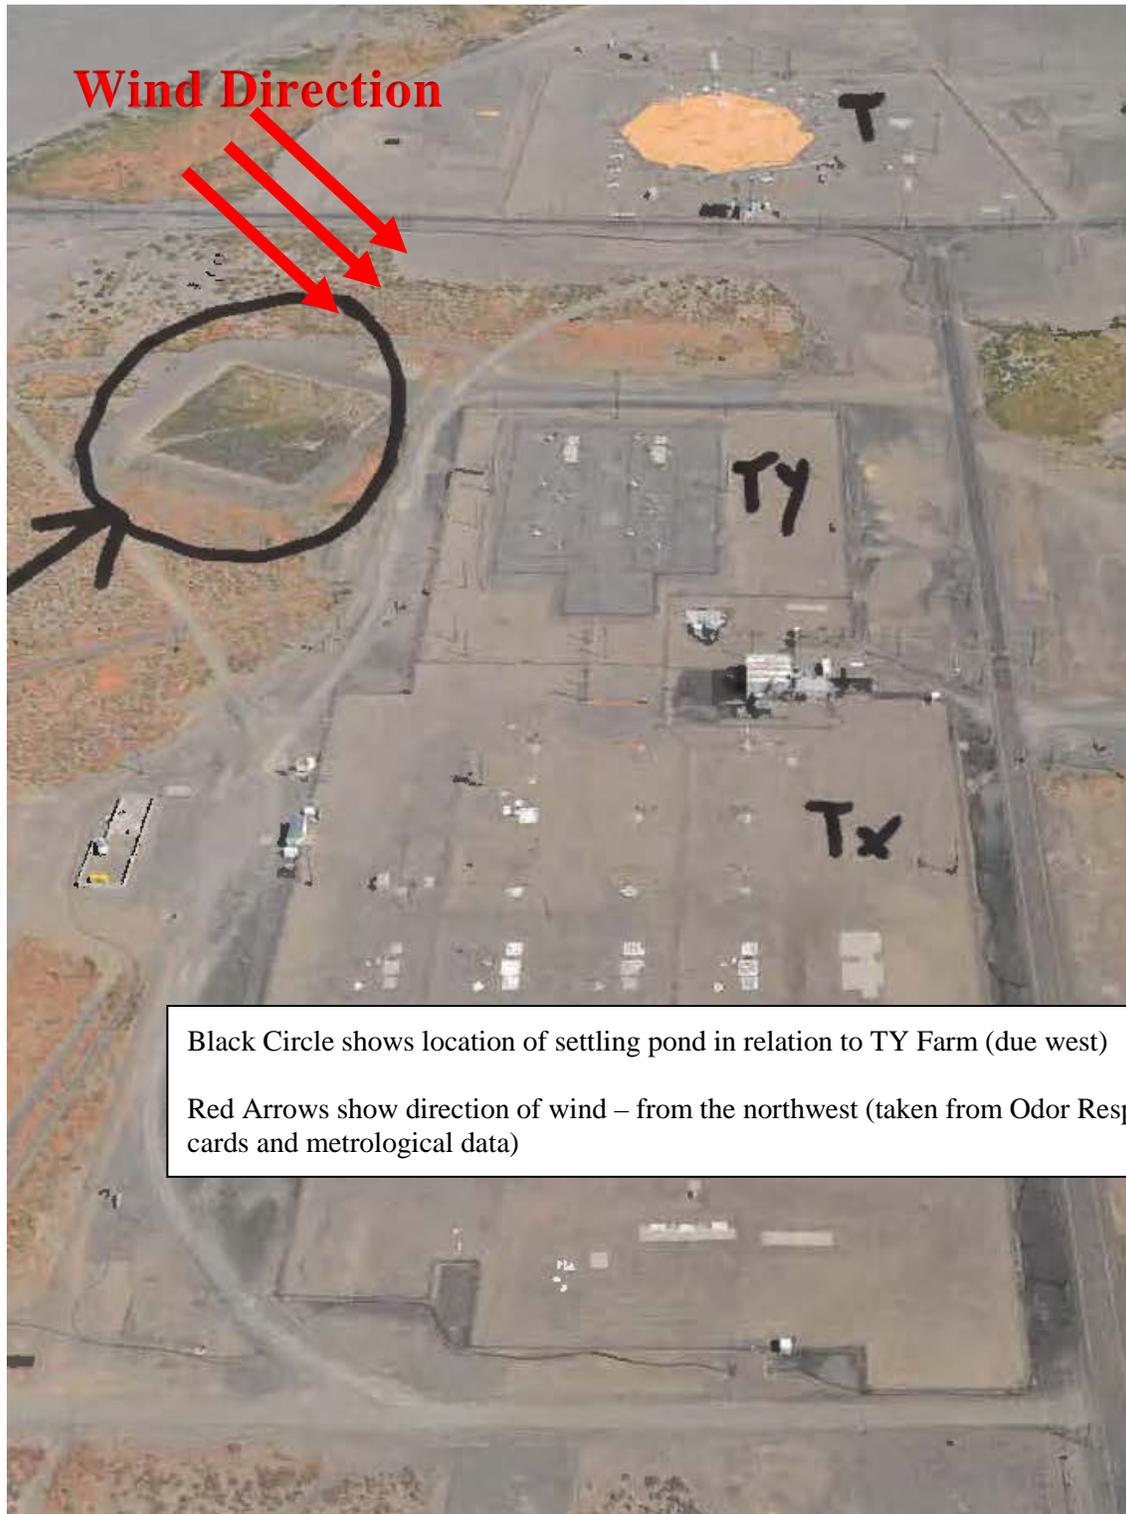
Figure 1- CSO Logs for investigation for TY Farm AOP-015 entry

03/19/2019 -- 13:24	Entered TF-AOP-015 Response to Reported Odors or Unexpected Changes to Vapor Conditions. [REDACTED] reports that 4 electricians were heading to TY Farm to perform electrical PMs. While traveling south on Camden Ave from 23rd St, the electricians reported smelling a rotten egg odor near the NE corner of TY Farm. None of the workers are experiencing symptoms and have declined medical evaluation.
03/19/2019 -- 13:31	Odor response cards have been received by the CSO. Review of the Odor response cards reveal that 2 individuals were on the west side of TY farm near the change trailer and the other two were on the east side of the farm on Camden Ave.
03/19/2019 -- 13:53	IHTs have been briefed and dispatched to TY Farm.
03/19/2019 -- 14:14	ER-2 reports that road blocks are in place at 23rd and Camden, and also at 23rd and a dirt access road west of Camden.

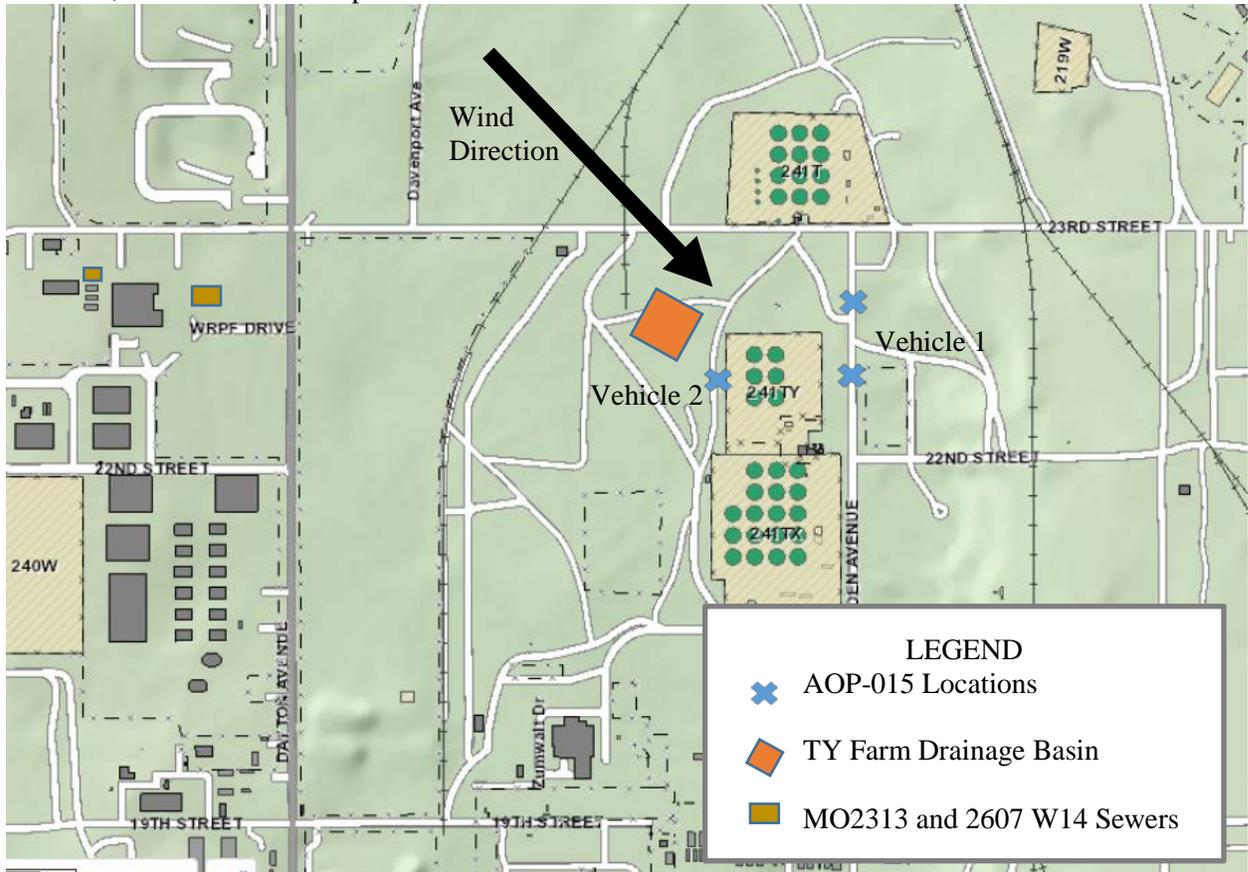
Figure 1. AOP-015 Locations in Relation to Potential Vapor Sources.

TY tank farm is a potential source of interest given that the AOP-015 locations surround the tank farm. Rotten egg smells are typical of H_2S evolution from sewer systems and swamps. Therefore, nearby sewers are also potential sources of interest. The MSA sewer map and pumping log were checked to determine upwind sewers of interest. The MO2313 and 2607-W14 sewers qualified as sewers to be investigated. A drainage basin directly upwind of the AOP-015 locations was observed to have standing water at the time of the AOP-015 event (see Figure 2). Although this basin may not qualify as a ‘swamp’, based on its proximity to the odor events it is a potential source of interest to be investigated.

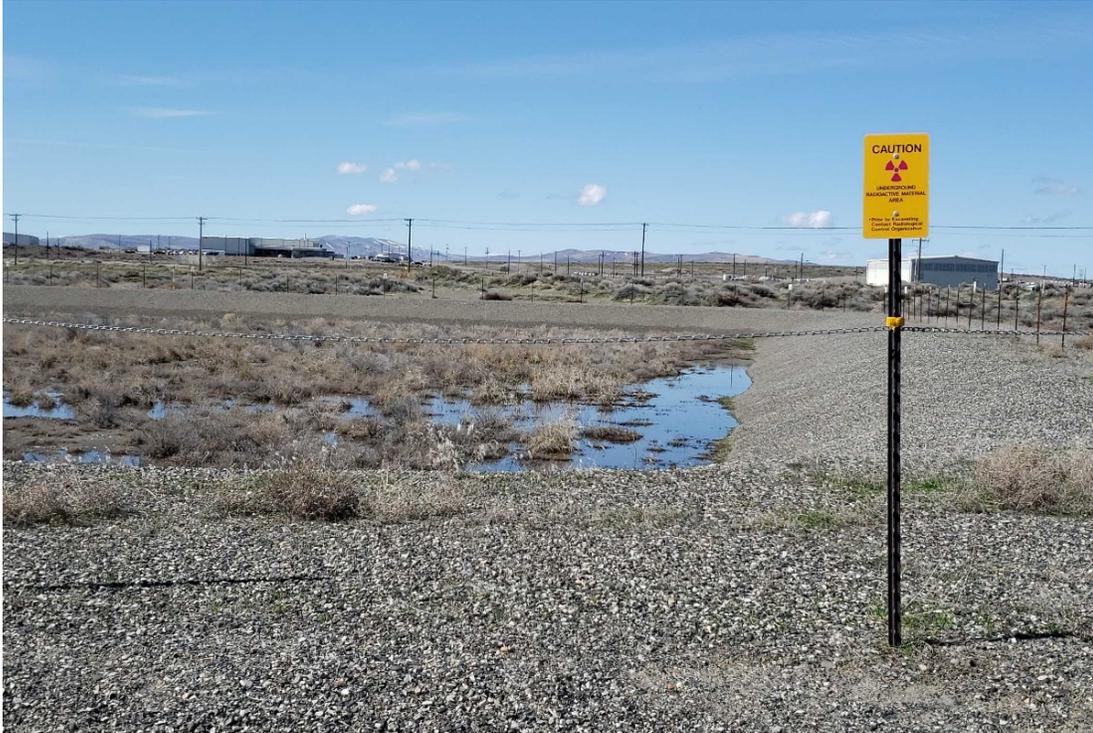
Figure 2. Photo of Drainage Basin to the West of TY-Farm.

- **The drainage basin adjacent to and NW of TY-Farm is a plausible but indeterminate source of the AOP-015 odors.** The reasoning for this conclusion are as follows:
 - The AOP-015 location was directly downwind of the drainage basin.
 - APGEMS-TF modeling indicates that the AOP-015 locations were in the center of the drainage basin plume and in or near the highest concentration region.
 - Hydrogen sulfide - H_2S (rotten egg smell) is often emitted from swampy areas due to the decomposition of plant organic matter.

- The source is indeterminate because IH workers were unsuccessful in observing a smell from the drainage basin on the day following the AOP-015 event, although they were unable to get close to or downwind of the basin.

A drainage basin to the West of TY-Farm was full of water on the day of the AOP-015 event. The ambient temperature was relatively warm on the day of the odor event (55 °F) and resulted in a significant snowmelt, potentially leading to accumulation of drainage water.

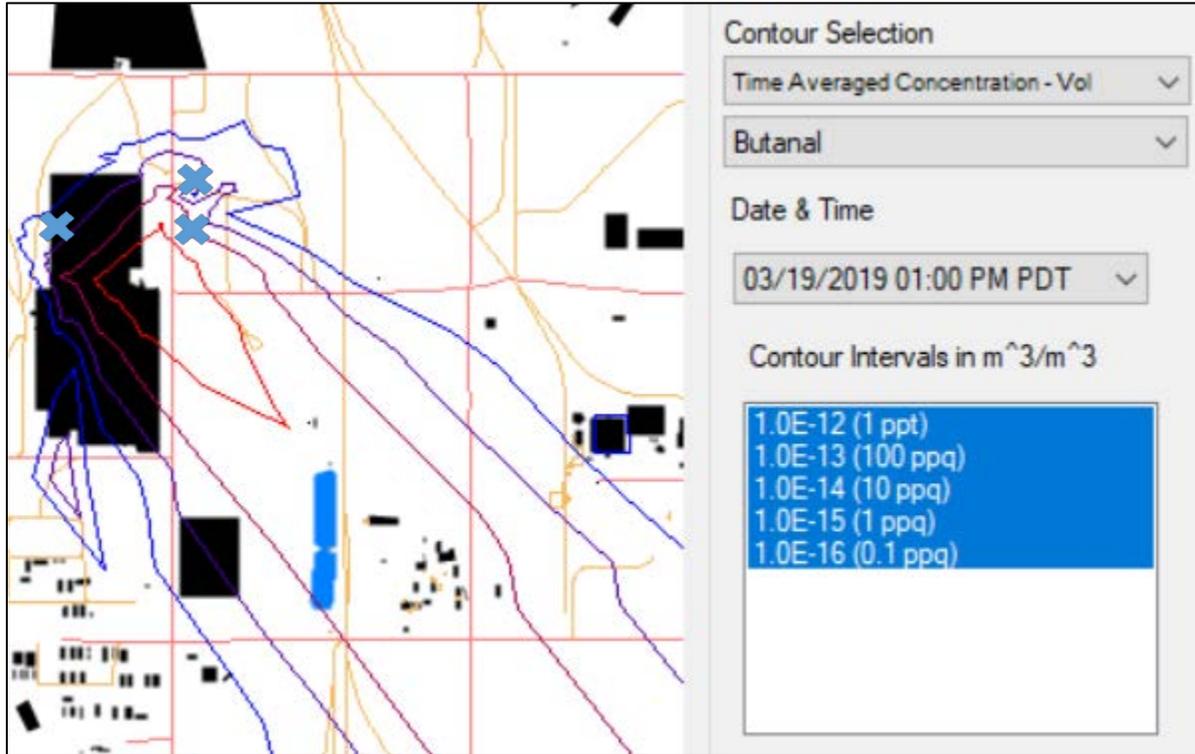
APGEMS-TF modeling was performed to predict the maximum release of butanal from TY-Farm tanks at the time of the AOP-015 event. TX-Farm and T-Farm tanks were not included in the model, since 1) they have significantly less butanal and butanol than the TY-Farm tanks, 2) they are further away from the AOP-015 locations than TY-Farm, and 3) their plumes do not intersect with one or more of the AOP-015 locations. The APGEMS-TF model uses source terms equal to the highest measured headspace concentration for each chemical and each tank and an upper bound emission rate for passive breather filters. Results from APTGEMS-TF modeling for butanal are provided in Figure 3. The image includes predicted butanal concentrations at the time of the AOP-015 event as shown by concentration contour lines with the innermost contour line equal to the highest concentration shown in the right-hand legend. Each successive contour line moving out from the center is 1/10 the concentration of the prior. The highest contour line shown in Figure 3 is 1 ppt, indicating that worker

exposure to butanal was at most 3.5 orders of magnitude below the odor threshold. To corroborate results from APGEMS-TF modeling, the TY-Farm Tank concentrations were compared to summary results from the Kenexis analysis with the fire dynamics simulator (FDS) computational fluid dynamics (CFD) model. Both models yielded the same answer, which is that butanal was below the minimum odor threshold at each of the receptor locations. Therefore, the TY and TX tank farms are an unlikely source of the odors smelled by the workers during the AOP-015 event.

Figure 3. APGEMS Modeling of TY Farm PBFs at time of AOP-015 Event, Butanal Concentrations at AOP-015 Locations (indicated by blue Xs) are 3.5+ orders of magnitude below its Odor Threshold APGEMS-TF modeling was performed for TY-Farm tanks for all COPCs present in the headspace above their occupational exposure limits (OELs). Only two compounds have been observed above their OELs in TY-Farm headspaces as follows: ammonia at 124% of OEL and furan at 650% of OEL (TWINS and SWIDS). Figures 4 and 5 show APGEMS-TF modeling results for TY-Farm passive breather filters (PBF) for ammonia and furan respectively based on emissions corresponding to the maximum observed headspace concentration for each tank and the maximum PBF release rates. Concentrations of ammonia and furan at the AOP-015 locations are estimated at < 0.01% of OEL. Therefore, the breathing spaces at the AOP-015 locations were safe with respect to tank vapors.

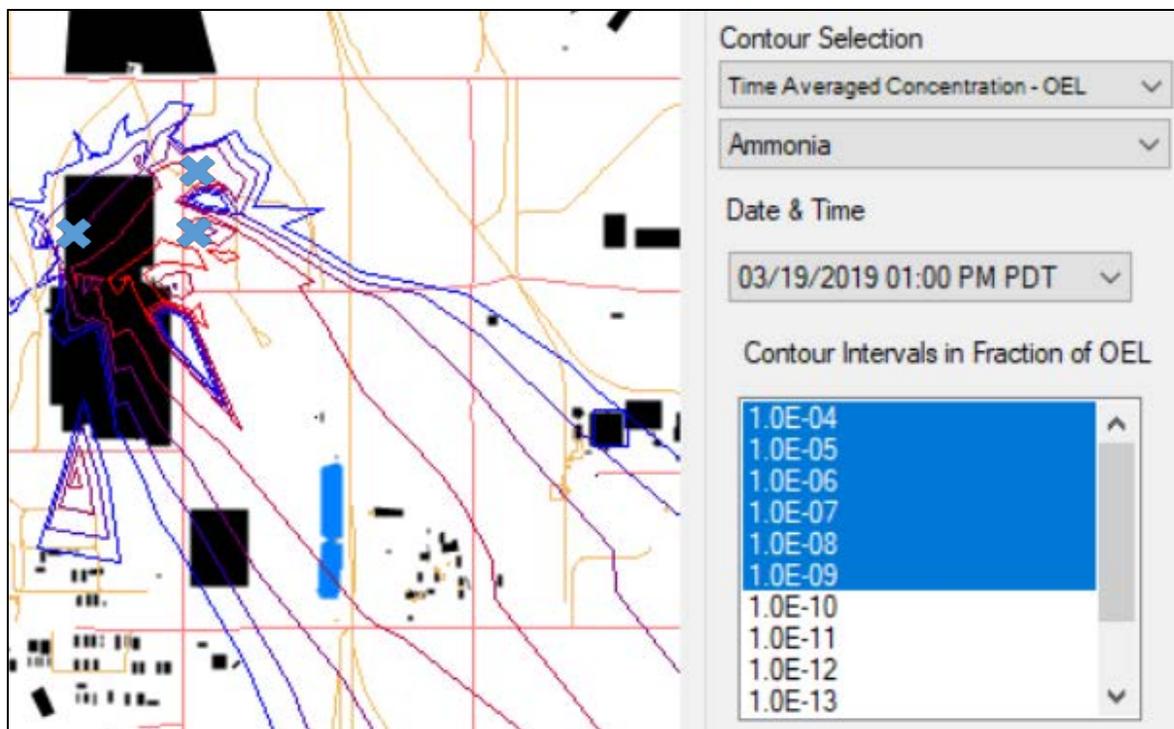
Figure 4. APGEMS Modeling of TY-Farm PBFs at time of AOP-015 Event, Predicted Ammonia Concentrations at AOP-015 locations (indicated by blue Xs) are 4+ orders of magnitude below its OEL

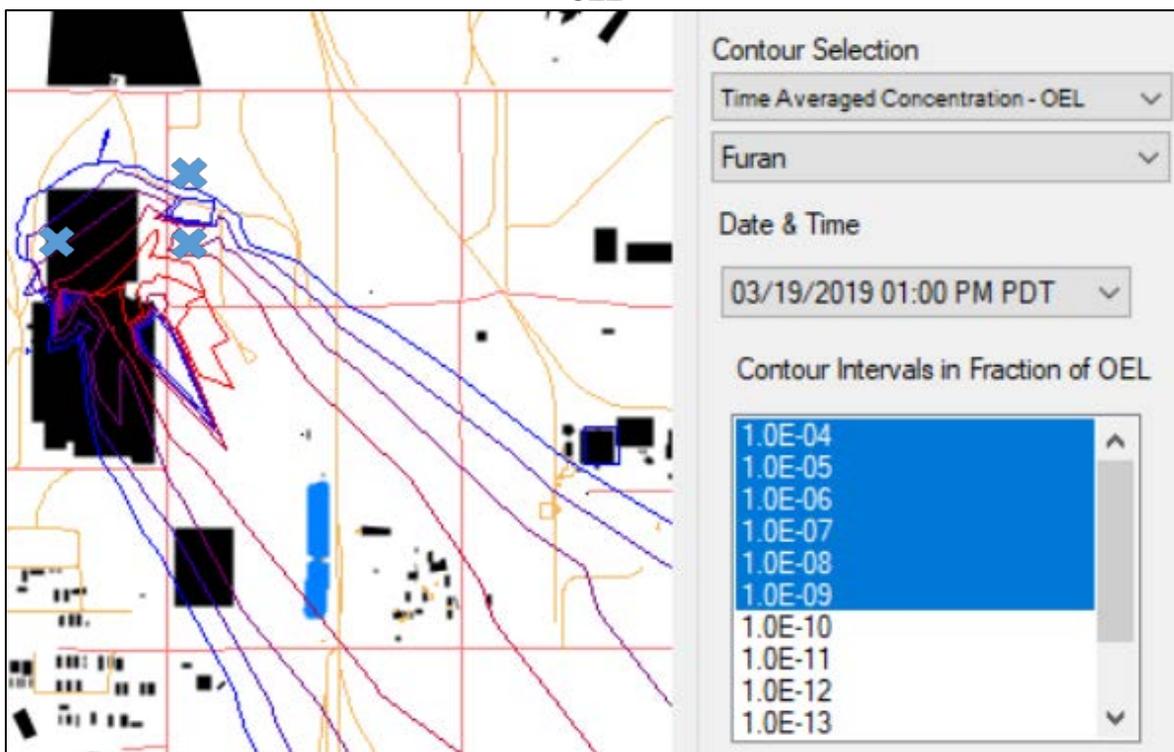
Figure 5. APGEMS Modeling of TY Farm PBFs at time of AOP-015 Event, Predicted Furan Concentration at AOP-015 Locations (indicated by blue Xs) are 4+ orders of magnitude below its OEL

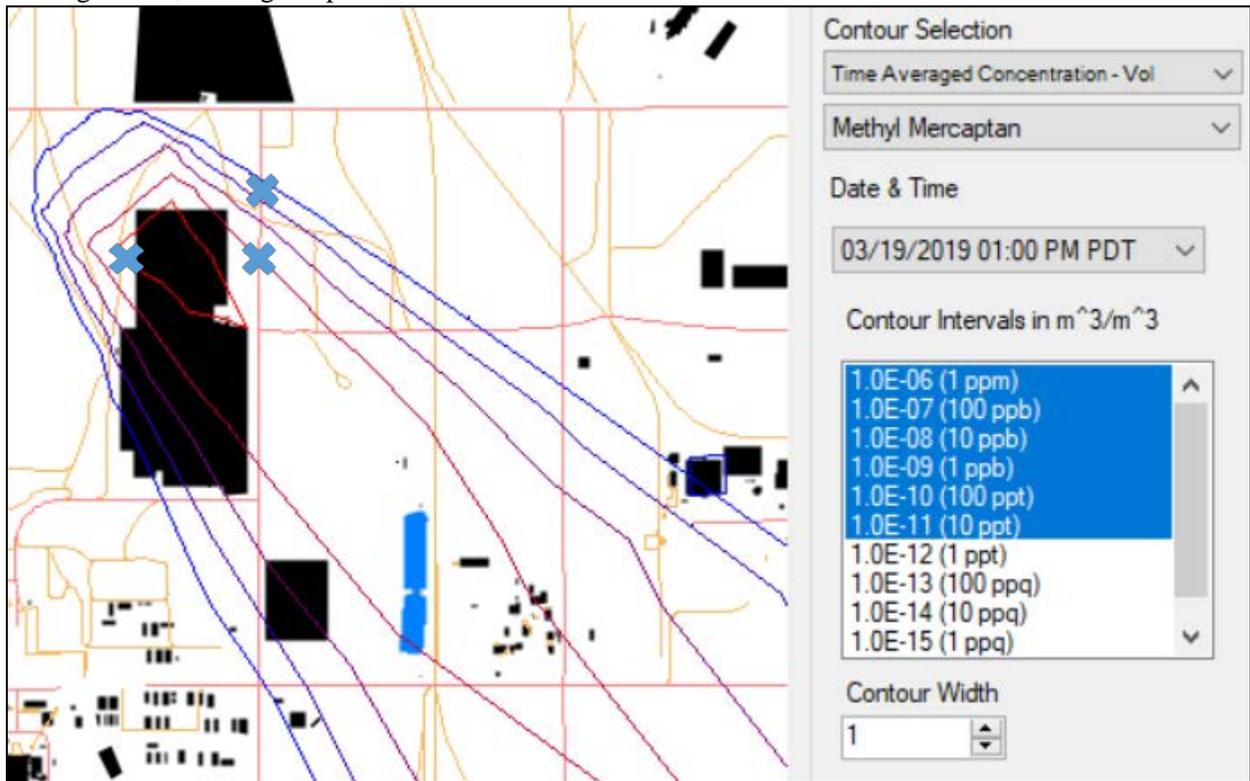
Figure 6 provides APGEMS-TF modeling of the drainage basin adjacent to and northwest of TY-Farm. Drainage basin vapors were modeled as methyl mercaptan (a common odor causing chemical associated with organic matter decay), but the source term was arbitrarily set at 1 g/s. This is due to the fact there is no data driven source term available (chemical type, concentration, and volumetric gas emission rate) for the drainage basin. The contour lines shown in Figure 6 cannot be attributed to specific methyl mercaptan concentrations, but they do reflect the direction of the drainage basin vapor plume and relative concentrations (each contour line from the center out is 1/10 the concentration of the previous).

The AOP-015 locations were in the center of the drainage basin plume and within or near the highest concentration contour. Modeling indicates that the drainage basin is a plausible source of the AOP-015 odors. However, IH workers at the same location on the following day did not observe odors emanating from the drainage basin. The IH workers were unable to get close to or downwind of the drainage basin, making it a plausible but indeterminate source.

Figure 6. APGEMS Modeling of TY Farm Drainage Basin, Methyl Mercaptan concentrations are arbitrary but the AOP-015 Locations (indicated by blue Xs) are in the Center of the Plume and within or close to the Highest Concentration Contour

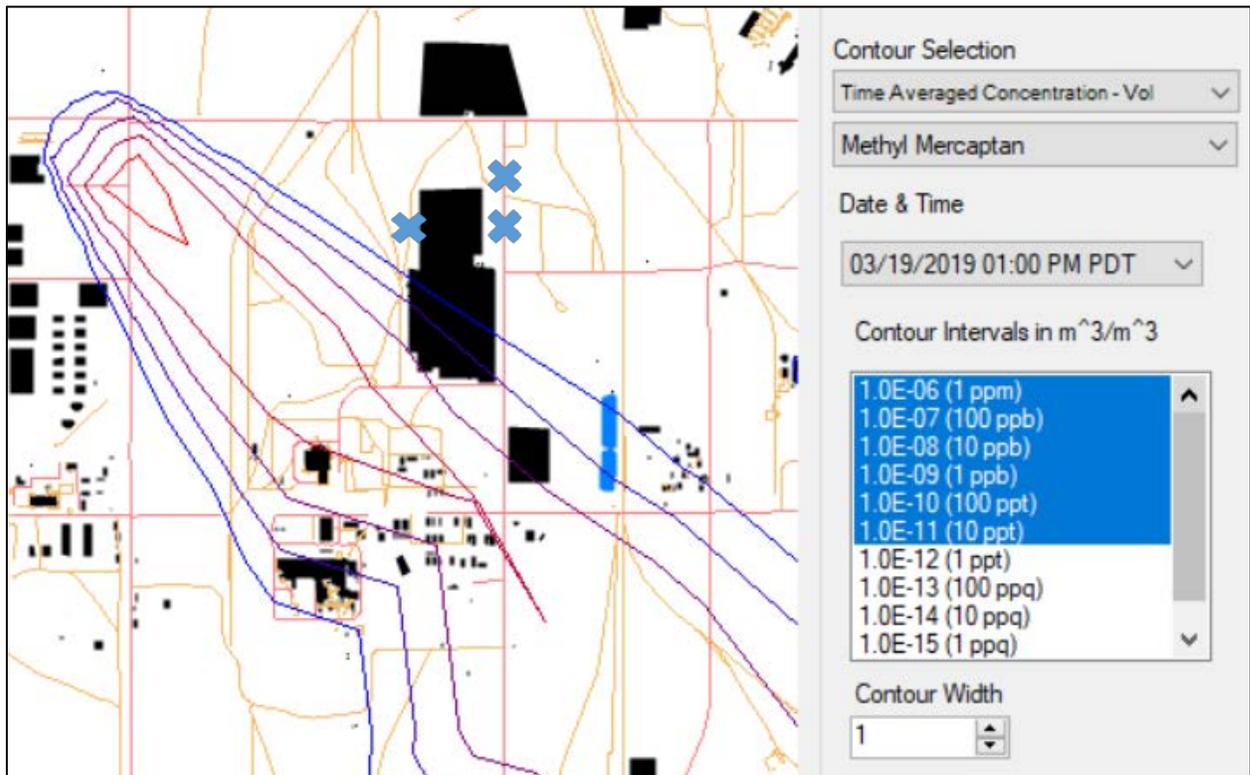
Figure 7 provides APGEMS-TF modeling of the MO-2313 and 2607-W14 Sewers. The sewer vapors were modeled as methyl mercaptan (a common odor causing chemical in sewer gases), but the source term was arbitrarily set at 1 g/s. This is due to the fact there is no data driven source term (chemical type, concentration, and volumetric gas emission rate) for sewer systems around the Hanford site. The contour lines shown in Figure 7 cannot be attributed to specific methyl mercaptan concentrations, but they do reflect the direction of the sewer vapor plume and relative concentrations (each contour line from the center out is 1/10 the concentration of the previous).

The AOP-015 locations are outside of the MO-2313/2607-W14 sewer plume, and a long distance from the source. The APGEMS-TF model is designed for light to moderate weight vapors. Many

sewer gases are large, heavy molecules that do not disperse as easily as lighter gas molecules. Thus, the APGEMS-TF model may over-predict dispersion of heavy sewer gases. Heavy sewer gases are known to migrate along the ground and resist dilution for significant distances. MSA personnel indicated that only a few hundred gallons of sewage were pumped from MO-2313 sewer on the day of the AOP-015 event and that the 2607-W14 sewer did not smell when inspected on the day after the event. Even though the APGEMS-TF model may be non-conservative for sewer gases, the direction of the plume and the large distance between the sources and AOP-015 locations leads to a conclusion that the MO-2313/2607-W14 sewers are an unlikely source of the AOP-015 event.

Figure 7. APGEMS Modeling of 2607-W14 Sewer with Methyl Mercaptan - AOP-015 Locations (indicated by blue Xs) are outside of the Sewer System Plume
