EVENT INVESTIGATION REPORT

Event Investigation Report, EIR-2019-014 244A AOP-015 Entry EIR-2019-014

PER No. WRPS-PER-2019-0574

244A AOP-015 Entry

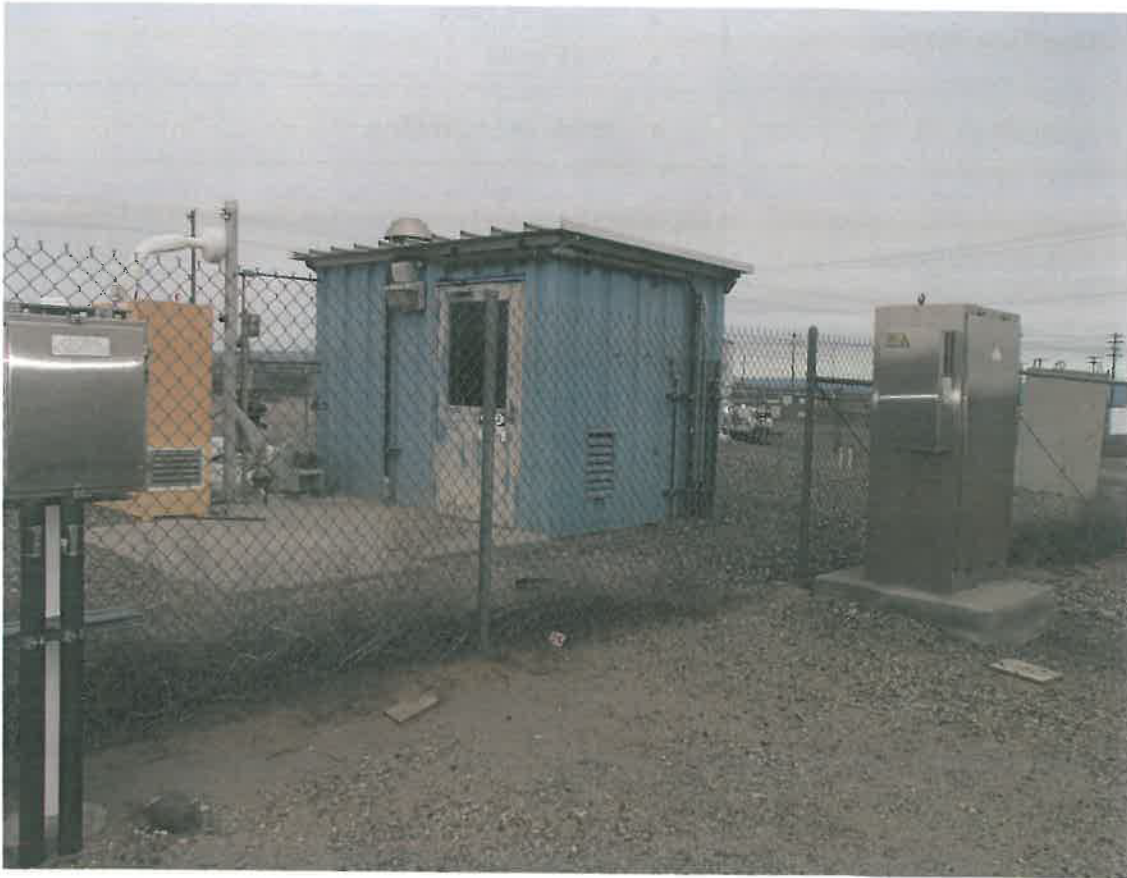
Figure 1. 244-A Instrumentation Building
