# COMBINED EVENT INVESTIGATION / CAUSE ANALYSIS REPORT

## AOP-015 for Odors East of 241-AP Farm

**EIR-2019-029**

**WRPS-PER-2019-1241**

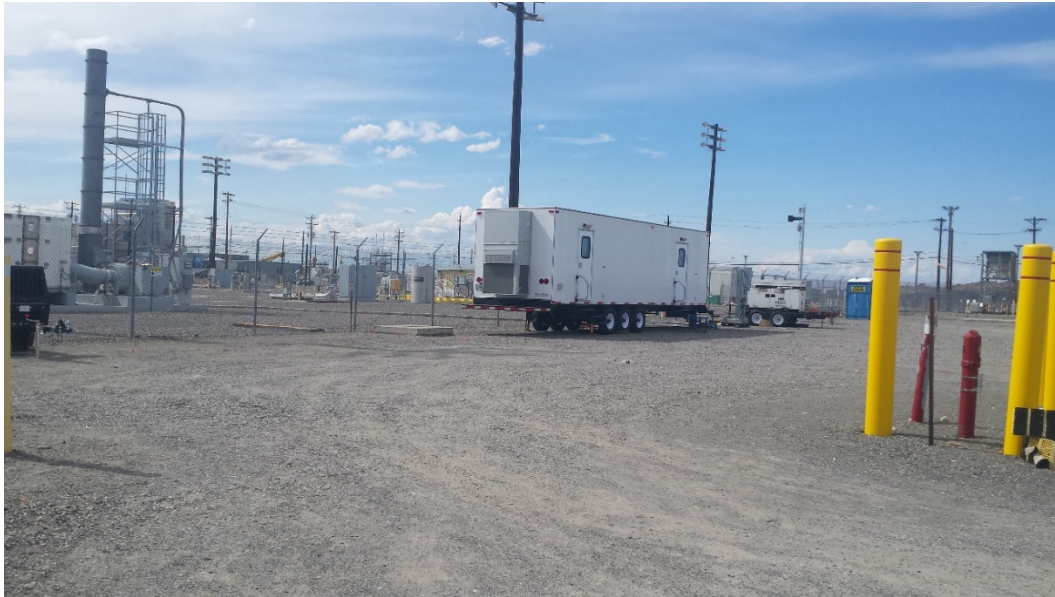
*Figure 1. East of 241-AP Farm and approximate location of personnel when they experienced odors. Trailer in the distance is the Ultrasonic Testing Control Room Trailer.*

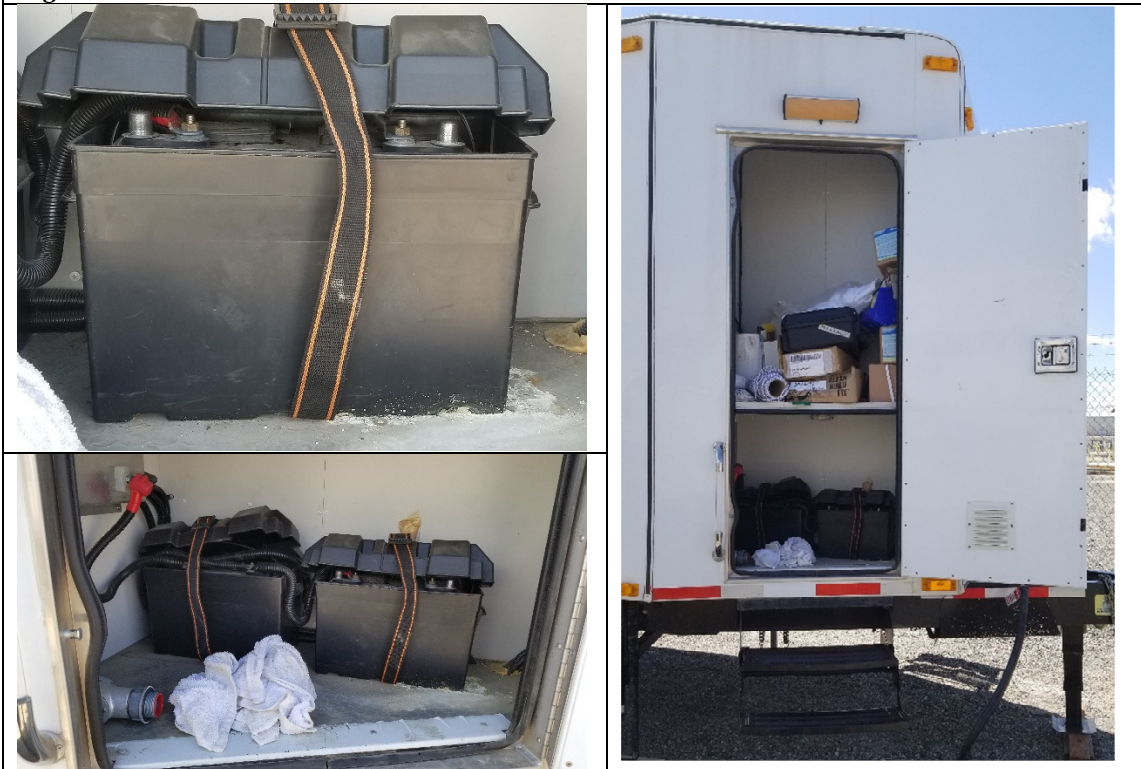
**Figure 3. Corroded Batteries Found in the UT Trailer**

The TGIHRV (i.e., mobile lab) continued to investigate and discovered the source of the odors. Initially, the TGIHRV team had been focused on the diesel generators as the possible source, but new information led them to investigate the trailer just south of the generators, the Ultrasonic Testing Control Room Trailer (i.e., UT trailer). At ~1330, the Field Work Supervisor (FWS) from the Ultrasonic Testing Control Room Trailer opened the storage area at the front of the UT trailer and the investigating technicians immediately detected a strong sewer/rotten egg smell being emitted from two corroded lead batteries inside (Figure 2).

The event was concluded to be a low level hazard and an isolated incident. The chemicals of concern (e.g., hydrogen sulfide) were not detected in the airborne samples collected by Industrial Hygiene and the presence of the degraded batteries was determined not to be a vapor concern. However, the batteries did exhibit exposed battery acid.

A Cause Analysis was performed to further explore the presence of the degraded batteries. The analysis discovered that the UT trailer had a recent history of batteries malfunctioning. In April 2018 and in August 2018, the batteries were replaced. Recently, on June 6, 2019, the UT trailer had been relocated from AN Farm to AP Farm. The DC batteries had been utilized and were functioning properly at the time. However, on June 19, 2019, the batteries were found to be in a state of corrosion with dried battery acid found on and around the batteries. The batteries had likely overcharged which resulted in the boiling off/over of battery acid. In the past, the UT crew had been manually disconnecting the battery from the generator-fed source to prevent the overcharging.

The cause of the overcharged/degraded batteries will require a mechanical inspection. Based on an interview with a mechanic from Mission Support Alliance (MSA) who is familiar with the battery issues of the UT trailer, the cause is likely a malfunctioning converter. Under normal conditions, the trailer would draw power from the AP Farm generator, and the converter would then convert the 110 volts from the generator to 12 volts for the DC battery. Under normal conditions, the converter would discontinue providing power to the battery when it reached the full 12 volts. However, in the instance of the UT trailer, it is likely that power continued to the battery causing it to become overcharged.

The cause analysis recommends conducting a mechanical inspection and then performing the necessary repairs to ensure that the batteries are not being overcharged.

Source of the odors was identified to be corroded lead acid batteries located at the front of the nearby UT trailer. The batteries were replaced the next day on June 20, 2019.

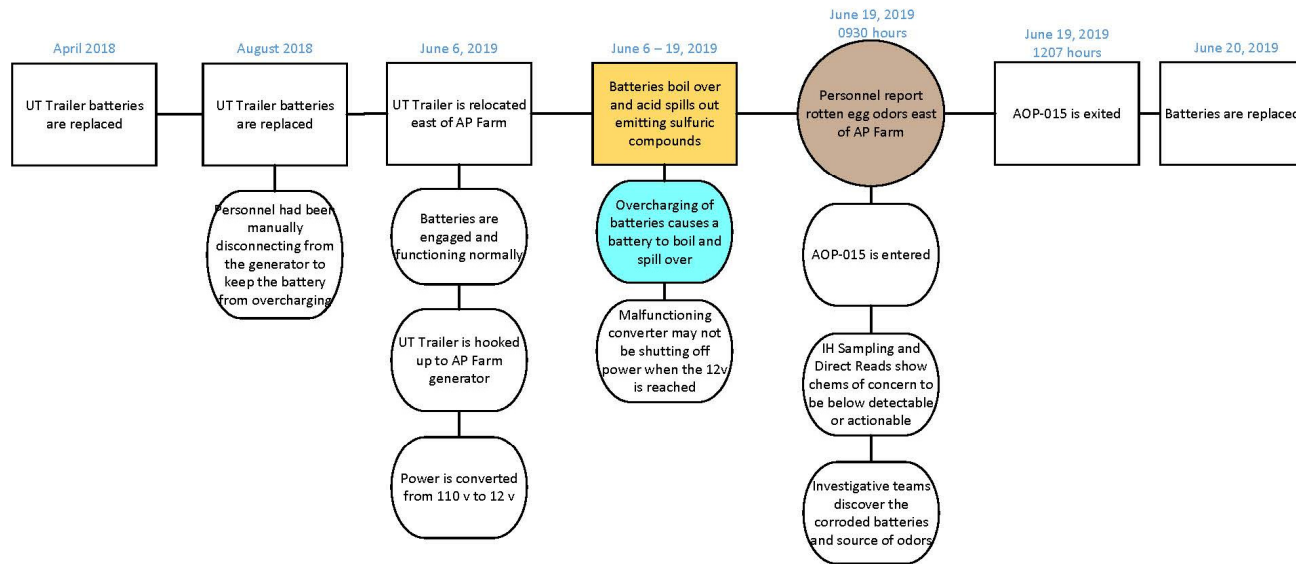
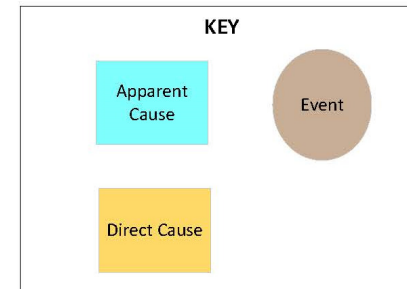
**Figure 4. Cause Analysis**

A Cause Analysis was performed to further explore the presence of the degraded batteries. A Cause-Effect chart shows the process of analyzing the events leading up to the discovery (Figure 4). The analysis found that the UT trailer had a recent history of batteries malfunctioning. In April 2018 and in August 2018, the batteries had been replaced. Recently, on June 6, 2019, the UT trailer had been relocated from AN Farm to AP Farm. The DC batteries had been utilized and were functioning properly at that time. However, on June 19, 2019, the batteries were found to be in a state of corrosion with dried battery acid found on and around the batteries. The batteries had likely overcharged which resulted in the boiling off/over of battery acid. In the past, the UT crew had been manually disconnecting the battery from the generator-fed source to prevent the overcharging.

The cause of the overcharged/degraded batteries will require a mechanical inspection. Based on an interview with a mechanic from Mission Support Alliance (MSA) who is familiar with the battery issues of the UT trailer, the cause is likely a malfunctioning converter. Under normal conditions, the trailer would draw power from the AP Farm generator, and the converter would then convert the 110 volts from the generator to 12 volts for the DC battery. Under normal conditions, the converter would discontinue providing power to the battery when it reached the full 12 volts. However, in the instance of the UT trailer, it is likely that power continued to the battery causing it to become overcharged.

- **Cause Code:** A2B6C04 End of life failure
- **ESTARS:** WRPS-PER-2019-1241.1
- **Action:** Submit KSR to MSA for facility electricians to inspect and diagnose. Specify in the notes of the request that this is a mobile trailer but due to high voltage levels, the work needs to be assigned to facility electricians. Note to check the converter and recommend repairs.
- **Deliverable:** Upload to ESTARS a copy of the inspection results and recommendations from the MSA facility electricians. If additional actions are recommended as a result of the MSA inspections, those actions will be added to this PER.
- **Responsible Manager:** Mike Hay
- **Due Date:** 9/30/2019

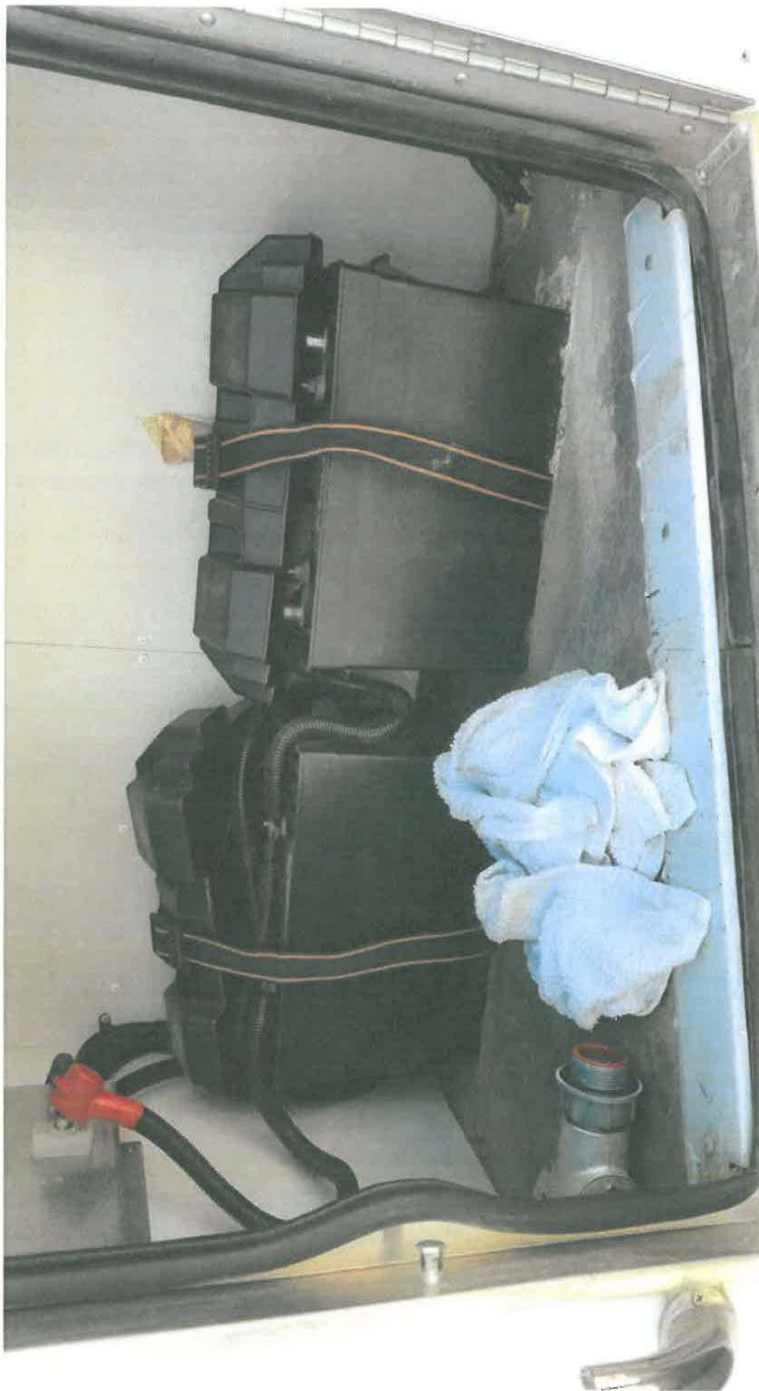
**Attachment B**  
**Photo of Lead Acid batteries**

Identification of Source of the Concern: ☒ Yes ☐ No  
 Lead acid batteries located in the front of a nearby Ultrasonic Testing Control Room-Trailer is the likely the source of the reported odor. When the storage area containing the batteries is opened, the odor became stronger. The batteries appeared to be overcharged. (See Attachment B) Over charged lead acid batteries can generate odors similar to those reported during this AOP-015.
