AOP-015 Event Investigation Reports (Redacted) EIR-2019-049 12022019

“TF-AOP-015 Event at AX Farm”

EIR-2019-049

WRPS-PER-2019-2370

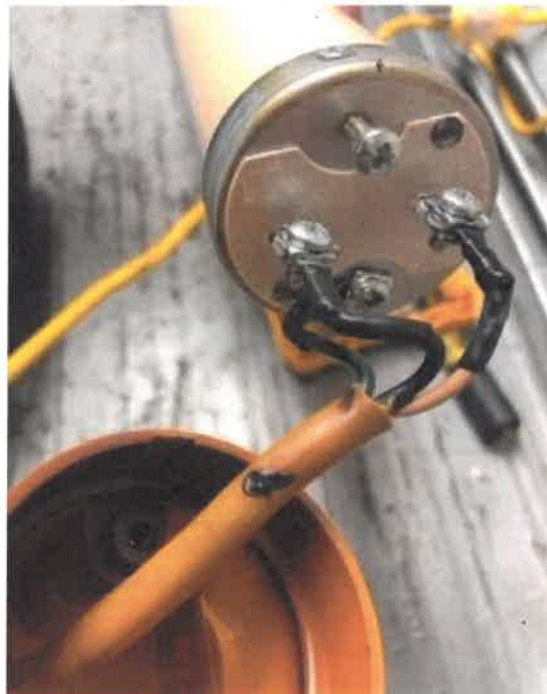
Figure 1: Partially Melted Outer Cord Covering

- A work crew entered AX Farm on SCBA on December 3, 2019 to investigate potential sources of odors. The work crew investigated the heated KNAACK job box, a fogco heat trace located on the AX-801A concrete slab, and 241-AX-103 Riser-3A. The work crew didn't identify any issues with the fogco heat trace or Riser-3A. The work crew removed the heating assembly from the KNAACK job box and discovered a melted outer insulation jacket around the power supply cord and the end cap of the heating assembly was discolored. The heating assembly was removed. Below is a photograph of the heating assembly after removal from the KNAACK job box.

The cause of the odor on December 2, 2019 was due to equipment failure. The heating assembly inside of a heated KNAACK job box located near the workers was defective. Poor assembly of the heating assembly piece caused the power supply outer cord protective covering to come into contact with a metal covering that was emitting 300F. This contact partially melted the covering causing the “burning” odor.

Cause	Corrective Action
<p>AC01: Power supply outer cord protective covering contacting a terminal. (Cause Codes: A2B6C01)</p>	<p>WRPS-PER-2019-2370.1: Issue a "Just in Time" Lessons Learned about the event and to notify other Department of Energy (DOE) contractors to identify any KNAACK job boxes model 89-H that may be in service. Actionee: ██████████ Due Date: 2/1/20 Deliverable: Issued "Just in Time" Lessons Learned.</p>
<p>AC01: Power supply outer cord protective covering contacting a terminal. (Cause Codes: A2B6C01)</p>	<p>WRPS-PER-2019-2370.2: Identify any KNAACK job boxes used within the Tank Farms, including WRPS subcontractors, and temporarily remove from service. Remove the internal heating assembly. Actionee: ██████████ Due Date: 2/1/20 Deliverable: Closure statement in ESTARS documenting the action has been completed.</p>
Other (Not Related or Extraneous to Cause)	Action
<p>Removal of FFAPR cartridges prior to IH inspection.</p>	<p>WRPS-PER-2019-2370.3: Issue a communication in the Safety Start-up to communicate to workers that during a response to odors, they should only doff their FFAPR and they should not remove the cartridges. Actionee: ██████████ Due Date: 2/1/20 Deliverable: A copy of the safety start-up slide.</p>

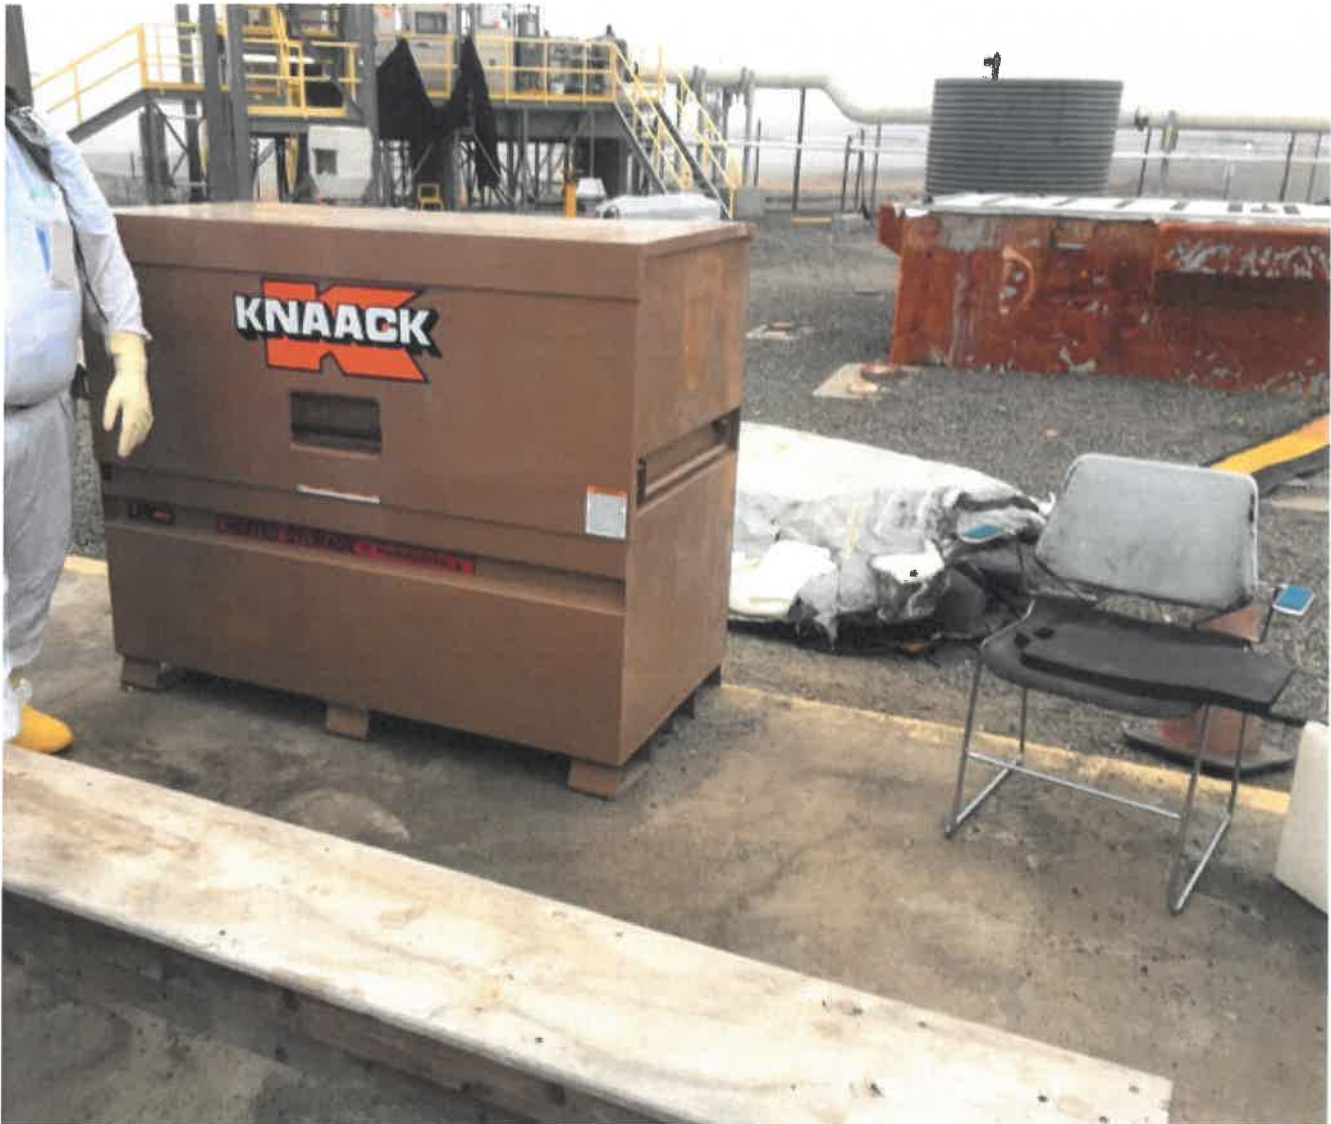
Figure 2: Heated KNAACK Job Box

During the investigation of the cause of the odor, a heated KNAACK job box located near where the odor was smelled was disassembled and it was discovered that the end cap on the heating assembly located inside of the job box was discolored. The crew removed the heating assembly for further inspection and it was discovered that the outer protective covering on the power supply cord had melted. The apparent cause of the odor was due to poor assembly of the heating assembly piece which caused the power supply outer cord protective covering to come into contact with a metal covering that was emitting 300F. This contact partially melted the covering causing the “burning” odor.

- On December 3, 2019 and December 4, 2019, WRPS Maintenance and WRPS Construction Subcontractors performed an extent of condition walk-down to identify if there were any other heated KNAACK job boxes (model 89-H) in service. It was identified that American Electric Inc (AEI) had a second heated KNAACK job box (model 89-H). The second KNAACK heated job box was also taken out of service.

WRPS work areas were walked down by WRPS and Subcontractor personnel to determine if there were any additional heated KNAACK job boxes model 89-H in service. A second KNAACK heated job box model 89-H was identified. The job box was pulled out of service.

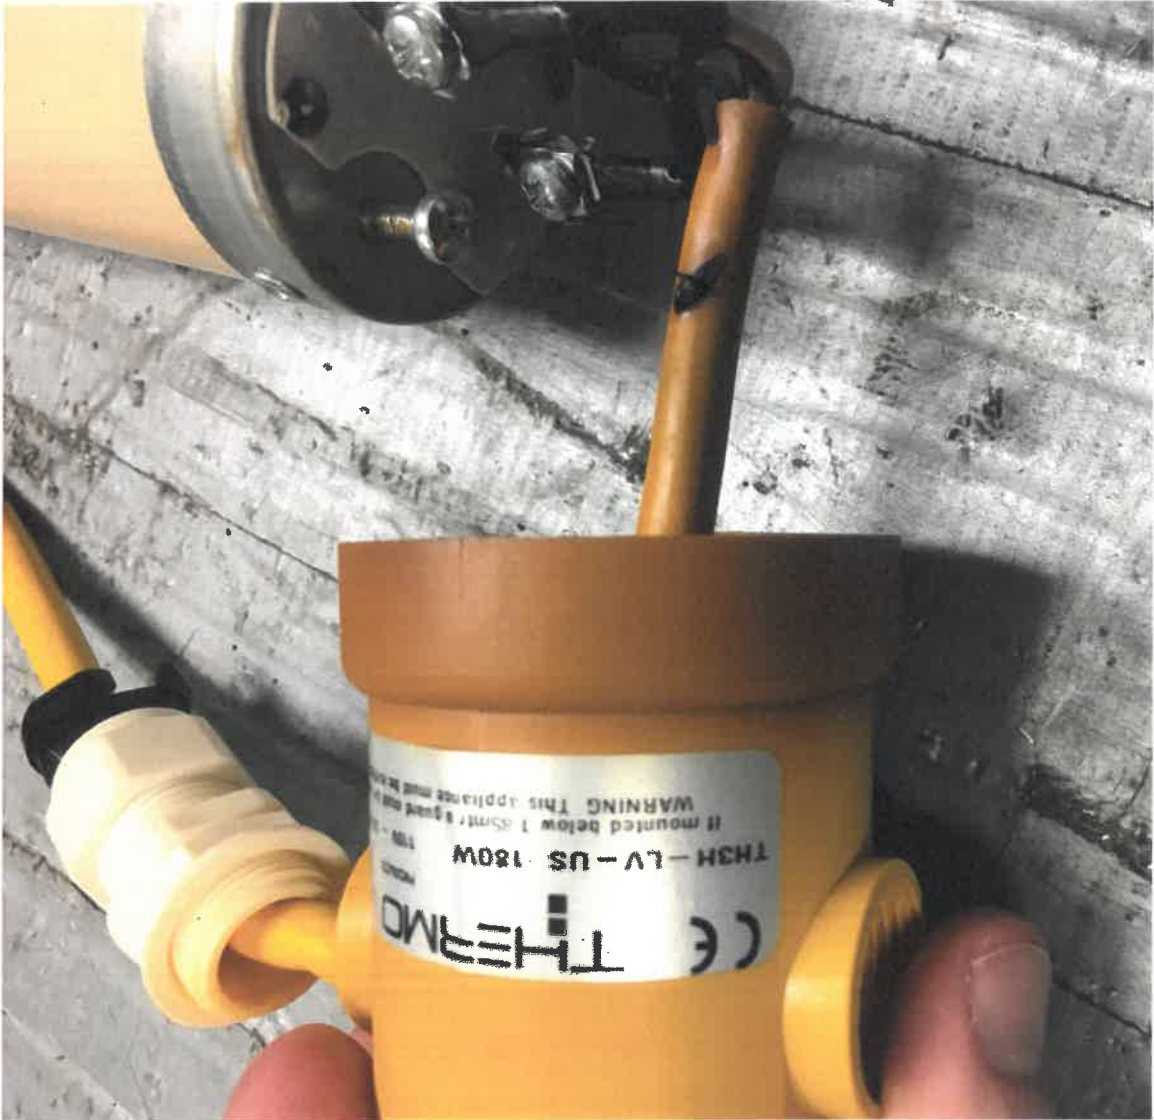
Figure 5: Discolored End Cap and Partially Melted Outer Cord Covering

When the heating assembly was assembled, the power supply outer cord protective covering was pushed up against a metal	When the part was assembled, the power supply cords should have been configured so that they were not making contact with the metal covering.	The outer protective covering around the power supply cord came into contact with the metal covering.	Due to poor assembly of the heating assembly piece, the power supply outer cord protective covering came into contact with a metal covering

What did (or did not) happen	What should have happened	Difference	Analysis
covering that was emitting 300F of heat.			that was emitting 300F. This contact caused the outer cord protective covering to partially melt. (Apparent Cause)
