**COMBINED EVENT INVESTIGATION /
CAUSE ANALYSIS REPORT**
Investigation of TF-AOP-015 Entry in the 242-A Condenser Room
EIR-2019-051
WRPS-PER-2019-2400

Event Investigation EIR-2019-051/Apparent Cause Analysis WRPS PER-2019-2019-2400
Title: Investigation of TF-AOP-015, Entry in the 242-A Condenser Room

Washington River Protection Solutions, LLC

February 4, 2020

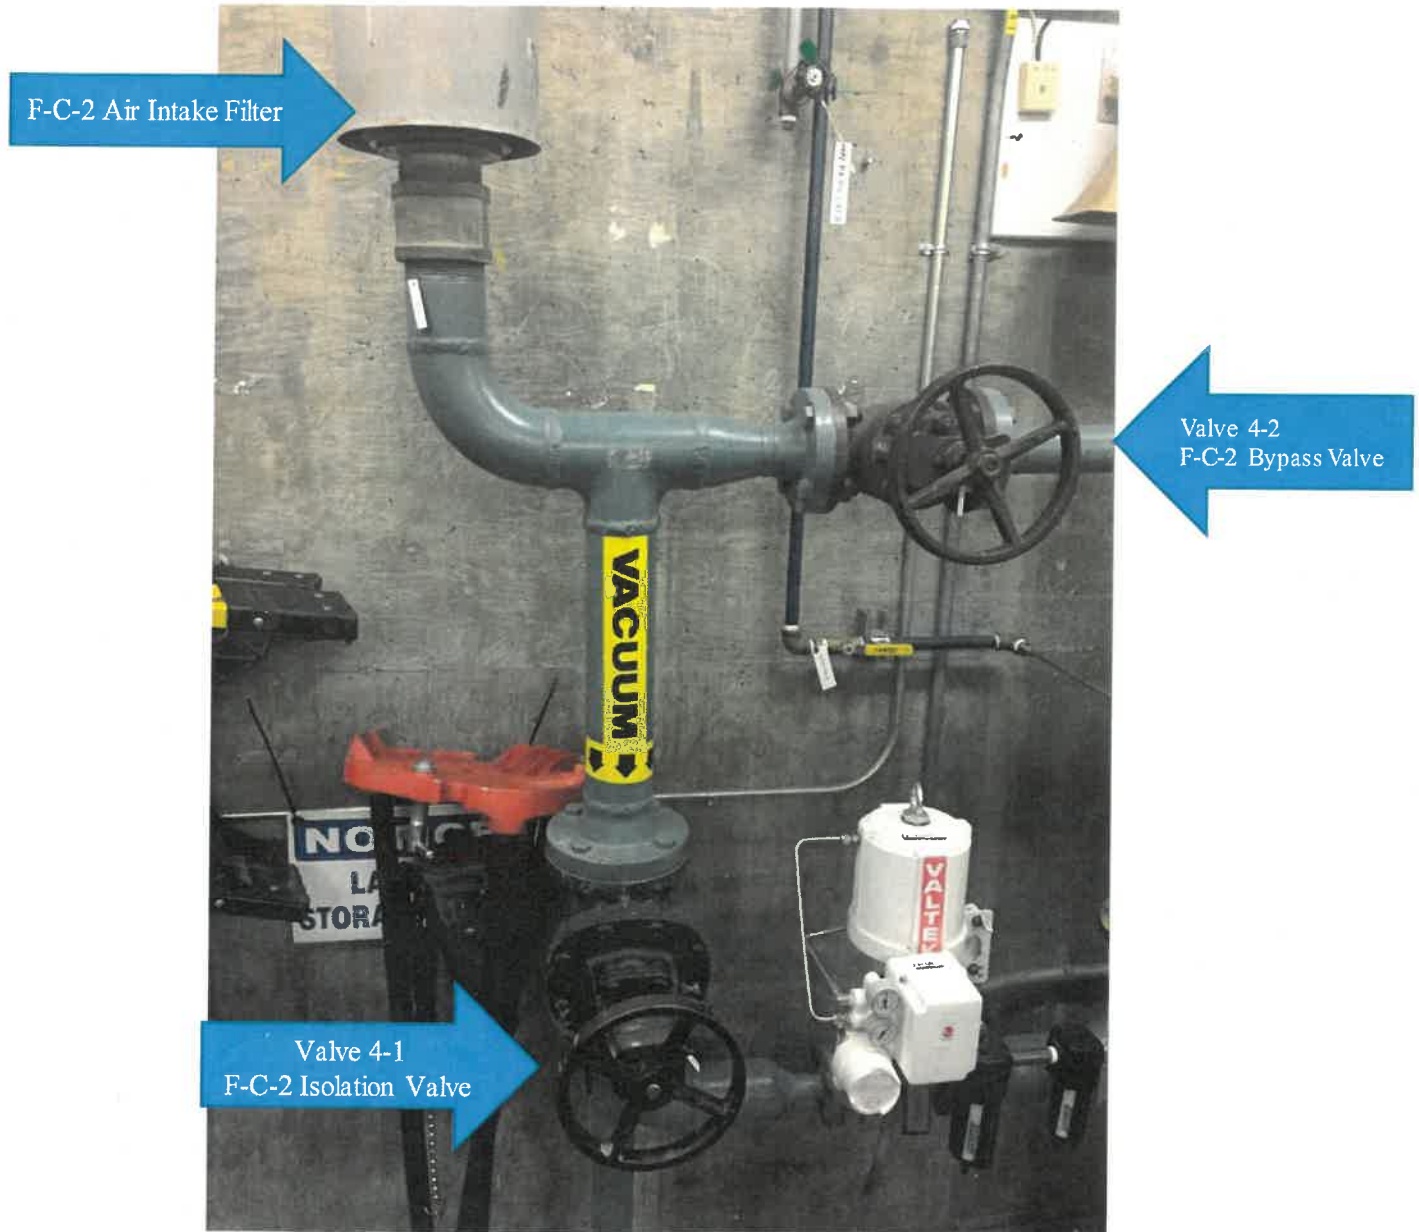
ATTACHMENT 1

The 242-A Evaporator SM reviewed drawings to research the potential source of the odor/readings and concluded that the source of the readings/odor was the open 4-1 isolation valve to the F-C-2 air intake filter. A procedure revision to TO-600-060 was issued, that allowed the 4-1 isolation valve to the F-C-2 air intake filter to be closed to isolate the source and in support of shutdown activities.

Picture of F-C-2 air intake filter, 4-1 isolation valve, and 4-2 isolation valve

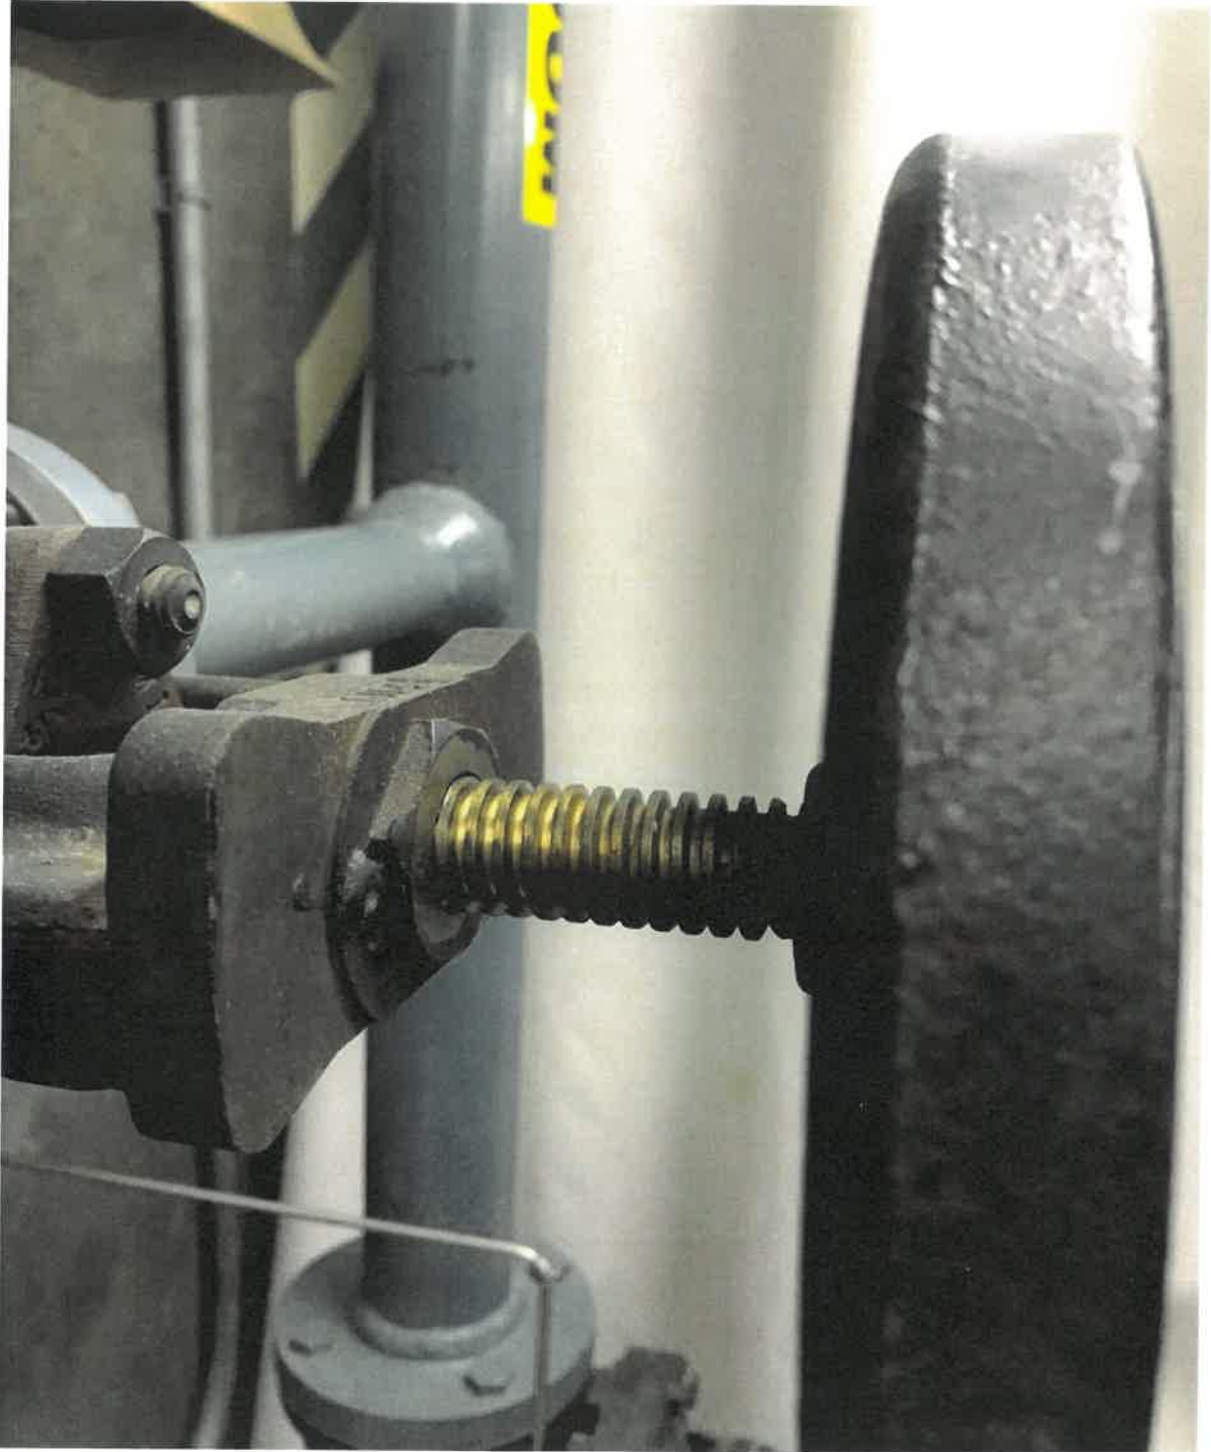
ATTACHMENT 7

- 1045 NCO closes valve 4-1. IHTs monitor for ammonia; levels do not decrease. IHT supervisor notice valve 4-2 (F-C-2 air intake filter bypass valve) in the open position. IHT supervisor informs NCO that valve 4-2 is open and inquires about closing it.

- Restoring 242-A system at the completion of electrical outage in September 2019, TO-680-010 instructed operator to open F-C-2 intake filter bypass valve 4-2. There is no technical basis to open the valve to support electrical outage activities.

The analysis concludes that procedure TO-680-010, *Perform Scheduled Electrical Power Outage at the 242-A Evaporator* contained was less than adequate instructions because there was no technical basis for placing bypass valve 4-2 in the open position at the conclusion of the outage as part of restoring 242-A systems. With the condition of aforementioned barriers, leaving valve 4-2 in the open position created a potential open pathway from 241-AW 102 tank to the condenser room. This allowed vapors/gases to be vented into the room, which caused the event.

4-2 (F-C-2 AIR INTAKE FILTER BYPASS VALVE) AS FOUND ON 12/10/19 IN OPEN POSITION

1. Initiated procedure change authorization (PCA) to TO-600-060, "Shutdown 242-A Evaporator System" to REQUEST Backside Operator to ensure valve 4-1, F-C-2 air intake filter isolation valve is CLOSED.
2. Closed 4-2 bypass valve to the F-C-2 air intake filter

On February 3, 2020 discussions with 242-A management and 242-A Engineering concluded that there is no technical basis for opening valve 4-2 at the conclusion of TO-680-010, *Perform Scheduled Electrical Power Outage at the 242-A Evaporator Restore 242-A Systems* activities. These instructions appear in the first issue of the procedure revision A-0 on 05/08/2014. A procedure change request (PCA) should be submitted to delete section 5.4.7.

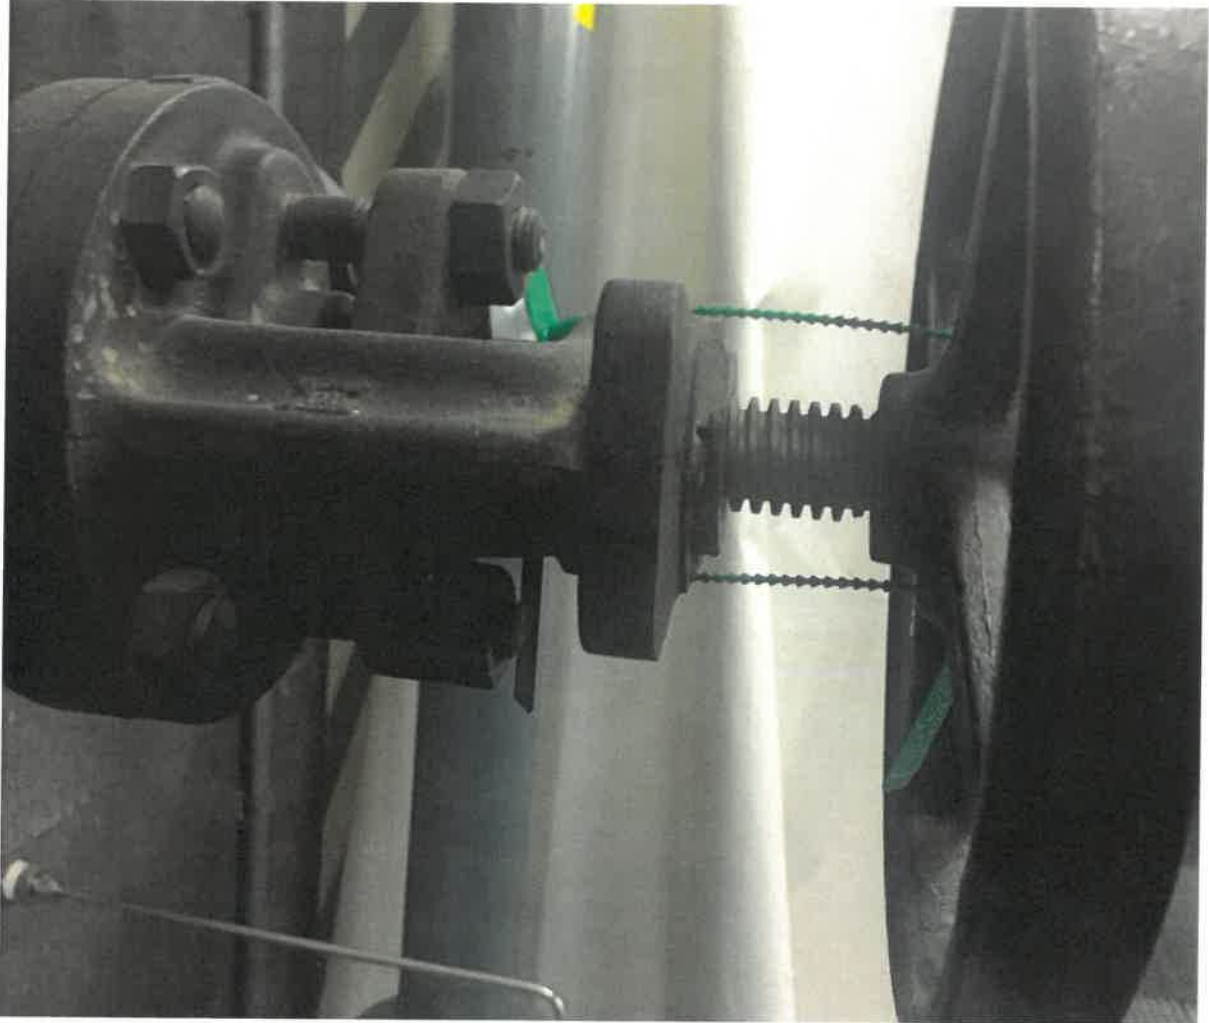
ATTACHMENT 8
4-2 (F-C-2 AIR INTAKE FILTER BYPASS VALVE) IN CLOSED POSITION 01/23/2020
