AOP-015 Event Investigation Reports (Redacted) EIR-2022-26 (03/22/2022)

Project: Tank Farm Projects / Construction

Area/Building/Location: 200E/A Farm near tank 241-A-101 PIT 01A Approximate Time of Event:

EIR Number: EIR-2022-026

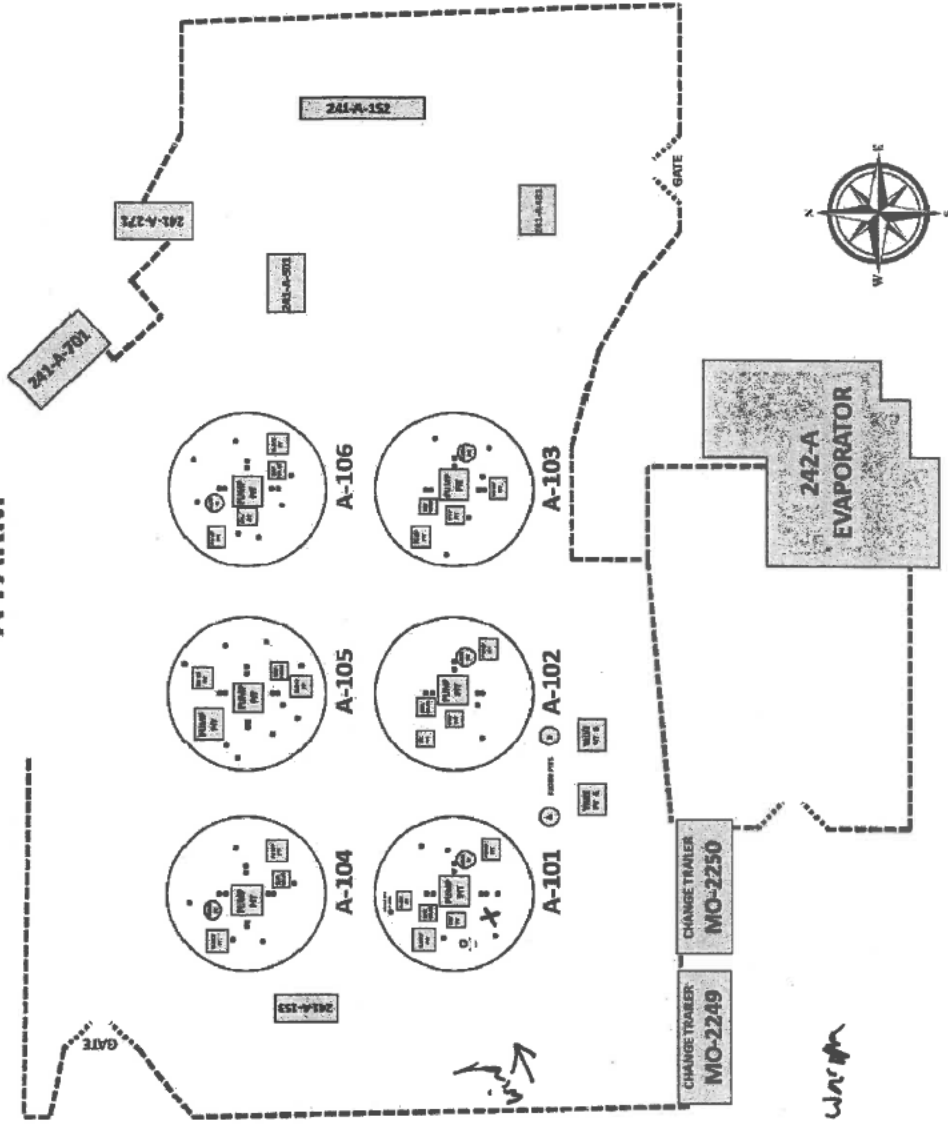
A FARM

Location of event (mark area on map and wind direction): A-101
