Washington River Protection Solutions
EVENT SUMMARY

Project: Retrieval/Construction Date: 08/31/2022

Area/Building/Location: 200E/241-A-103-A Pump Pit Approximate Time of Event: 0852

AR Number: WRPS-AR-2022-2391 Responsible Manager: [REDACTED]

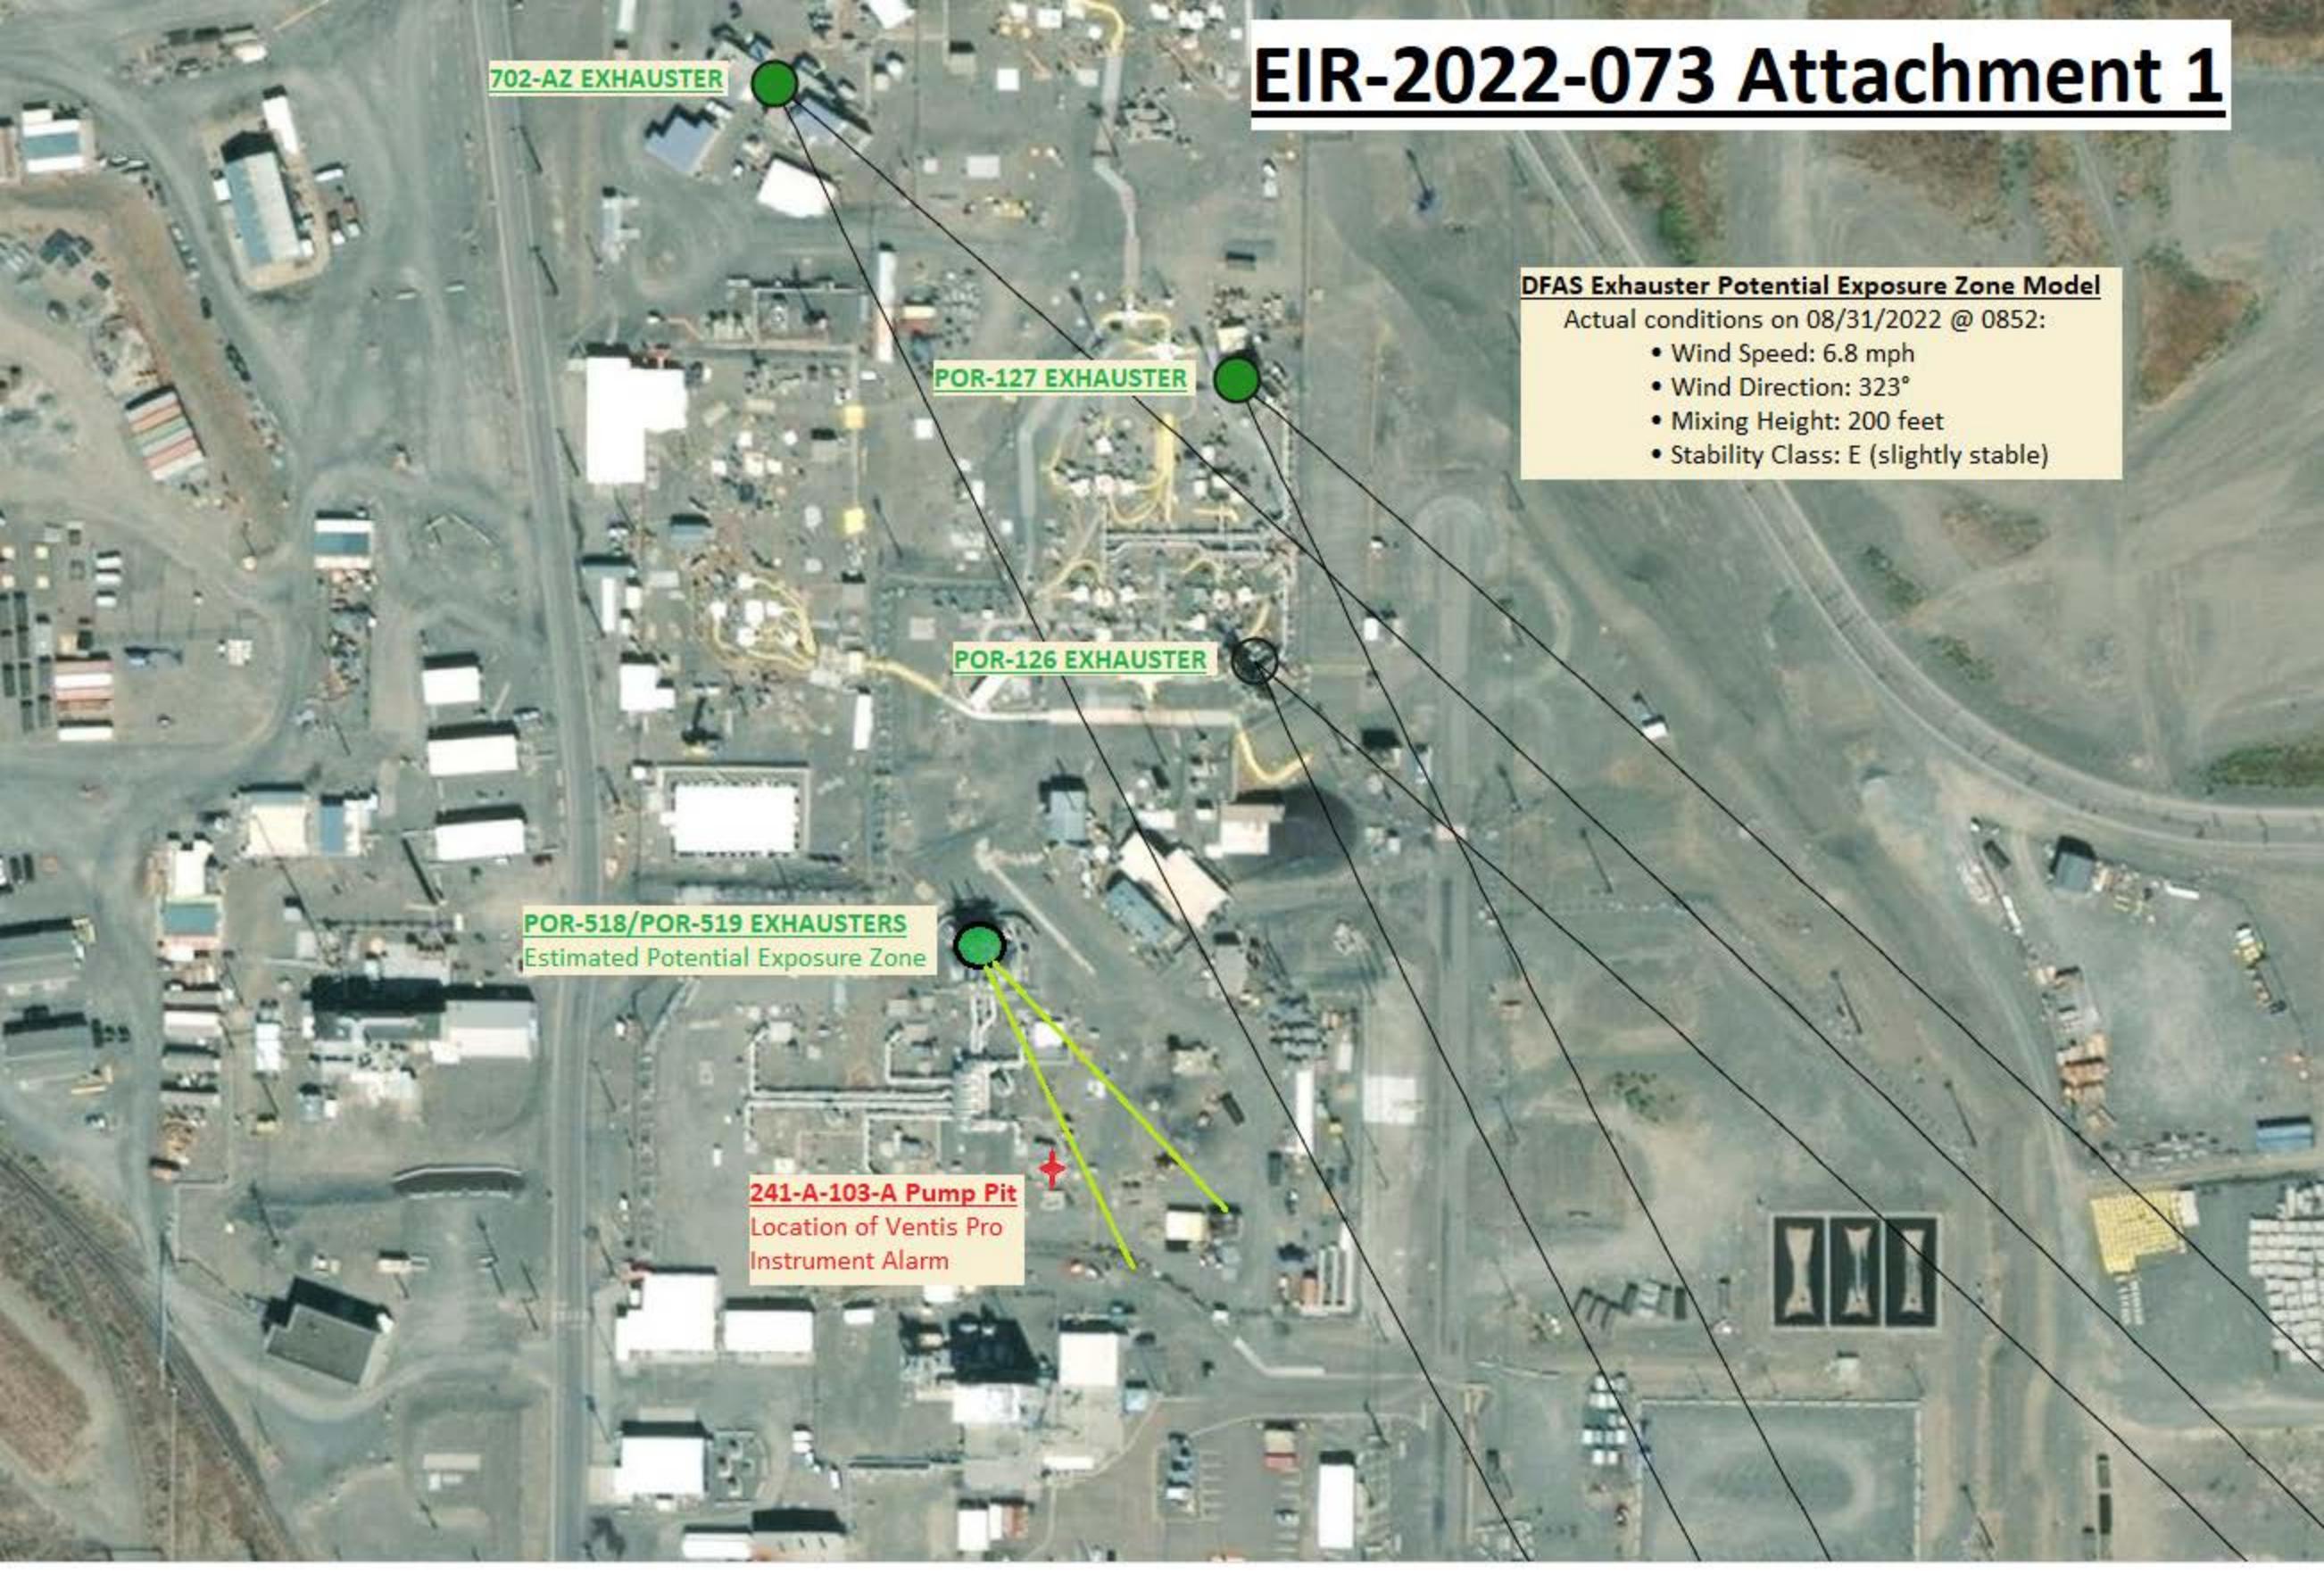
EIR-2022-073 Attachment 1

The DFAS dashboard provides a Exhauster Potential Exposure Zone (PEZ) Model of the exhaust plumes at the reported time of the event based on wind speed, wind direction, mixing height, and stability class. Evaluation of the PEZ Model indicates no exhaust plumes were within the work area location at the reported time of the event, thus determining the cause of the personal ammonia alarm was unlikely to be resultant of Tank Farms exhauster emissions (Refer to Attachment 1).

- (3) Evaluation of the weather details determined the cause of the odor source was unlikely to be resultant of Tank Farms exhauster emissions based on the wind direction, wind speed, mixing height, and stability class at the reported time of event (Refer to Attachment 1 for DFAS PEZ Model).

241-A-103-A Pump Pit
Location of Ventis Pro
Instrument Alarm
