# **AOP-015 Event Investigation Reports (Redacted) EIR-2022-079 (10072022)**

Project: Retrieval/Construction - Wire Pull      Date: Oct 7, 2022

Area/Building/Location: 200 East, 241-A-101      Approximate Time of Event: 09:36

EIR Number: EIR-2022-079      Event Investigator: [REDACTED]

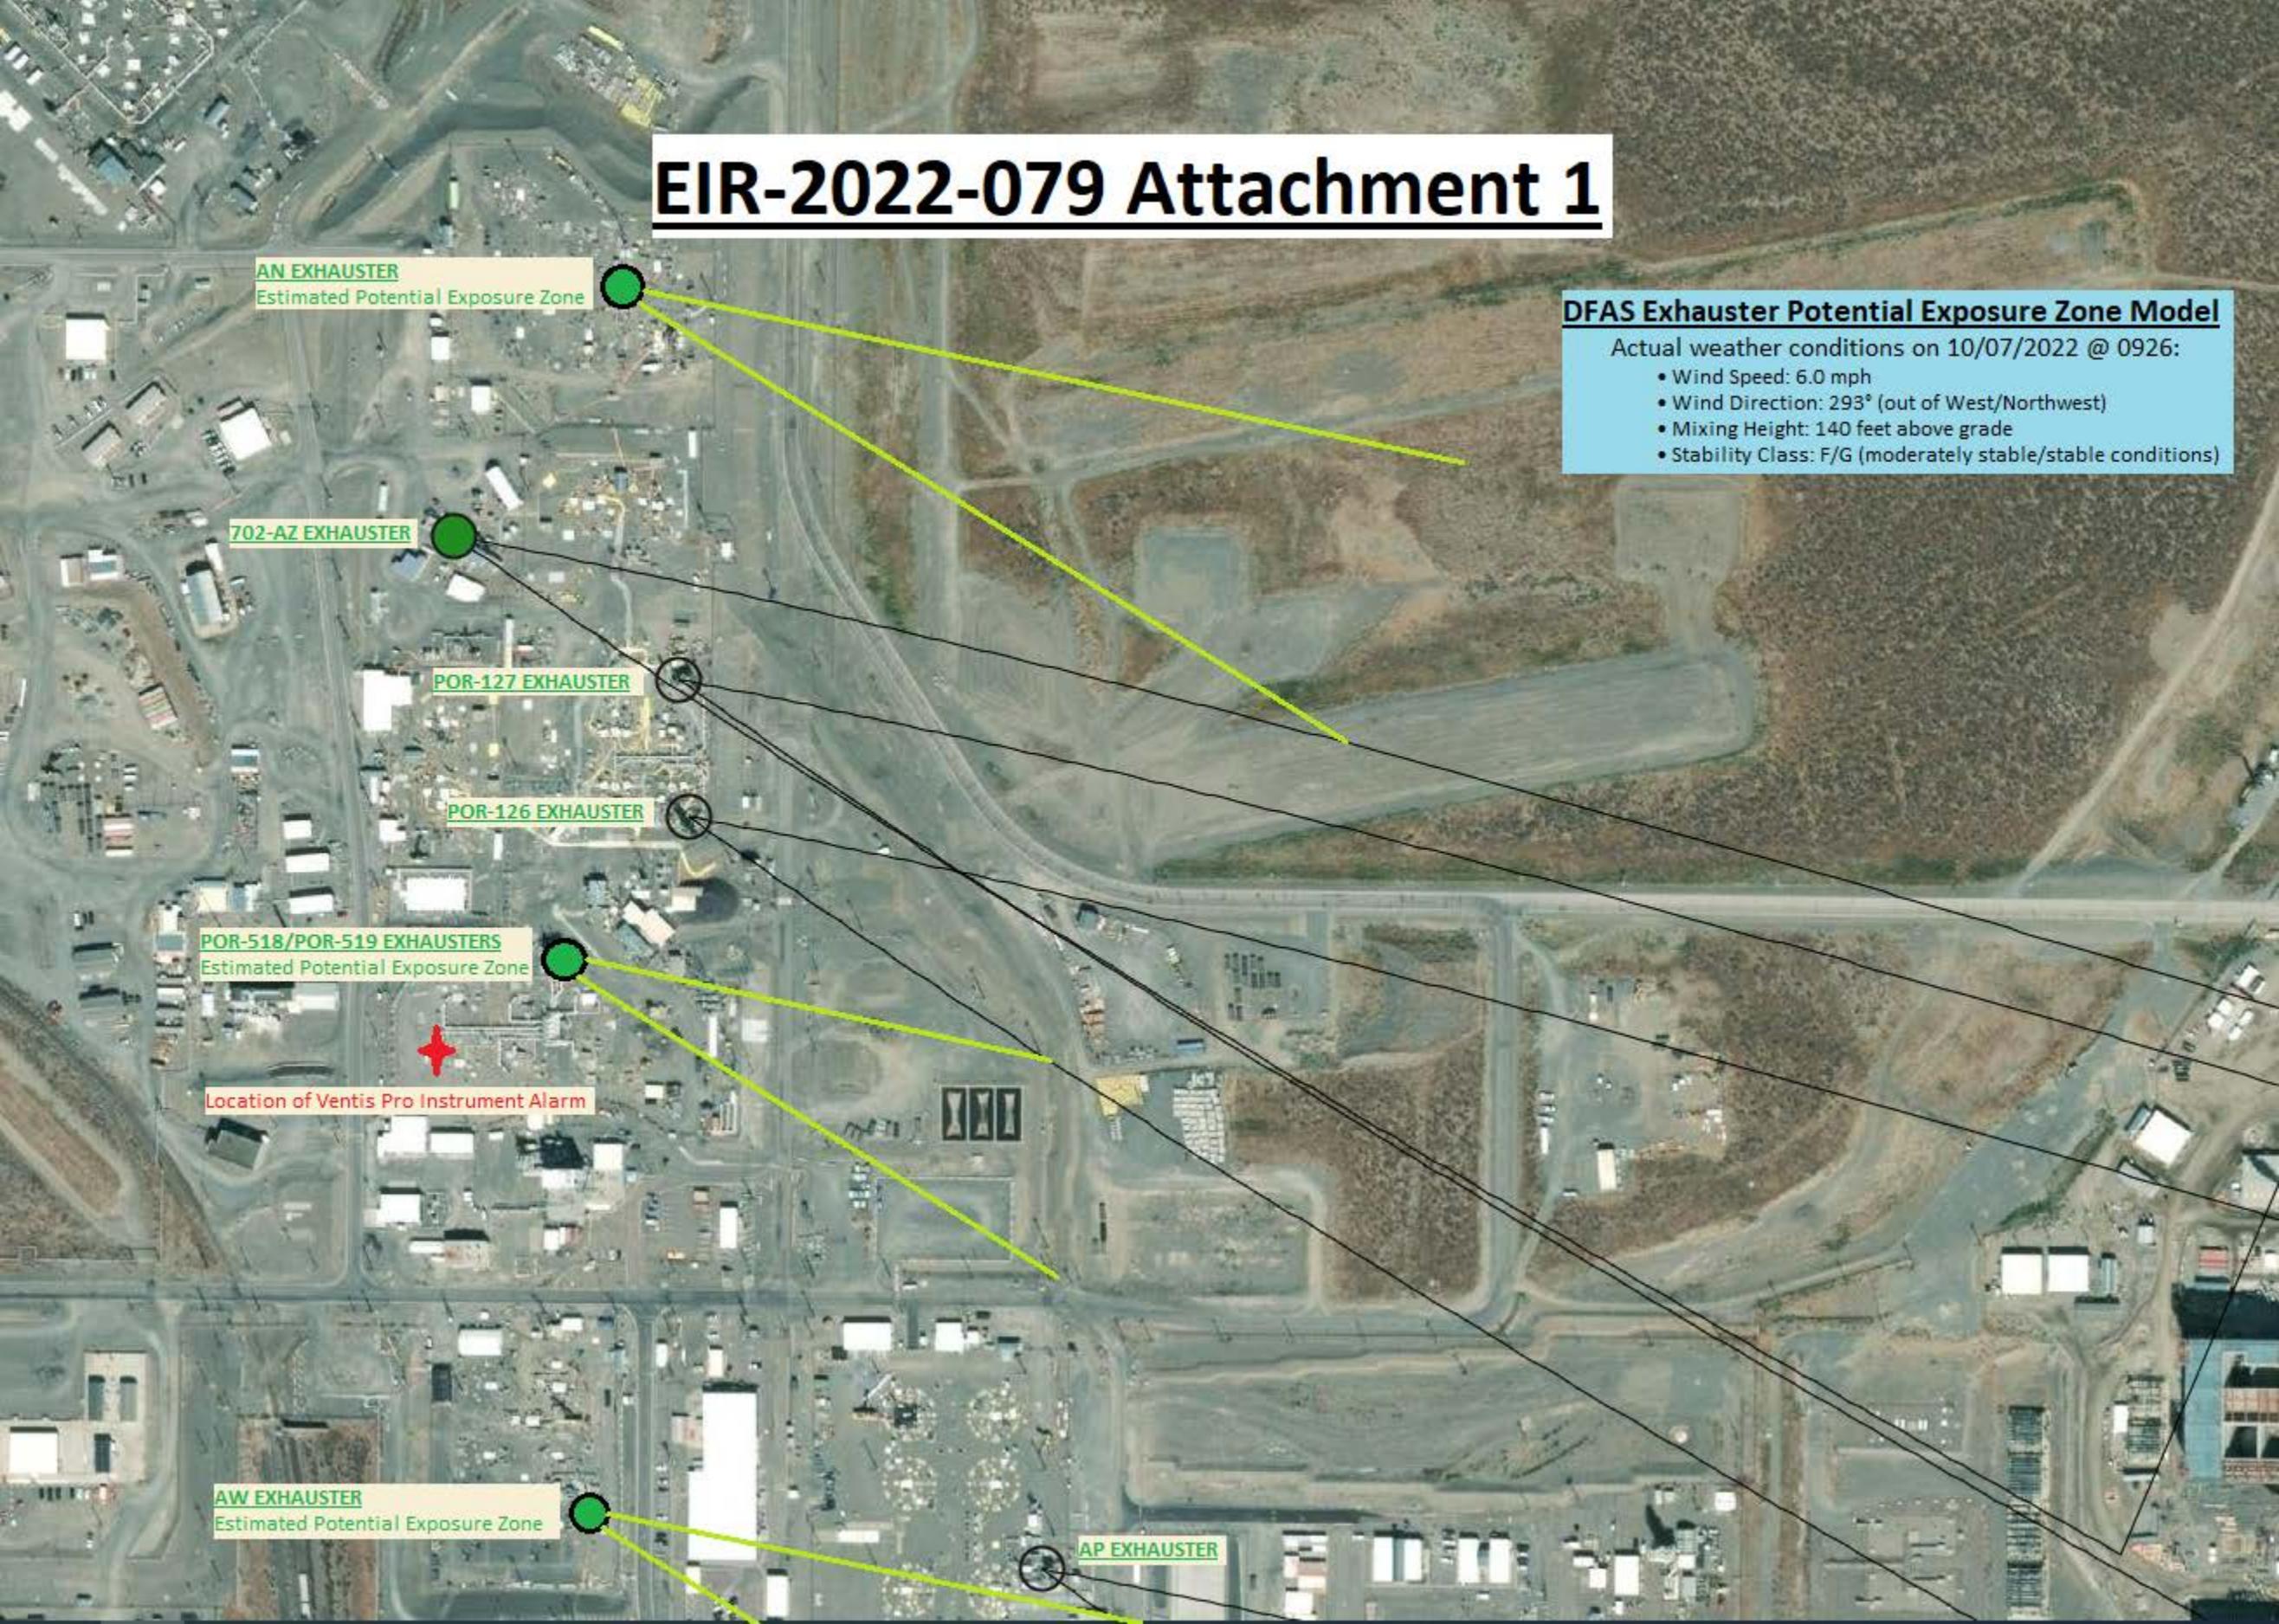
# EIR-2022-079 Attachment 1

- (2) Evaluation of the weather details determined the cause of the odor source was unlikely to be resultant of Tank Farms exhauster emissions based on the wind direction, wind speed, mixing height, and stability class at the reported time of event (Refer to Attachment 1 for DFAS PEZ Model).

## DFAS Exhauster Potential Exposure Zone Model

Actual weather conditions on 10/07/2022 @ 0926:

- Wind Speed: 6.0 mph
- Wind Direction: 293° (out of West/Northwest)
- Mixing Height: 140 feet above grade
- Stability Class: F/G (moderately stable/stable conditions)
