Washington River Protection Solutions
EVENT SUMMARY

Project: Retrieval/Construction Date: 05/19/2023

Area/Building/Location: 200E/AY Change Tent Approximate Time of Event: 1408 Hours

EIR Number: EIR-2023-034 Event Investigator: [REDACTED]

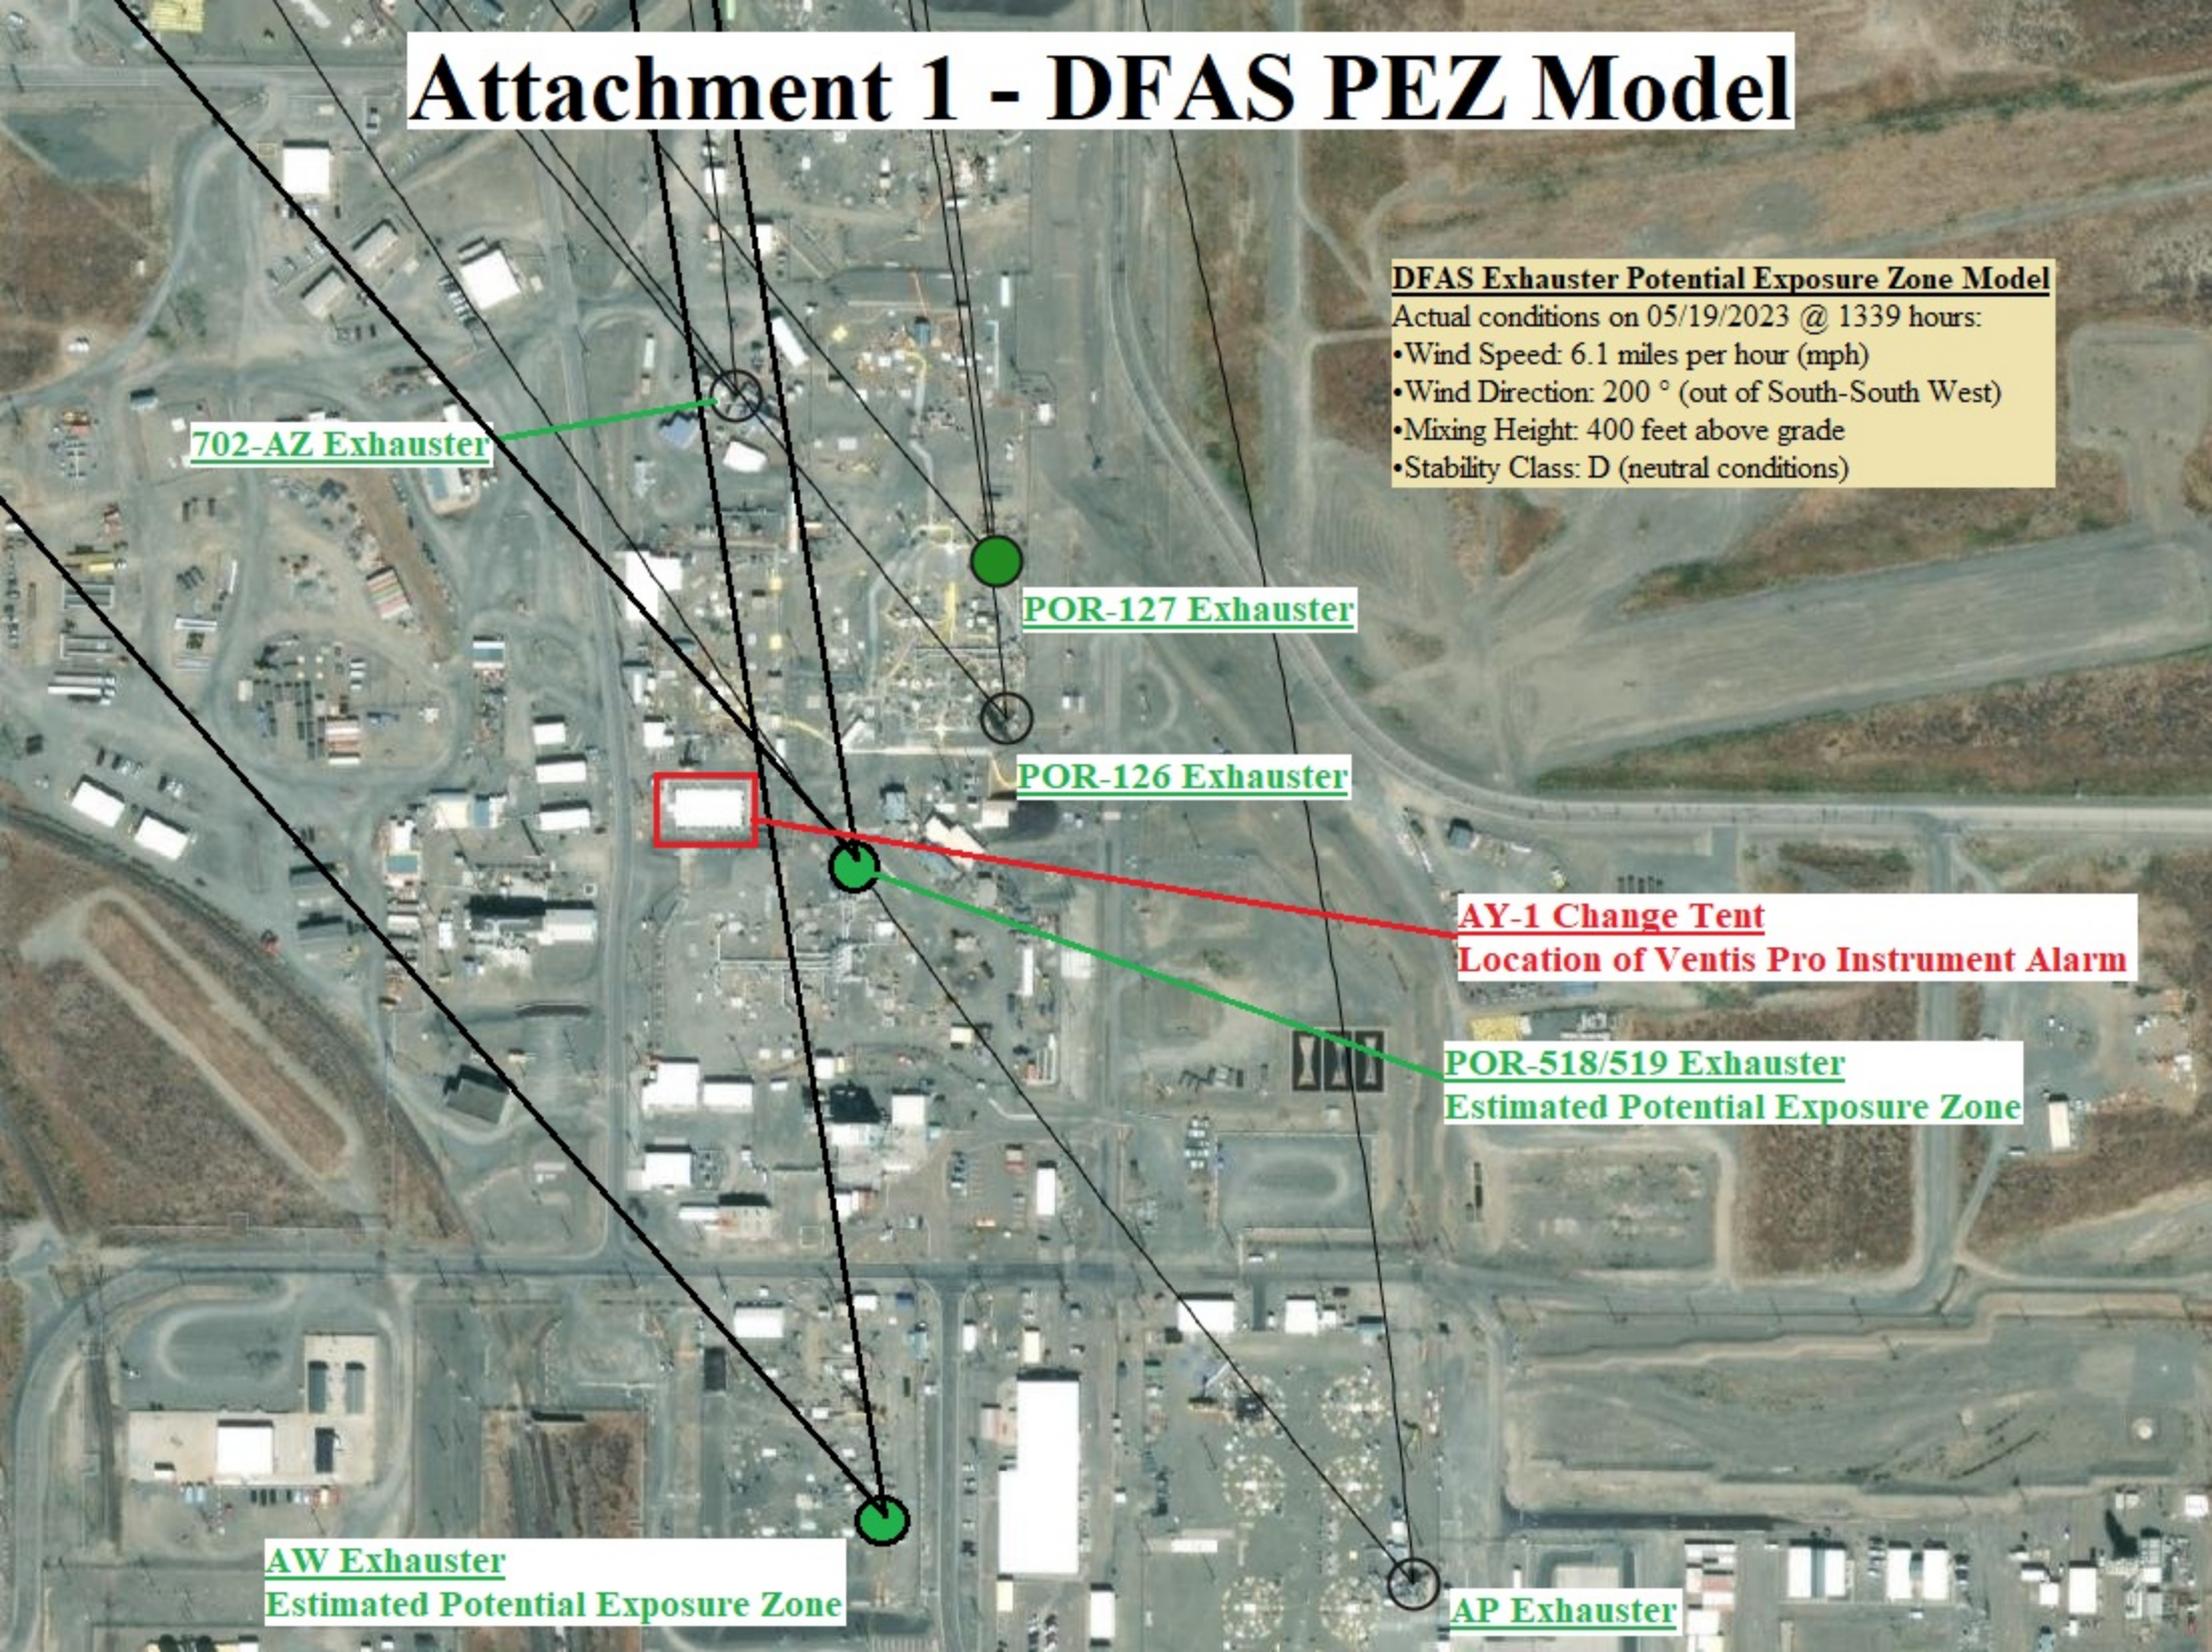
Attachment 1 - DFAS PEZ Model

(4) The DFAS dashboard provides a Exhauster Potential Exposure Zone (PEZ) Model of the exhaust plumes at the reported time of the event based on wind speed, wind direction, mixing height, and stability class. Evaluation of the PEZ Model indicates exhaust plumes of the 702-AZ Exhauster, AP Exhauster, POR-126 Exhauster, POR-127 Exhauster, POR-518 Exhauster, and POR-519 Exhauster were not within the work area location at the reported time of the event. Thus, determining the cause of the personal ammonia alarm was unlikely to be resultant of 702-AZ Exhauster, AP Exhauster, POR-126 Exhauster, POR-127 Exhauster, POR-518 Exhauster, and POR-519 Exhauster emissions (Refer to Attachment 1 for DFAS PEZ Model).

While the AY-1 Change Tent appeared to be within the Potential Exposure Zone of the AW Exhauster emission plume, the approximate distance of AY Change Tent from the AW Exhauster Exhauster is approximately 1,000 feet. Thus, determining the cause of the observed odors was unlikely to be resultant of POR-126 exhauster emissions (Refer to Attachment 1).

DFAS Exhauster Potential Exposure Zone Model
Actual conditions on 05/19/2023 @ 1339 hours:
• Wind Speed: 6.1 miles per hour (mph)
• Wind Direction: 200 ° (out of South-South West)
• Mixing Height: 400 feet above grade
• Stability Class: D (neutral conditions)

AY-1 Change Tent
Location of Ventis Pro Instrument Alarm
