AOP-015 Event Investigation Reports (Redacted) EIR-2023-083 (11/30/2023)

Washington River Protection Solutions
EVENT SUMMARY

1. **Project:** Tank Farm Projects **2. Report Date:** 11/30/2023
3. **Investigation Title:** TF-AOP-015 at B-105
4. **Investigation Report Number:** EIR-2023-083
5. **Responsible Manager:** [REDACTED]
6. **Event Investigator:** [REDACTED]
7. **Area / Building / Location:** 200E/241-B Farm/Near Tank 241-B-105
8. **Date and Approximate Time of Event:** Date: 11/27/2023 Time (military): 0850
9. **Associated Action Request (AR) Number:** WRPS-AR-2024-0439
10. **Associated Occurrence Report Number (if applicable):** _____
11. **Event Investigation Meeting Held:** Yes [] or No [X] Date: _____ Time (military): _____

Washington River Protection Solutions
INDUSTRIAL HYGIENE EVENT INVESTIGATION REPORT

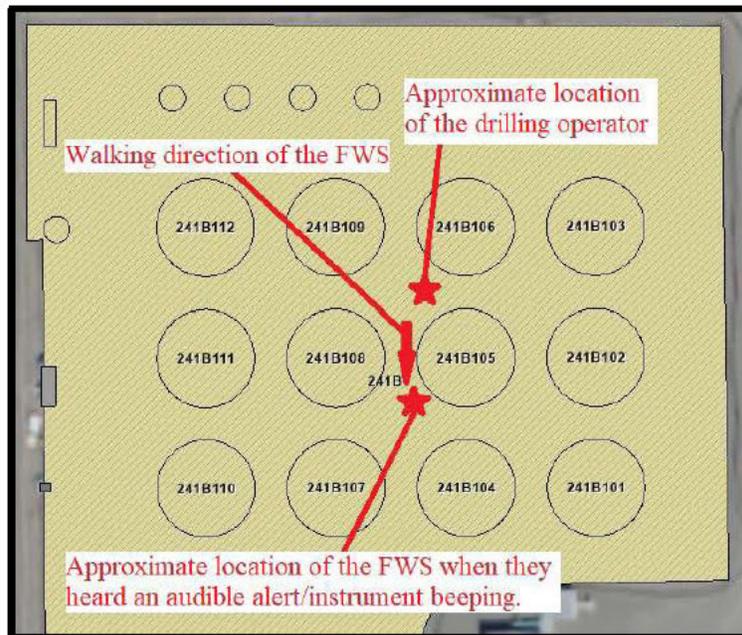
At 241-B Farm, near tank 241-B-105 (Refer to Figure 1).

Figure 1 – Location of Personnel at the Time of The PAM Alarm
