Washington River Protection Solutions
EVENT SUMMARY

1. **Project:** Production Operations **2. Report Date:** 12/13/2023
3. **Investigation Title:** TFC-OPS-OPER-C-67 Response at MO-2522
4. **Investigation Report Number:** EIR-2023-092
5. **Responsible Manager:** [REDACTED]
6. **Event Investigator:** [REDACTED]
7. **Area / Building / Location:** 200E/MO-2522
8. **Date and Approximate Time of Event:** **Date:** 12/11/2023 **Time (military):** 0730 Hours
9. **Associated Action Request (AR) Number:** WRPS-AR-2024-0516
10. **Associated Occurrence Report Number (if applicable):** N/A
11. **Event Investigation Meeting Held:** Yes [] or No [X] **Date:** _____ **Time (military):** _____

Washington River Protection Solutions
INDUSTRIAL HYGIENE EVENT INVESTIGATION REPORT

Event Title: <p style="text-align: center;">TFC-OPS-OPER-C-67 Response MO2522</p>	PER Number: <p style="text-align: center;">N/A</p>	
		IHIR Number: <p style="text-align: center;">IHIR-00086</p>

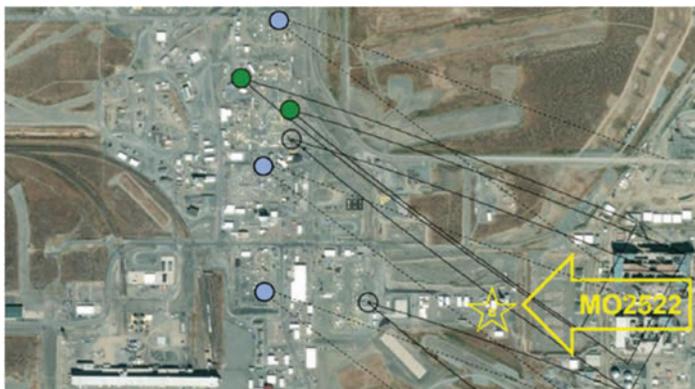
Figure 1- DFAS Exhauster Potential Exposure Zone Model

- (5) The Affected Area has a long history of similar odors that have been found to be associated with sources other than Tank Farm vapor source emissions, such as septic tank gaseous emissions which are known to change odor profile across a gradient when diluted by ambient atmosphere with distance from a point source. The initiating event was a stronger than normal "sewer/septic" odor, which could be indicative of nearby septic related equipment. The closest sewer system located upwind of the Affected Area, and connected to the Affected Area's drains, is the 2607-E10 Septic Tank system (~100' upwind).
- (6) Evaluation of the weather details determined the cause of the odor source was unlikely to be resultant of Tank Farms exhauster emissions based on the wind direction, wind speed, mixing height, and stability class.

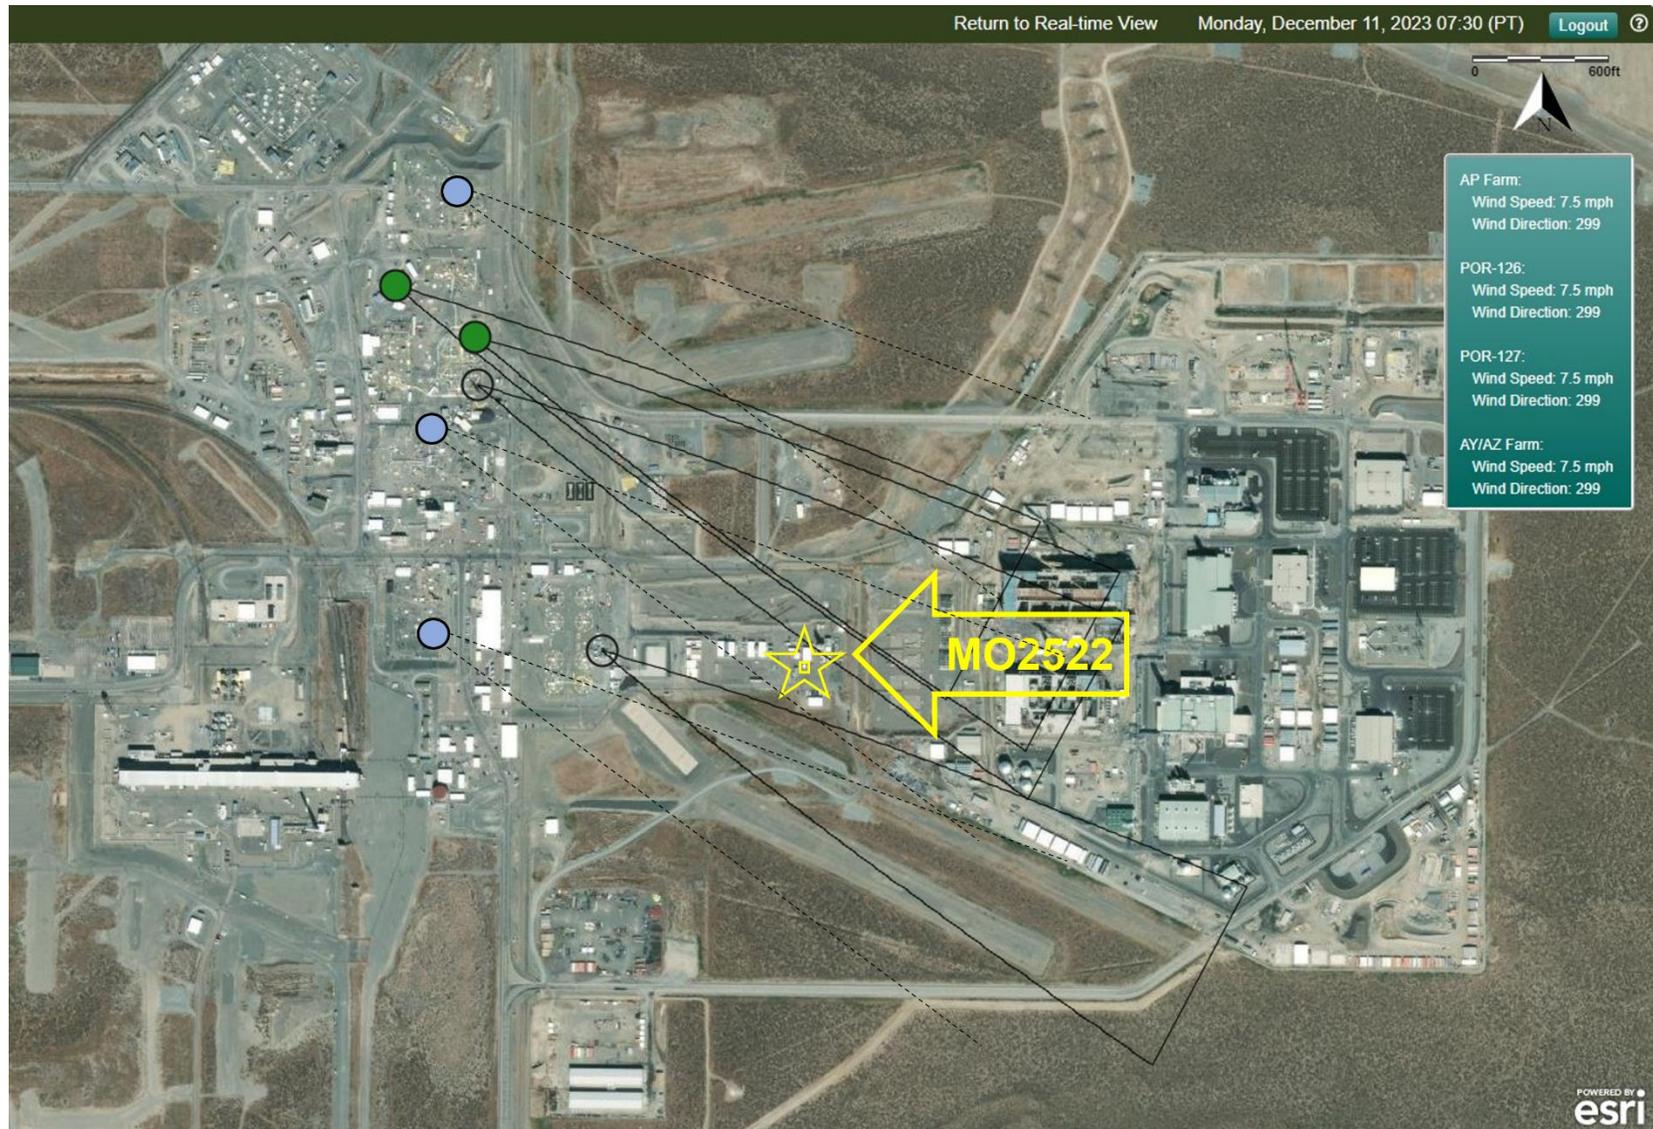
Figure 1. 200-East Area (with 241-AW, 241-AP, 241-AN, 241-AY/AZ, 241-AX, 241-A Farm projected plume models) at 0730 12/11/2023 from Data Fusion and Advisory System (DFAS) application, powered by SmartSite™

Investigative TFC-OPS-OPER-C-67 DRI monitoring in the general areas inside and outside of MO-2522 indicated less than detectable concentrations for ammonia (< 1 ppm) and 0.04 ppm VOCs, which are below anticipated background levels. Providing further indication the cause of the reported odors was unlikely to be resultant of Tank Farm exhauster emissions.

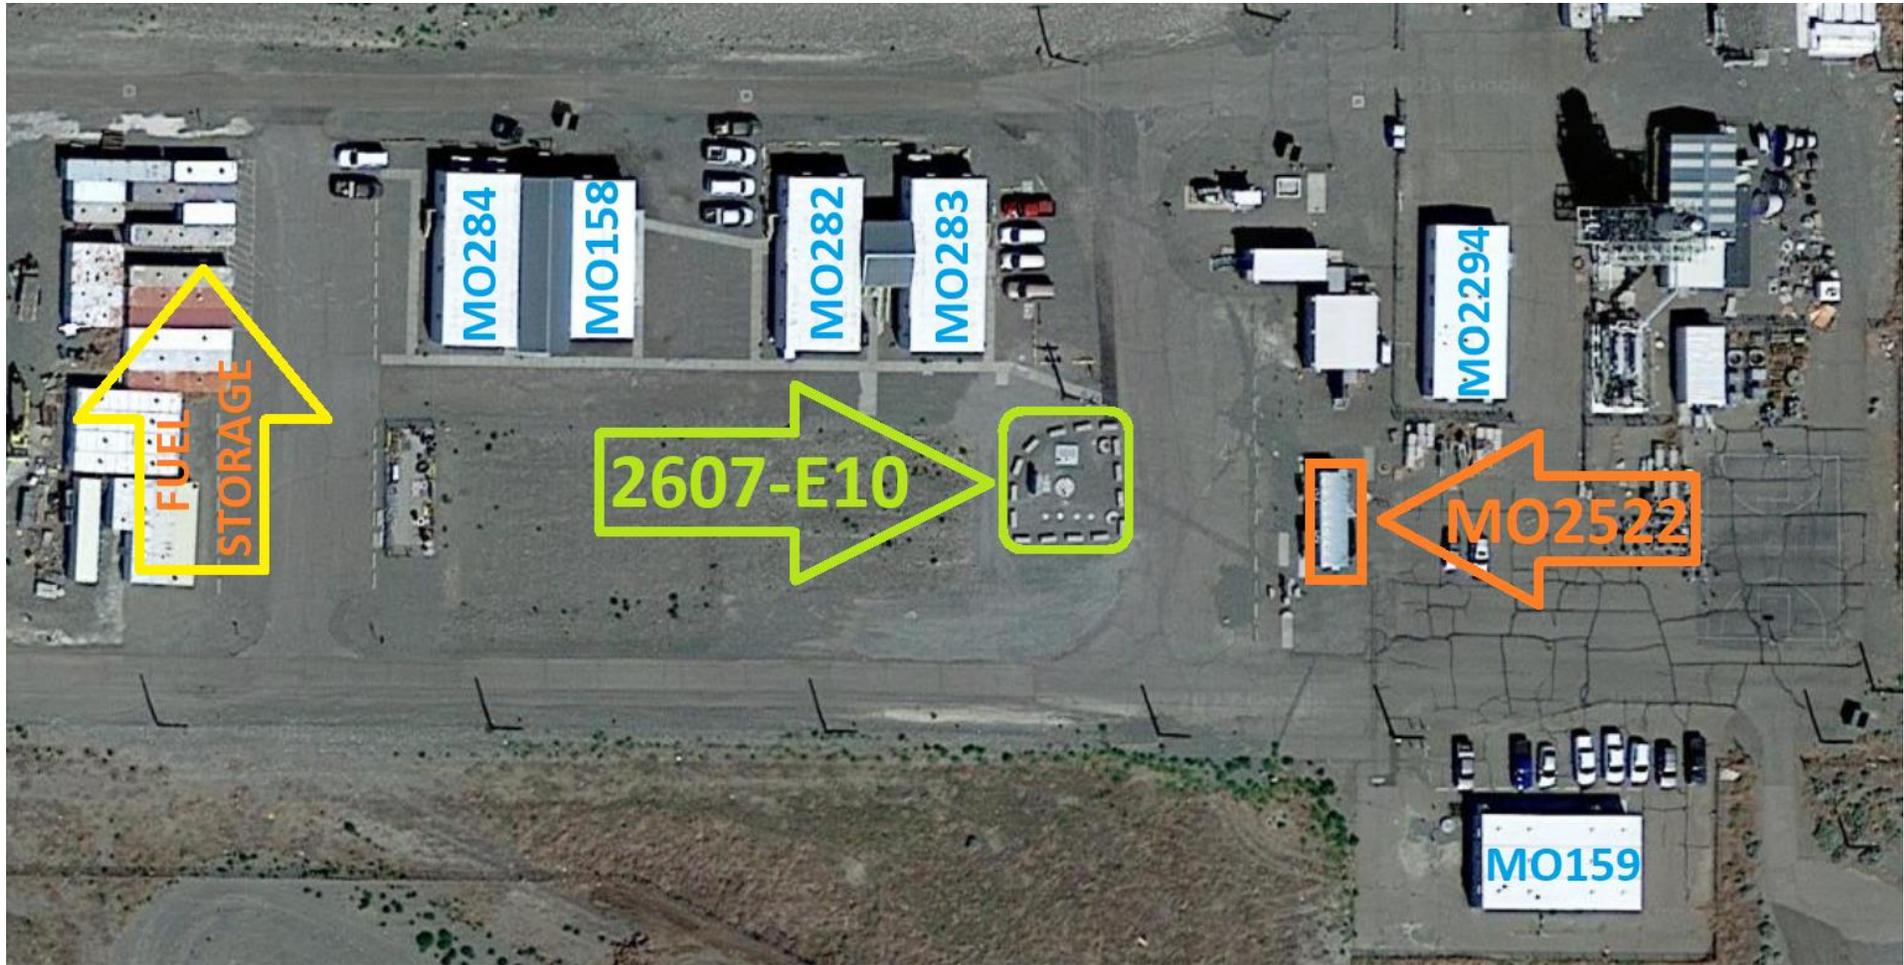
Figure 3. Wet Grout Loop Area and 2607-E10 Septic System

The Affected Area has a long history of similar odors or odors that have been found to be associated with sources other than Tank Farm vapor source emissions, such as septic tank gaseous emissions which are known to change odor profile across a gradient when diluted by ambient atmosphere with distance from a point source. The initiating event was a stronger than normal "sewer/septic" odor. These odors are indicative of nearby septic related equipment. The closest sewer system located upwind of the Affected Area, and connected to the Affected Area's drains, is the 2607-E10 Septic Tank system (~100' upwind).

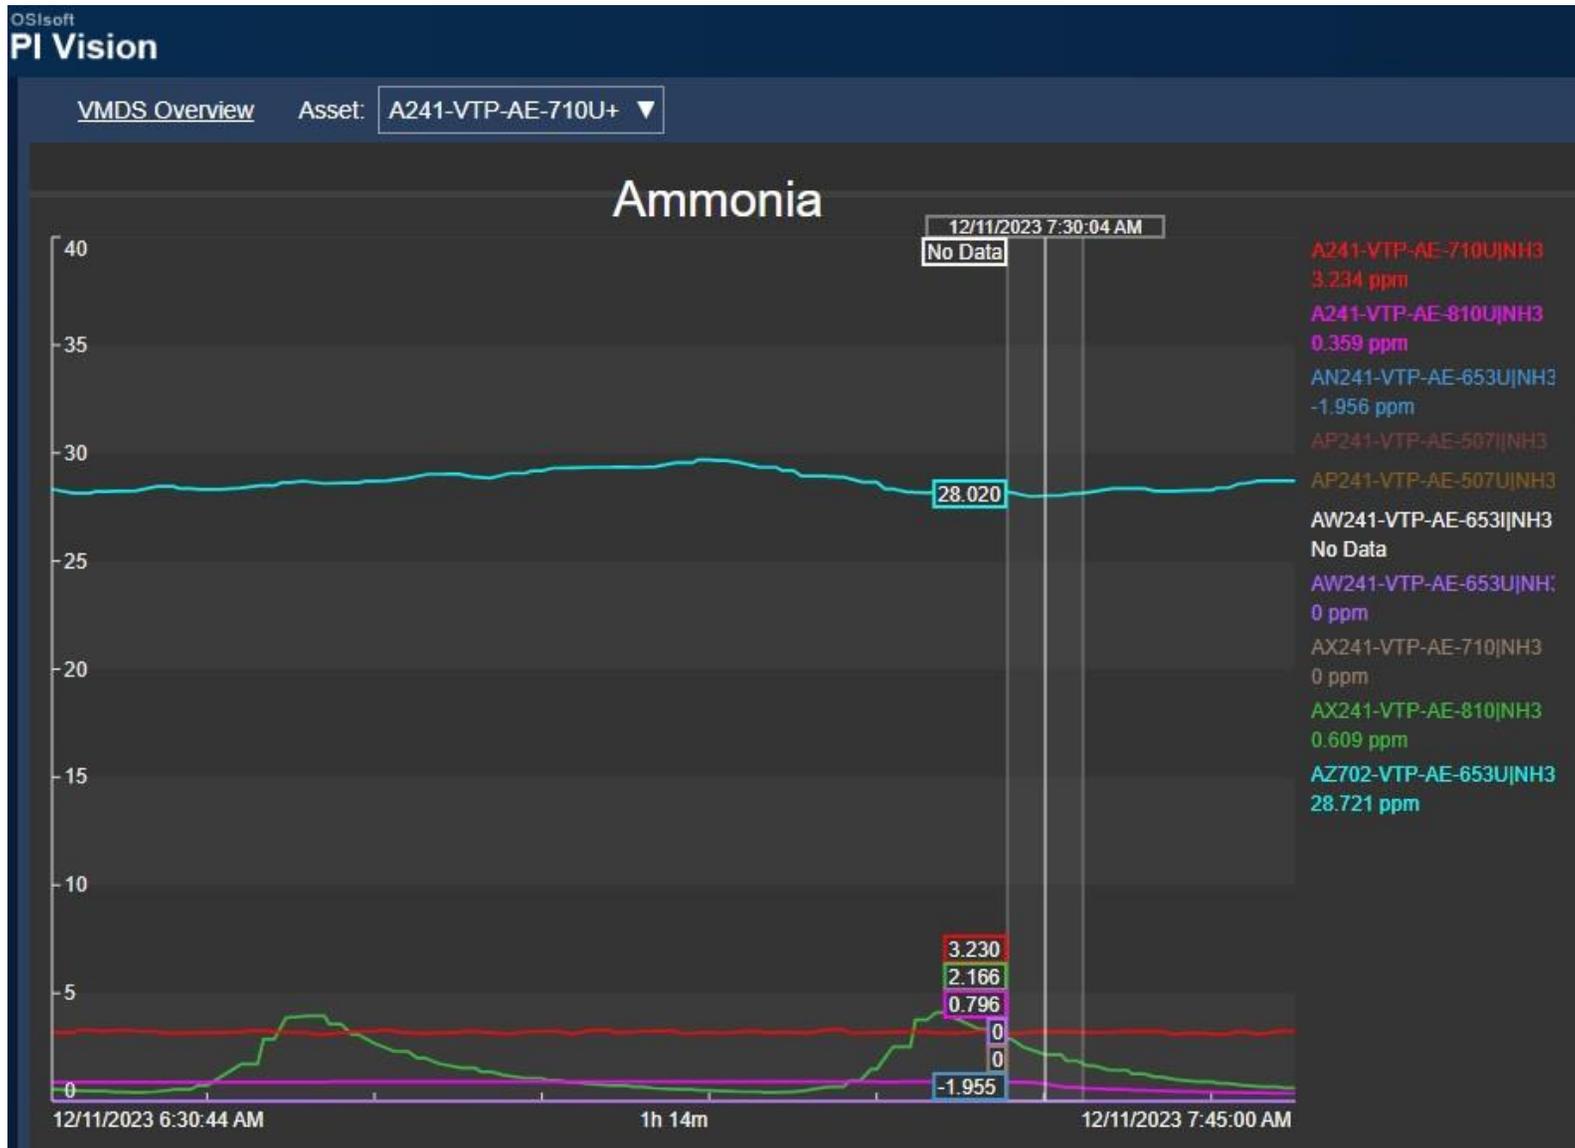
Figure 4. OSIsoft Pi Vision VMDS Ammonia Concentrations for 0730 12/11/2023

The exhauster high level alarm conservatively established for A Complex (excluding A farm) is 460 ppm. According to the Vapor Monitoring and Detection System (VMDS), the ammonia concentration observed at the time of event occurrence was 0 ppm at the 241-AW exhauster, 0 ppm at the POR-126 exhauster, 2.186 ppm at the POR-127, and 28.018 ppm at 702-AZ exhauster. The AP exhauster is not currently connected to VMDS, therefore, readings are acquired once per calendar day in accordance with TF-OPS-IHT-037, IHT Ammonia Monitoring on Exhausters, when ammonia stack monitoring via VMDS is unavailable. The highest ammonia concentrations observed between 12/04/2023 and 12/10/2023 was 5 ppm at the AP Exhauster. Conservatively utilizing the higher ammonia concentration observed in the 702-AZ exhauster, a predicted ground receptor ammonia concentration of 0.159 ppm (or 0.64% of the established Occupational Exposure Limit for ammonia) would be expected if AP, AY/AZ, AX tank, or AW farm exhauster emissions were present.

The exhauster high level alarm conservatively established for A farm is 160 ppm. According to the VMDS, the ammonia concentration observed at the time of event occurrence was 3.231 ppm at the POR-518 exhauster and 0.805 ppm at the POR-519 exhauster. Conservatively utilizing the higher ammonia concentration observed in the POR-518 exhauster, a predicted ground receptor ammonia concentration of 0.050 ppm (or 0.20% of the established Occupational Exposure Limit for ammonia) would be expected if A tank farm exhauster emissions were present.

Therefore, providing additional indication the reported odor was unlikely to be resultant of Tank Farms exhauster emissions.

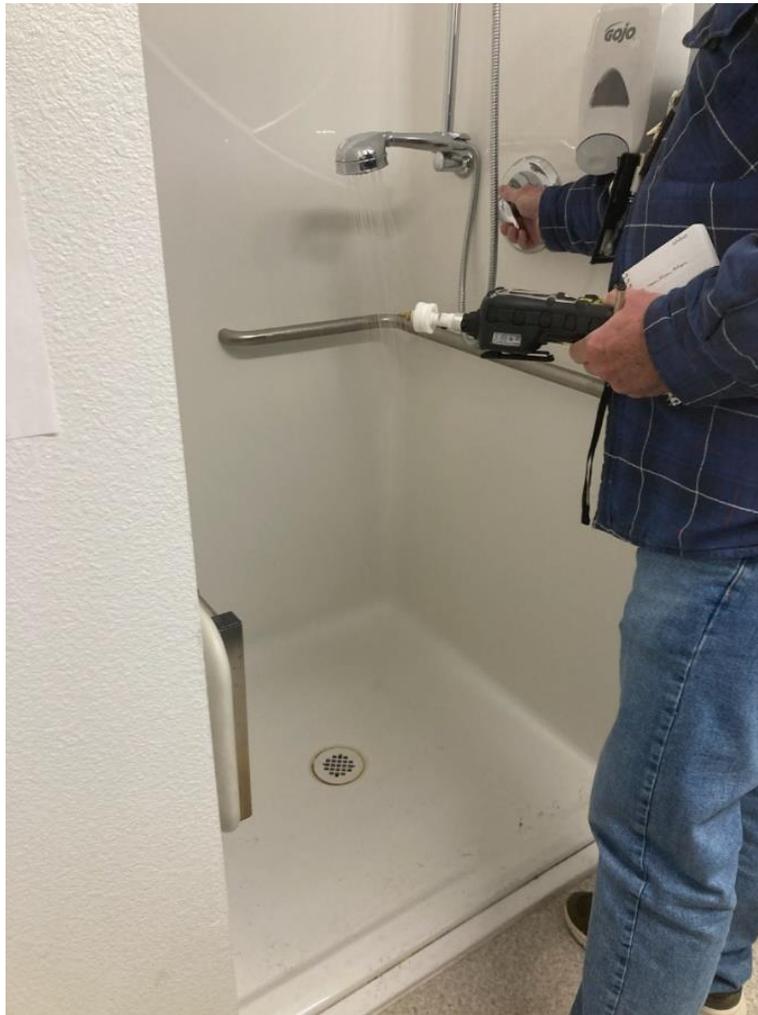
Figure 9. MO2522 South Shower Stall 1

- Entered south unit
 - Less than detectable source reading at shower 1 and running shower to flush water down drains
- 0839 POE IH-3 updates POE IH-2:
- VOC area readings ~0.030-0.050 parts per million (ppm)

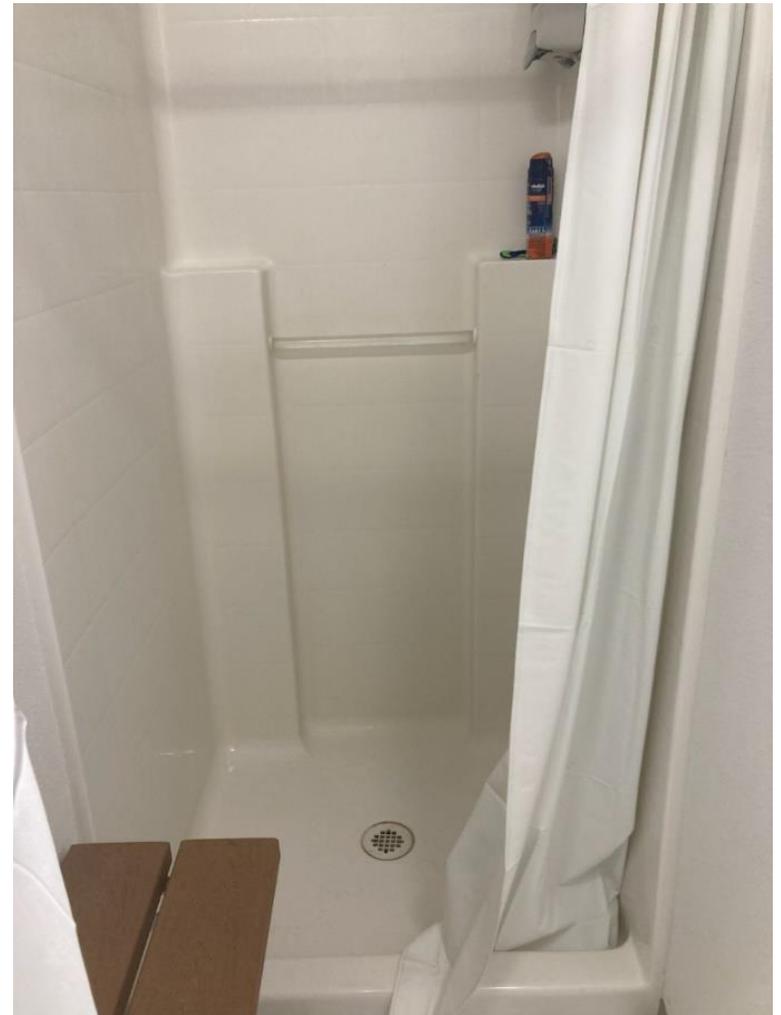
Figure 10. MO2522 South Shower Stall 2

- 0840 POE IH-3 updates POE IH-2:
- Less than detectable source reading at shower 2
- 0841 POE IH-3 updates POE IH-2:
- Less than detectable source reading at shower 3

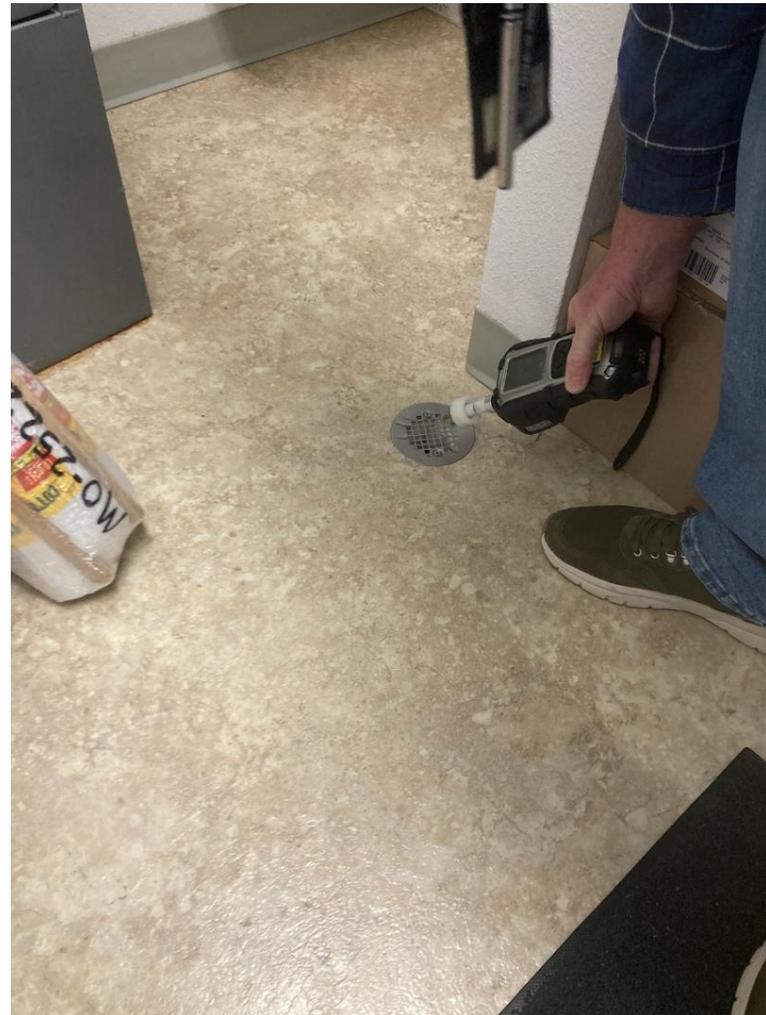
Figure 12. MO2522 North Floor Drain

- Less than detectable area readings for hydrogen sulfide and ammonia
- 0845 POE IH-3 updates POE IH-2:
- Entered north unit
 - Less than detectable source reading at floor drain

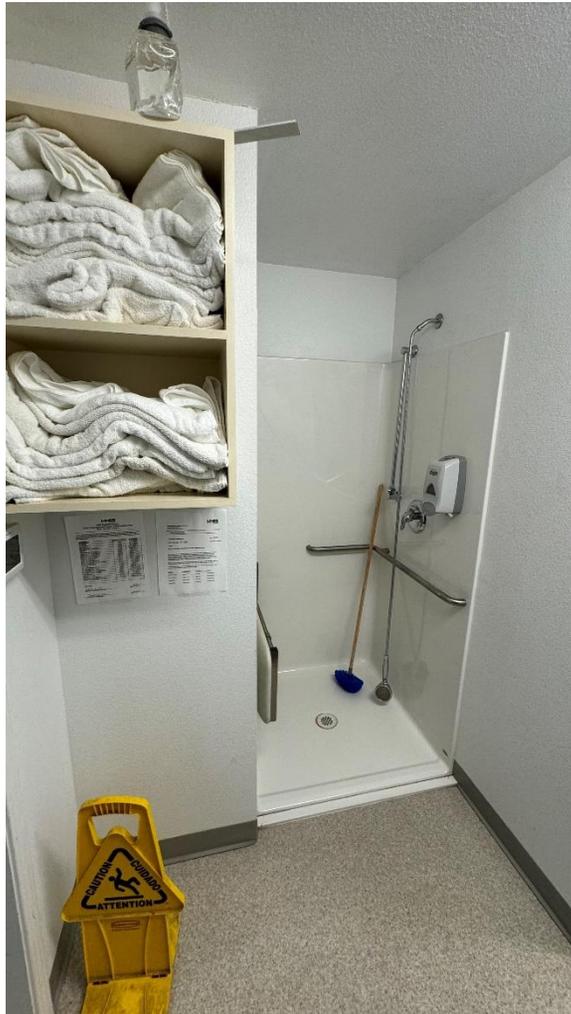
12/12/2023 0550 POE IHT Supervisor performed a follow-up walkdown of MO2522. Evidence indicated that the trailer had been cleaned. The current odor "smelled like it had been cleaned".

Figure 13. MO2522 North unit shower after cleaning, morning 12/12/2023

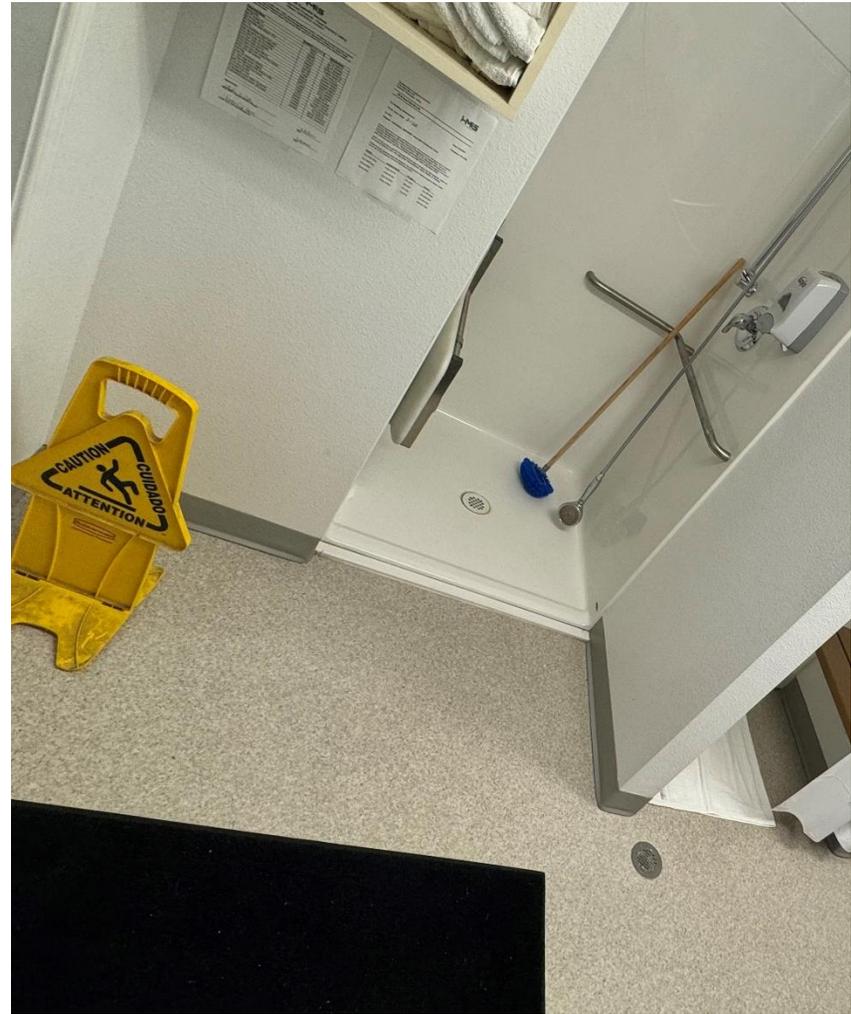
Figure 14. MO2522 South unit shower after cleaning, morning 12/12/2023
