C-67 Event Investigation Reports (Redacted) EIR-2023-063 C-67 (08/18/2023)

Project: Production Operations/242A Evaporator

EIR Number: EIR-2023-063

Washington River Protection Solutions
INDUSTRIAL HYGIENE EVENT INVESTIGATION REPORT

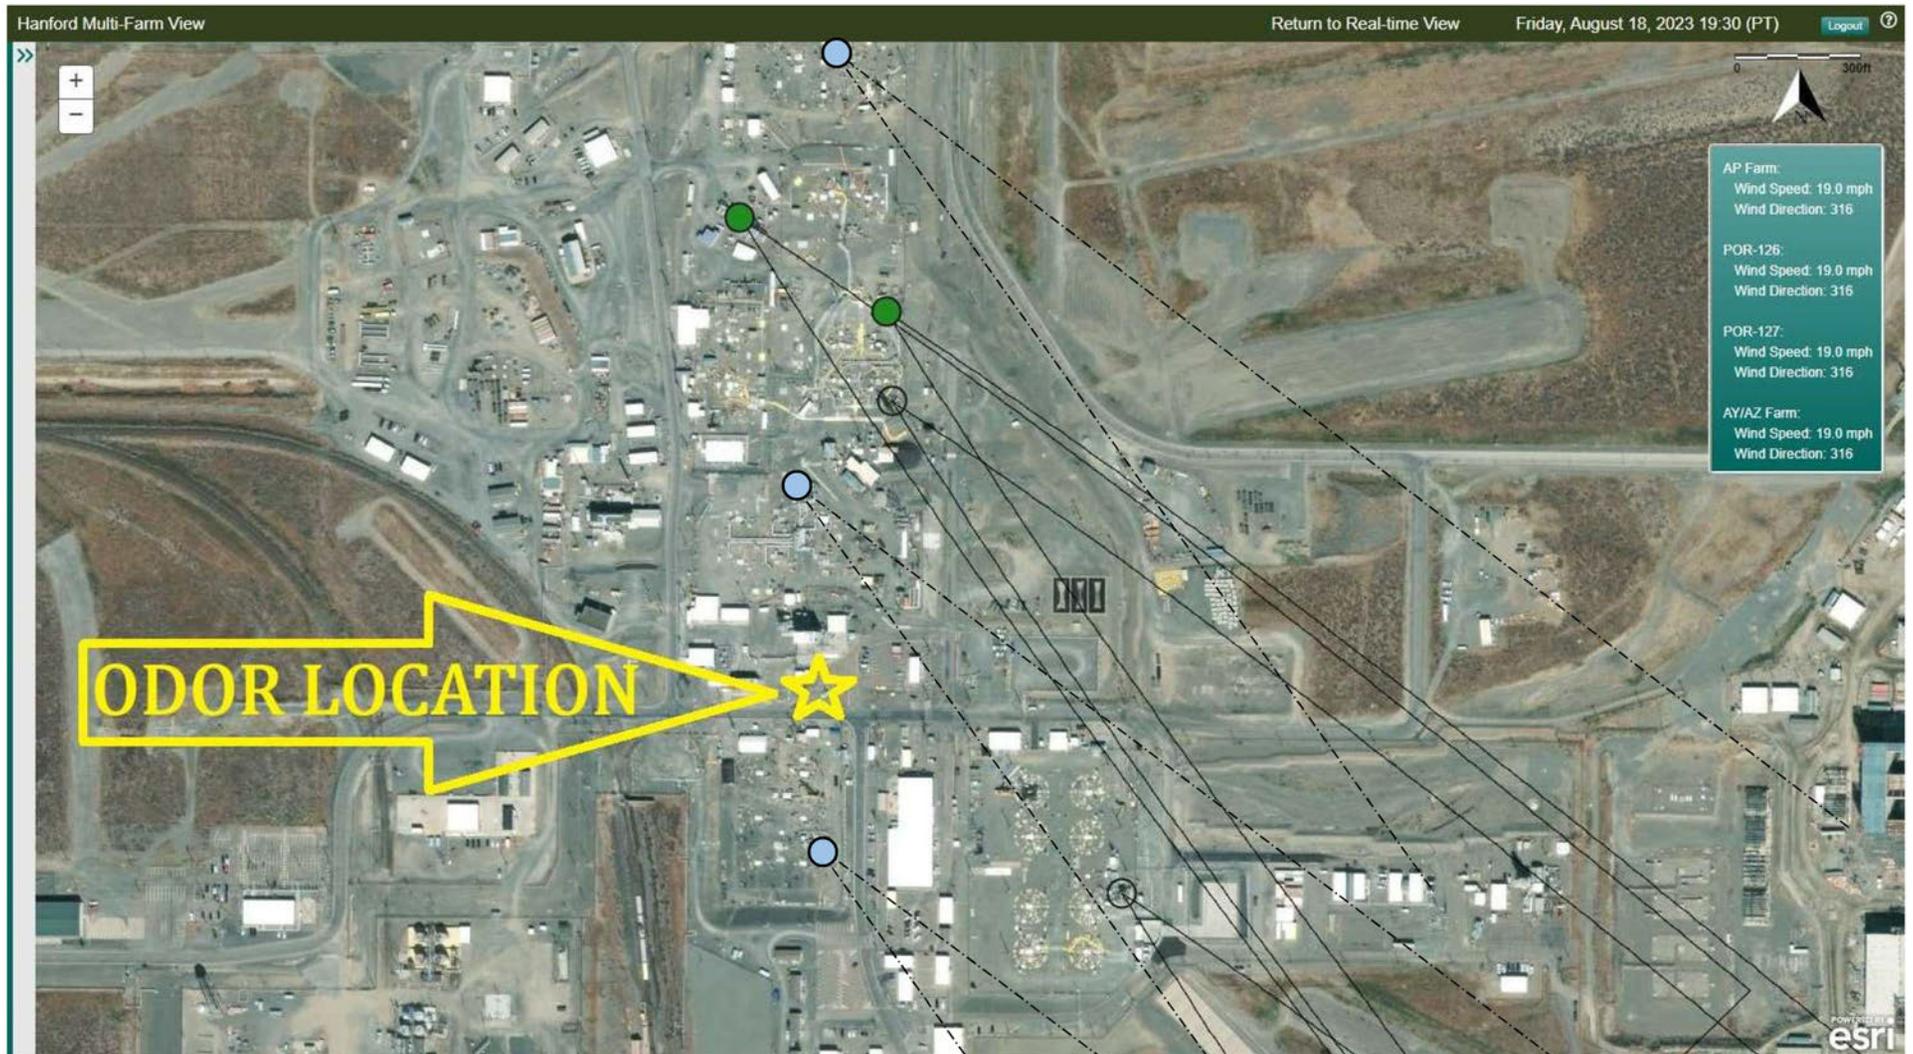
Figure 1. 200-East Area (with 241-AW, 241-AP, 241-AN, 241-AY/AZ, 241-AX, 241-A Farm projected plume models) at 1930 08/18/2023 from Data Fusion and Advisory System (DFAS) application, powered by SmartSite™

NOTE: 241-AN, 241-A, 241-AW Farm Exhausters are not connected to the DFAS; however, an approximate exhauster plume was added for each based on other modeled plumes.

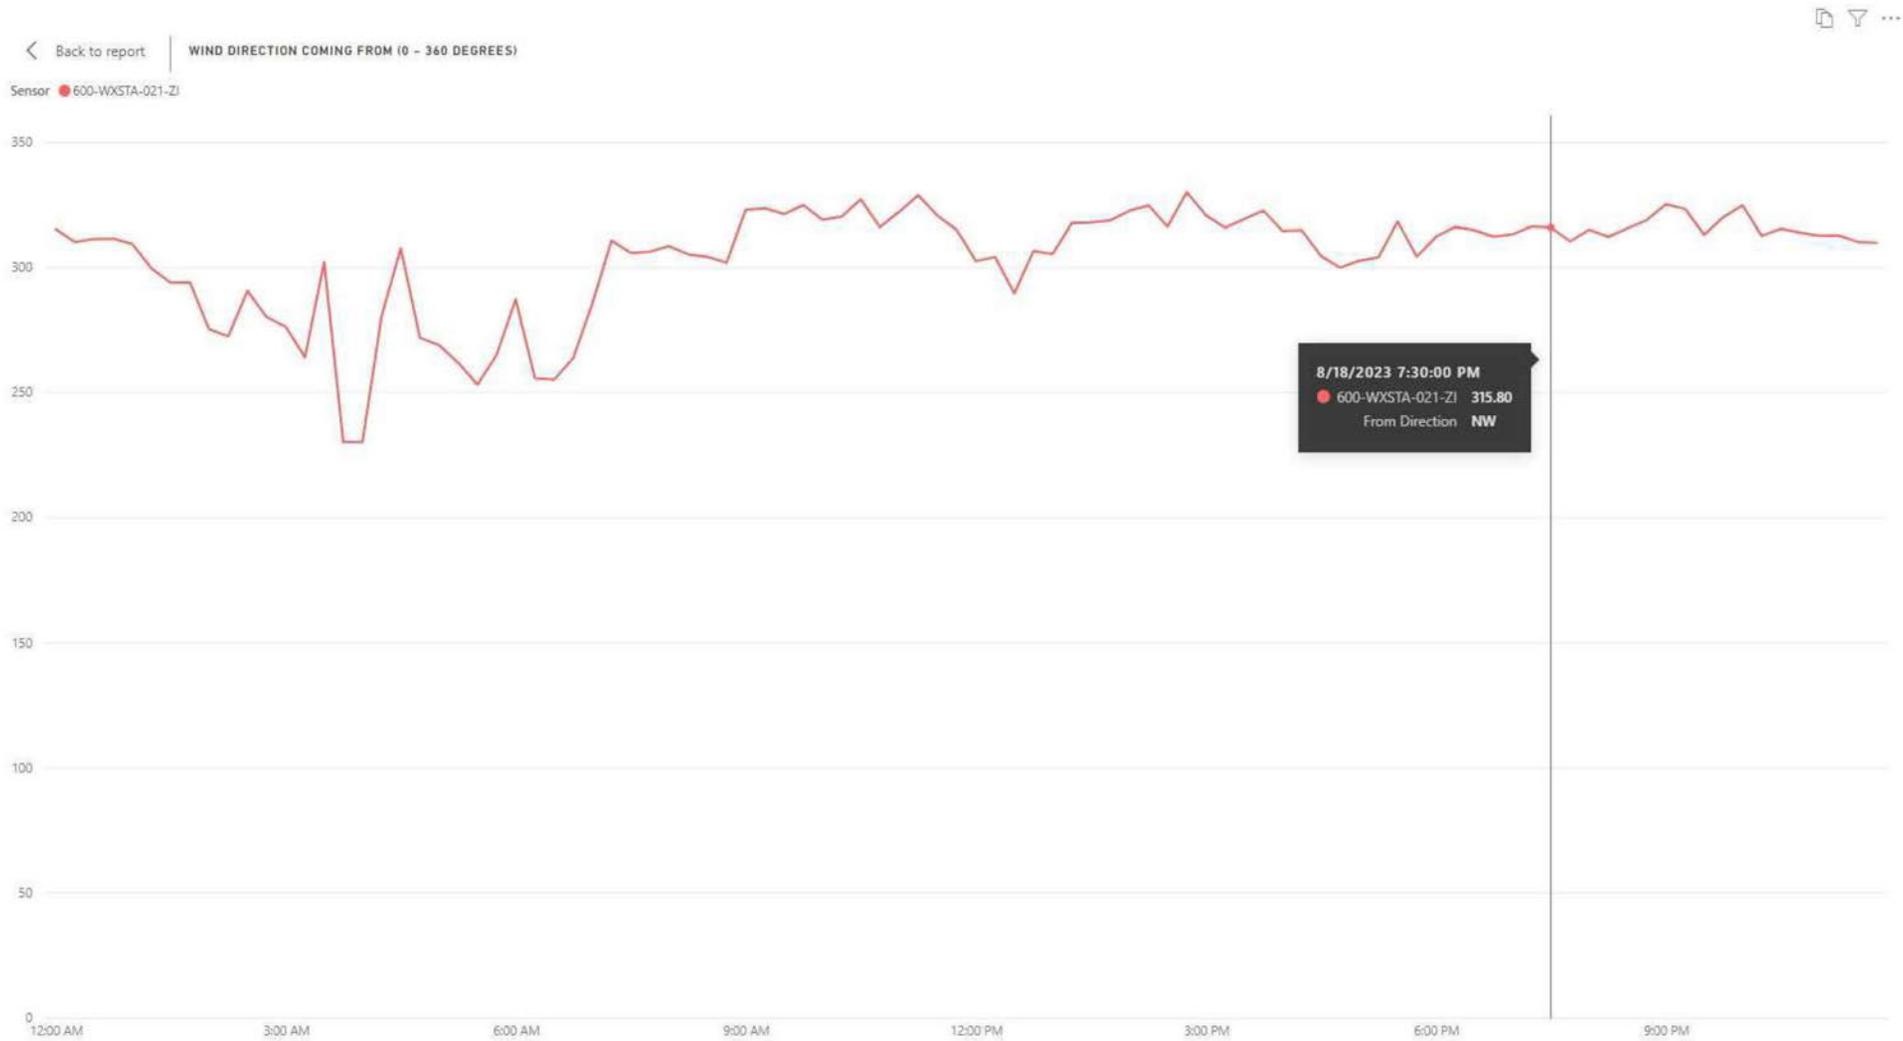
- Wind Speed: 19 mph (15 minute average)
- Wind Direction: 315.80° (out of Northwest)
- Mixing Height: 1200 feet above grade
- Stability Class: E (slightly stable conditions)

Figure 2. DFAS application, powered by SmartSite™ Weather Data (Wind Direction) from 1930 08/18/2023

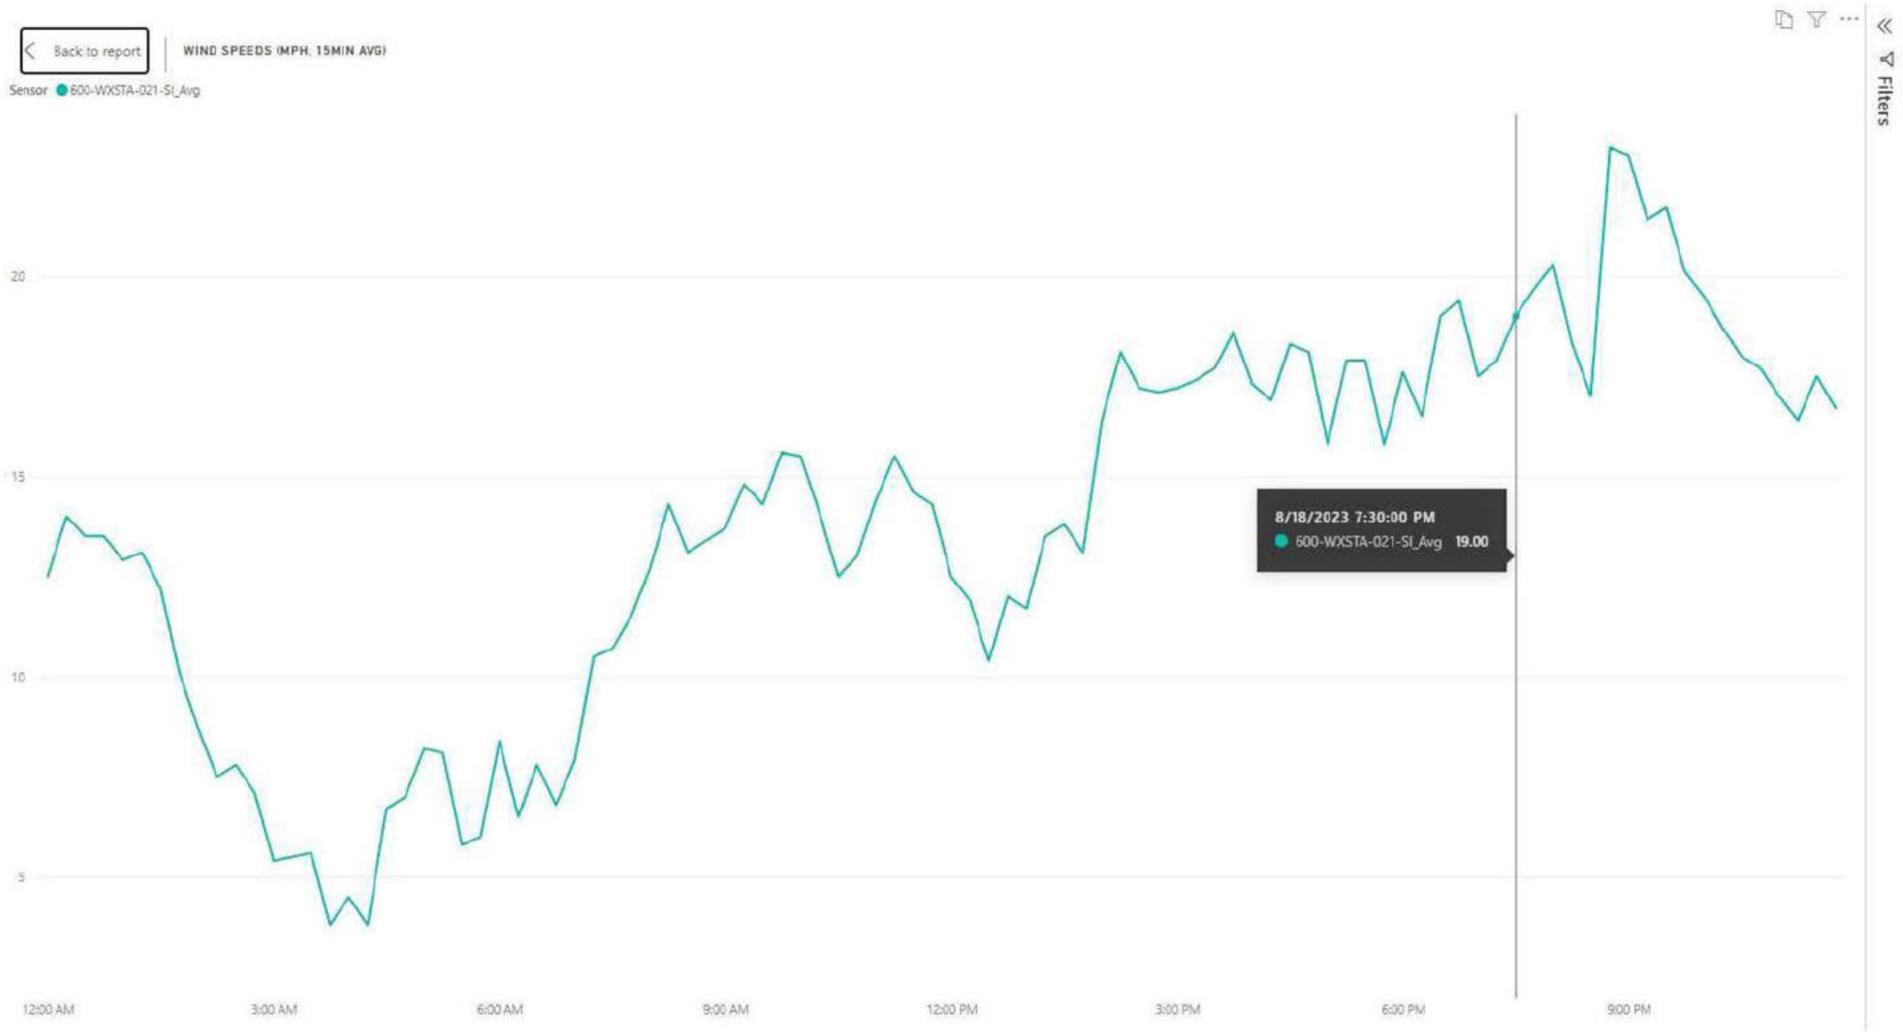
Figure 3. DFAS application, powered powered by SmartSite™ Weather Data (Wind Speed) from 1930 08/18/2023

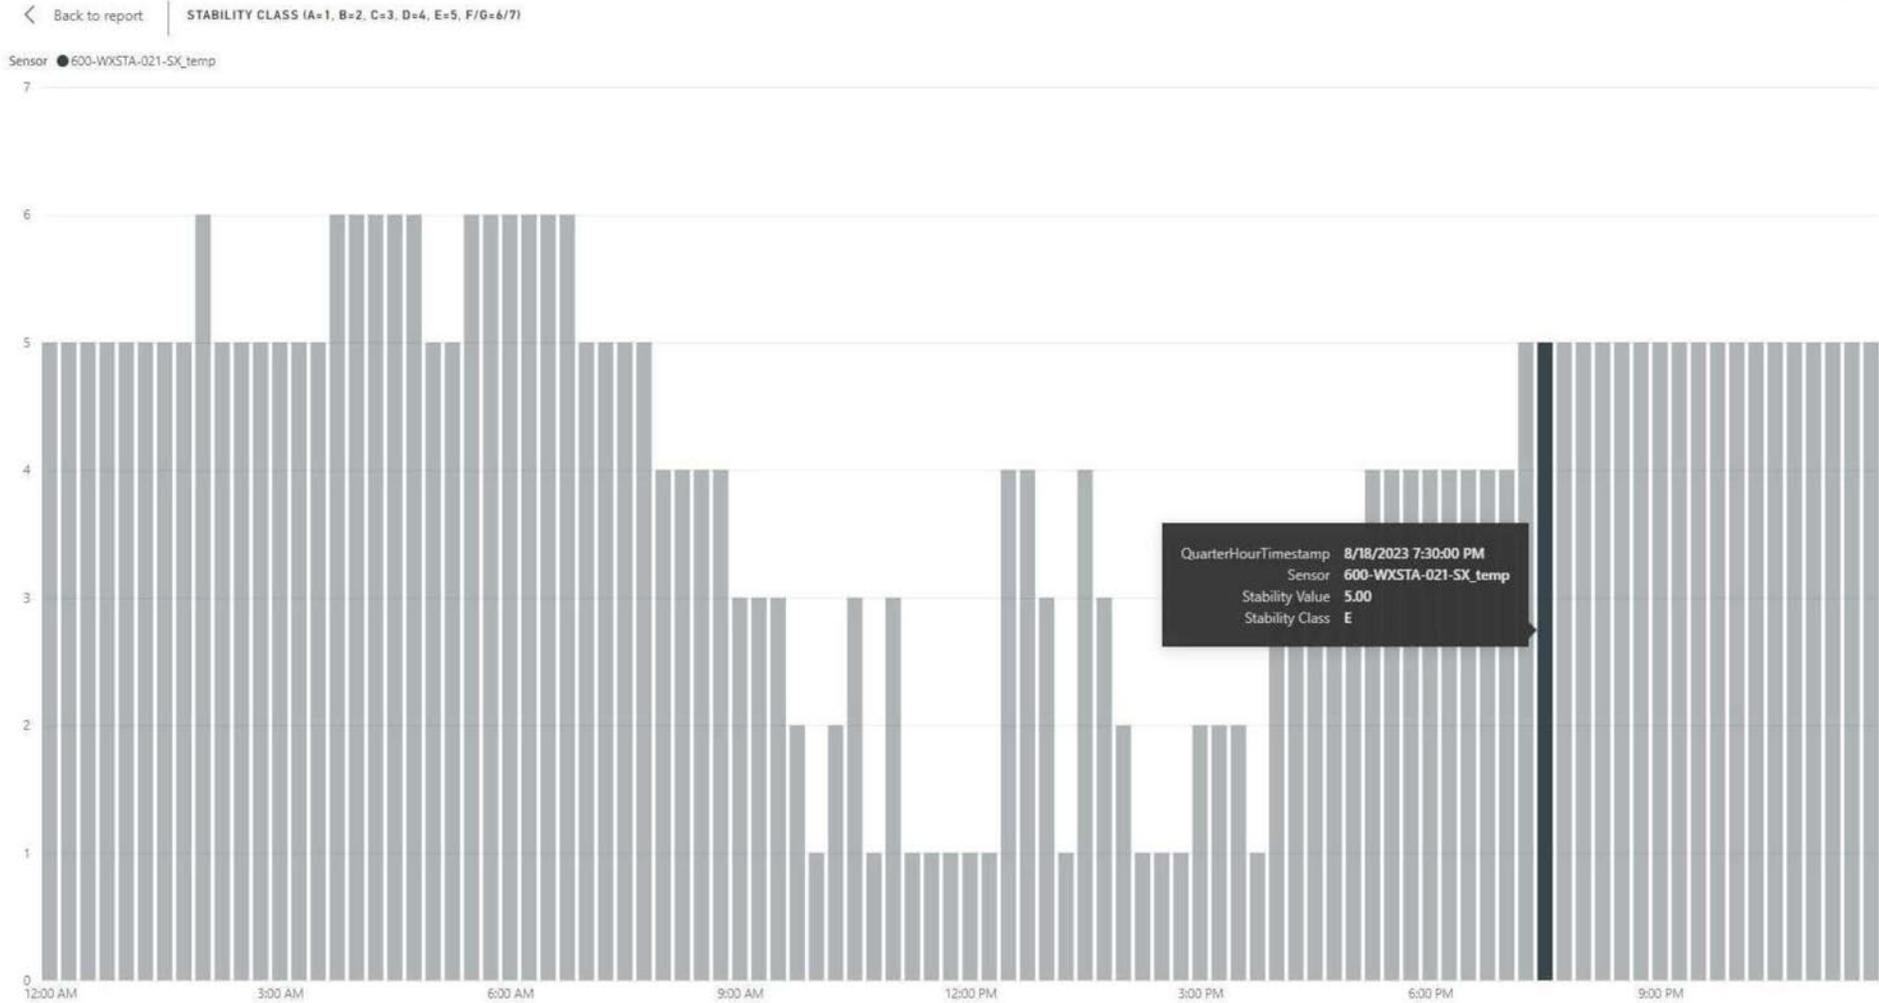
Figure 4. DFAS application, powered by SmartSite™ Weather Data (Stability Class) from 1930 08/18/2023

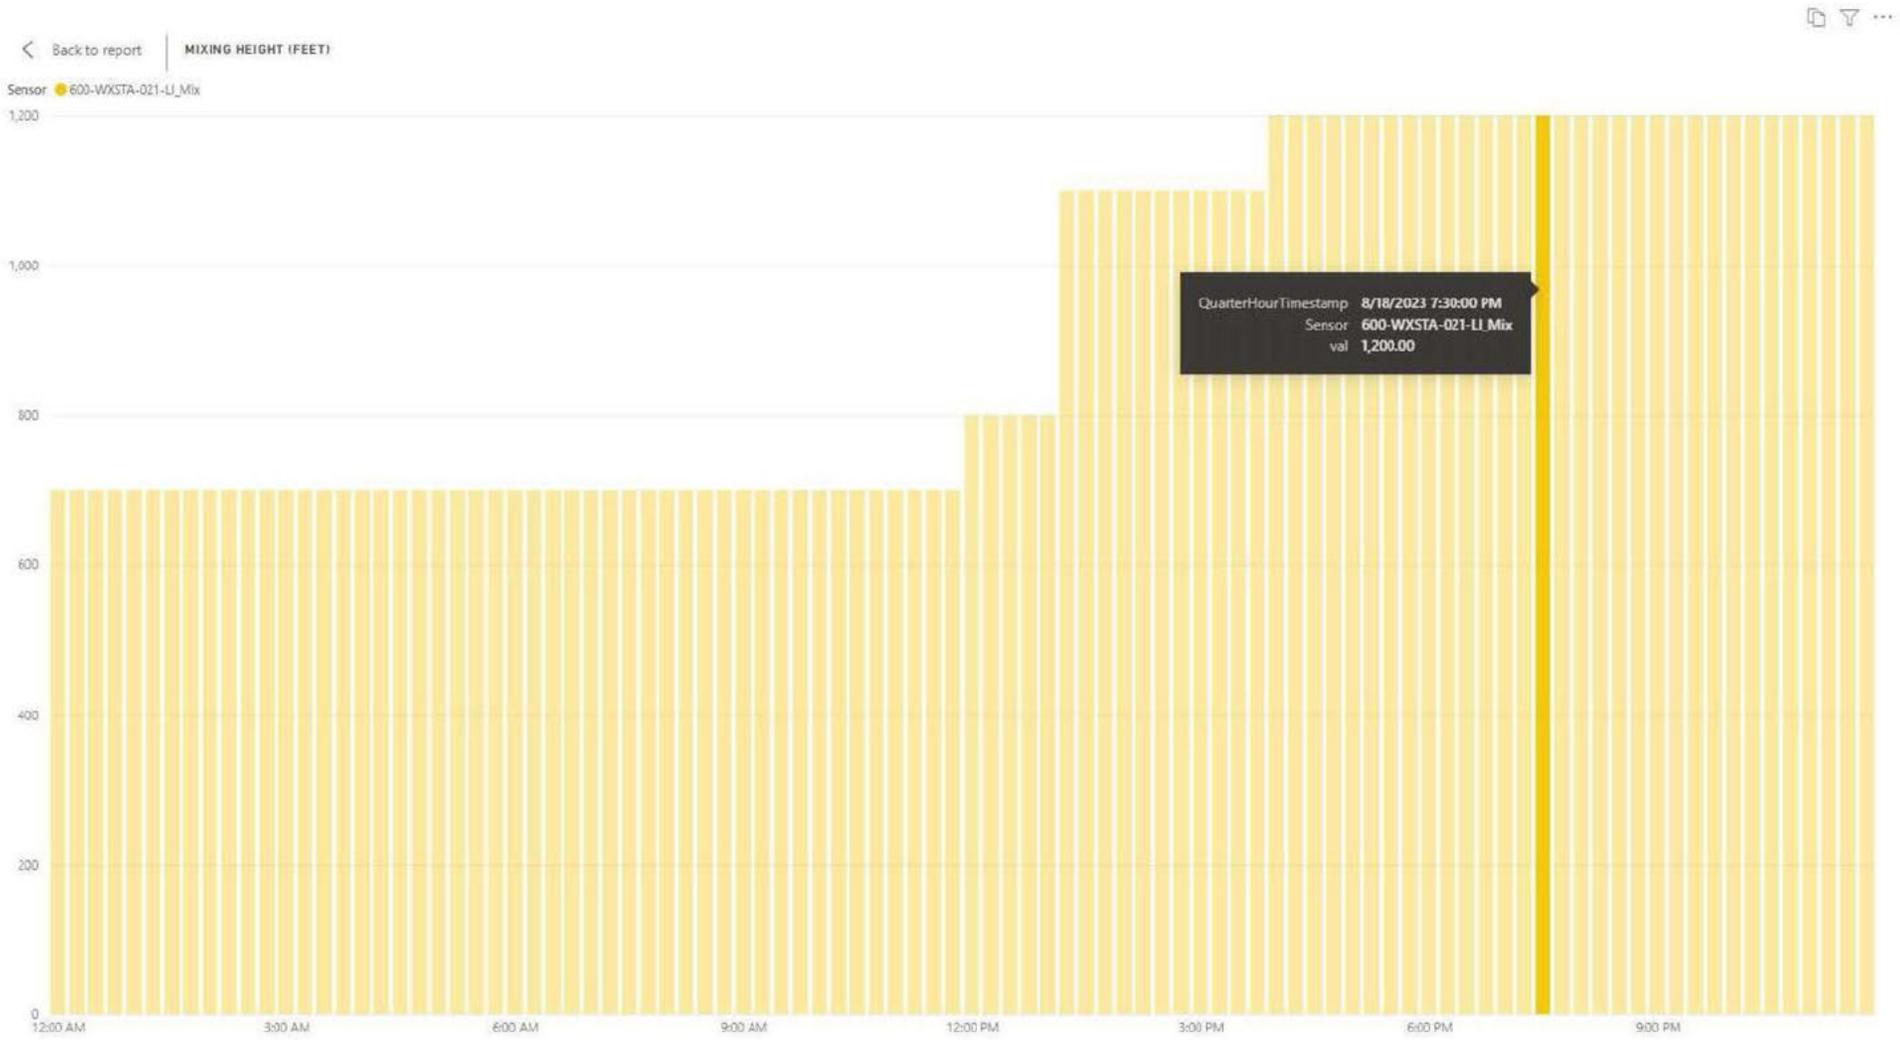
Figure 5. DFAS application, powered by SmartSite™ Weather Data (Mixing Height) from 1930 08/18/2023

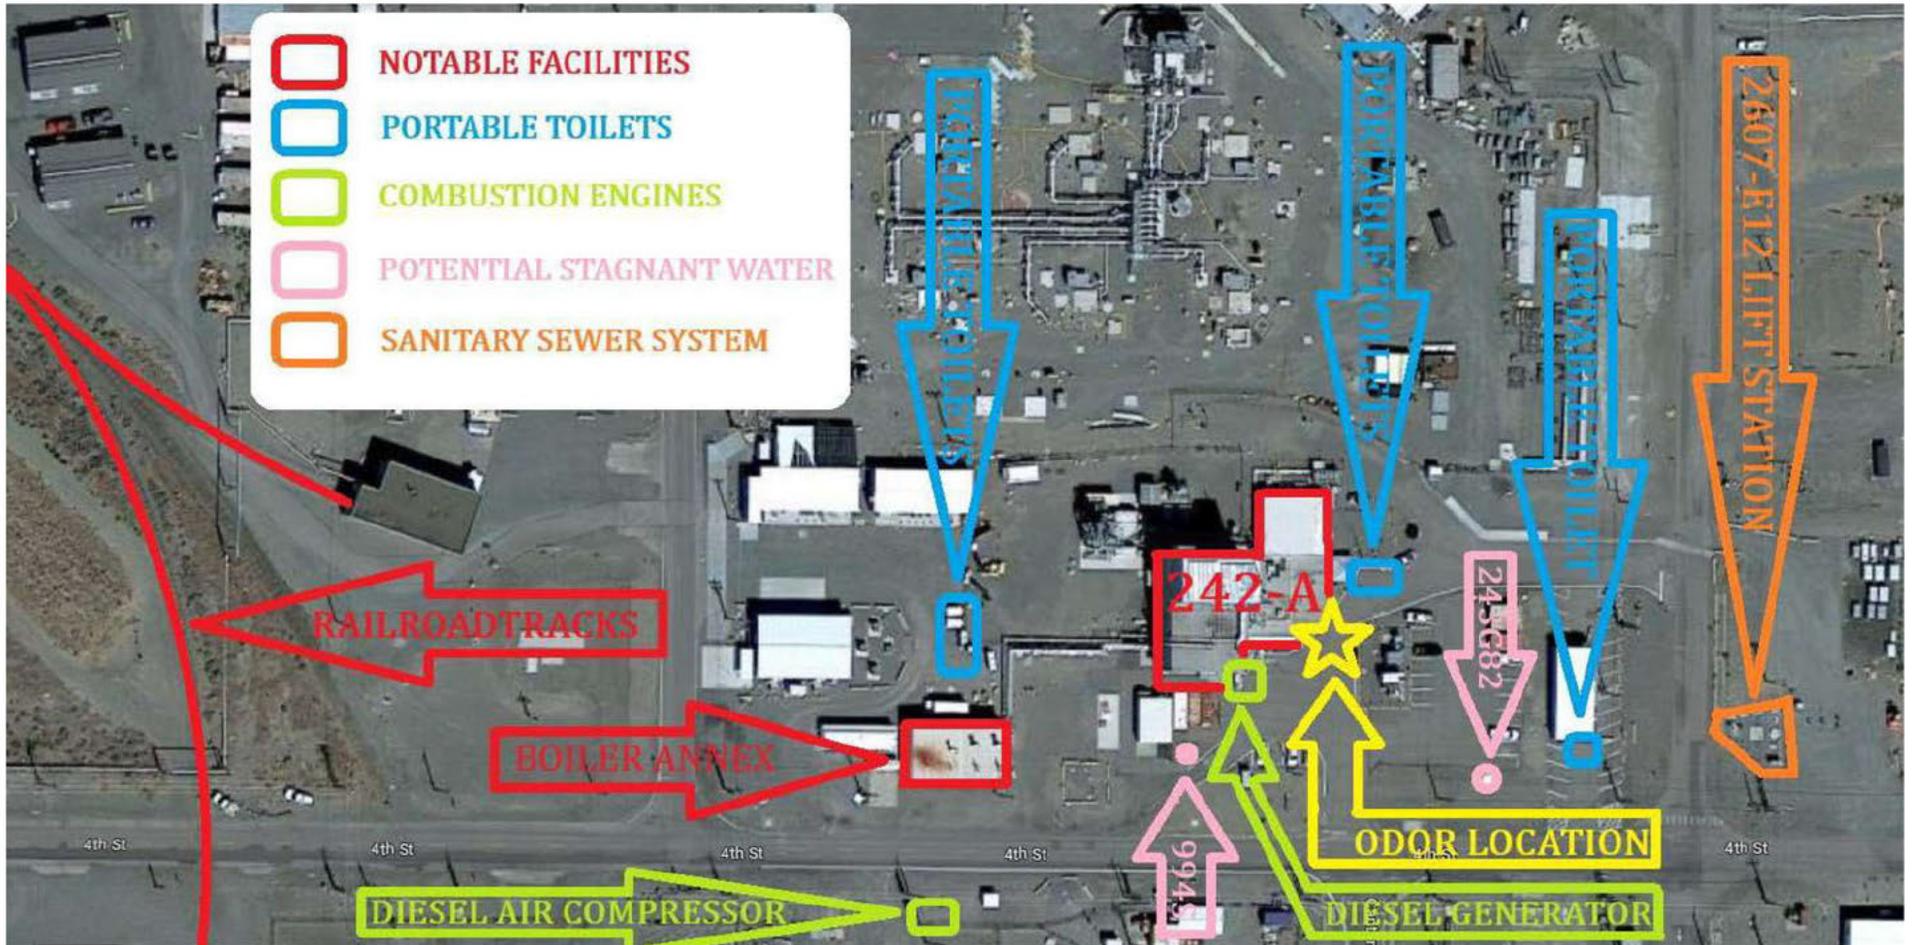
Figure 6. Event Location map showing notable facilities and potential odor locations consistent with odor descriptor.

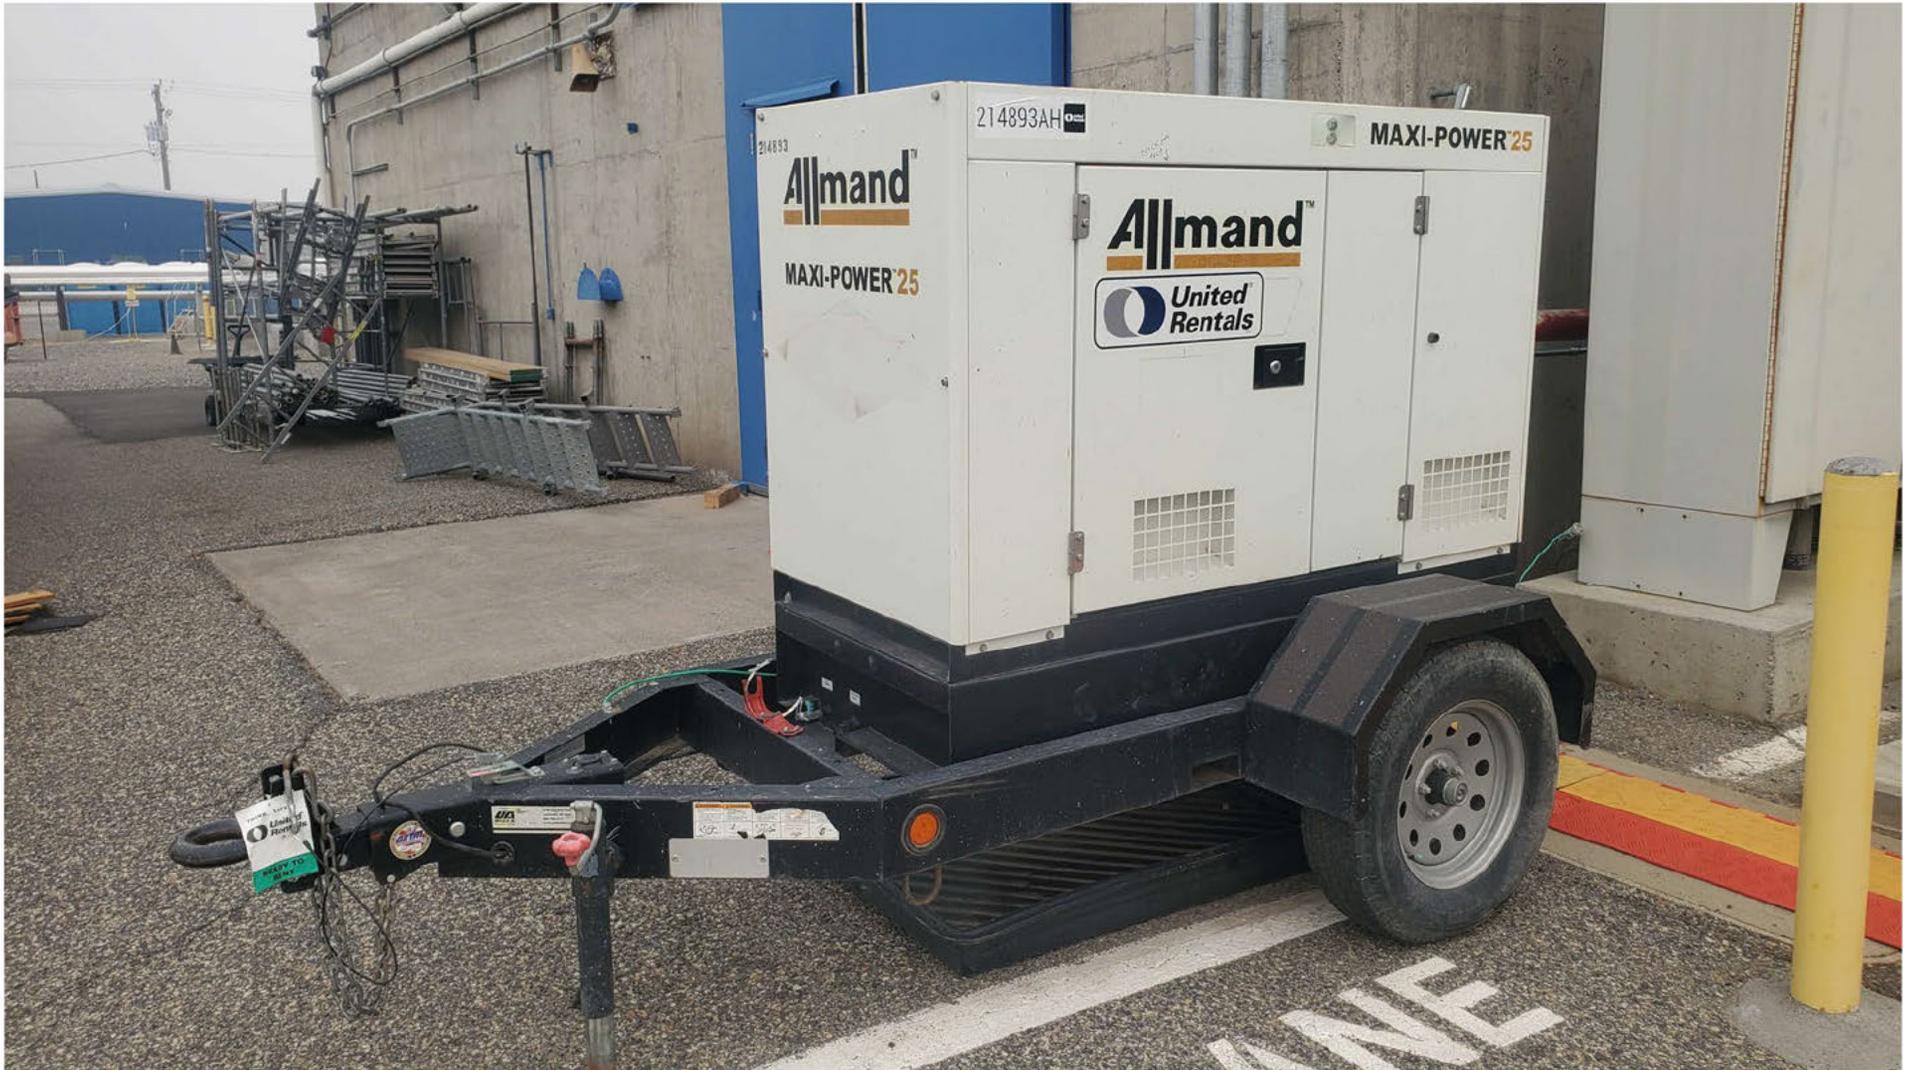
- Internal Combustion Engines -
 - o An Allmand MAXI-POWER 25 diesel electrical generator is located immediately adjacent to the reported odor location. This diesel generator was in operation at the time of the odor event to supply temporary electrical power to the 242A Facility during an ongoing planned electrical outage. MAXI-POWER 25 consumes approximately 1.6 U.S. Gallons of diesel per hour of operation.

Figure 7. Allmand MAXI-POWER 25 Diesel powered generator (located adjacent to reported odor location).

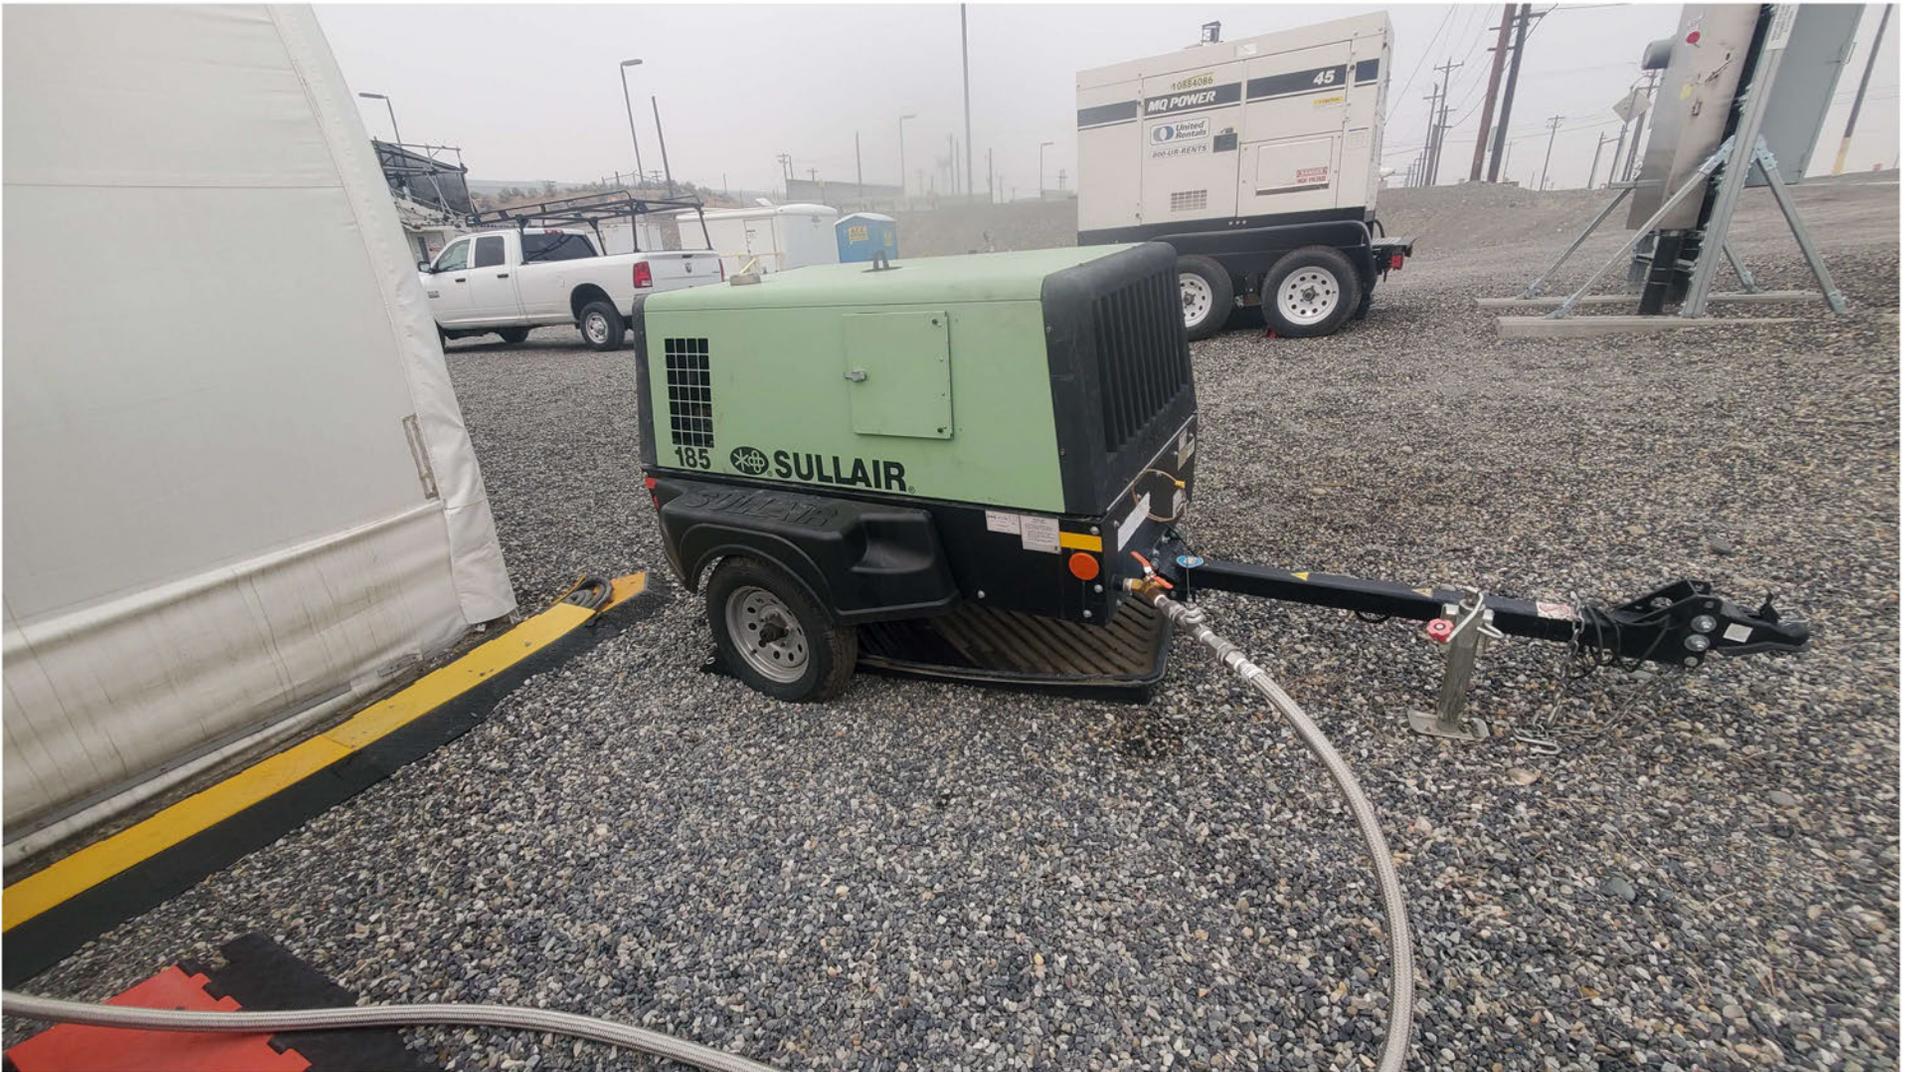
- o A SULLAIR 185 diesel air compressor is located nearby to the Southeast of the reported odor location.
- Potential stagnant water sources -
 - o The 243-G82 Pressure Reducing Valve Pit is a 8 feet diameter 10.5 feet deep corrugated culvert pipe with a compacted gravel floor located to the South-Southwest of the reported odor location. The pit contains service water piping which may be a source of standing or interstitial (within the gravel and soil) water source if the water service piping/fittings are leaking.

Figure 7. SULLAIR 185 Diesel powered air compressor (located East-Southeast of reported odor location).

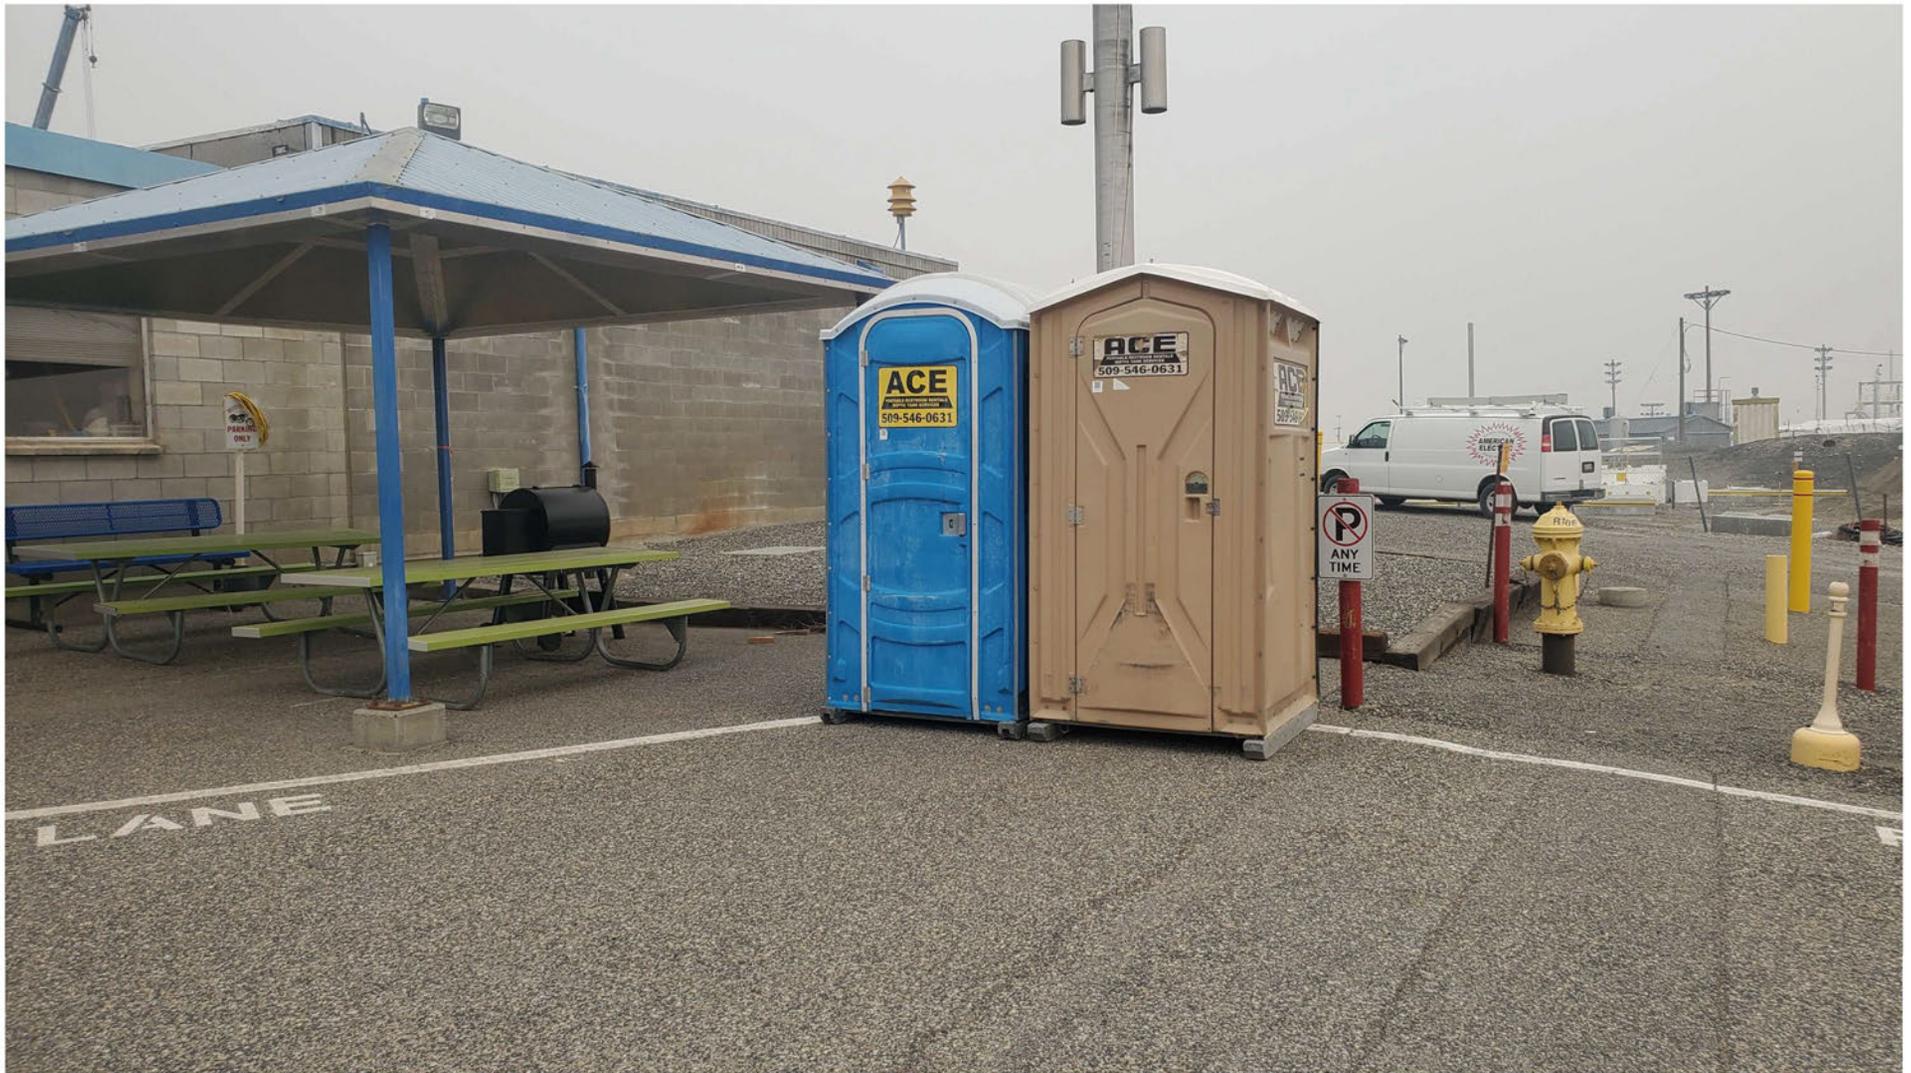
- Sanitary sewage sources -
 - o Portable Toilets are ubiquitous throughout the A-Complex Tank farm facilities due to the large number of Tank Farm personnel and deficiencies in permanent bathroom facilities and related sanitary sewer system capacity. Multiple portable toilets are located adjacent to the 242A Evaporator facility; on the North side of the parking lot, to the Southwest at MO2251, and to the East at the western extent of the 241-A Farm change trailer lot.

Figure 8. Portable toilets in 242-A Parking Lot (located North of reported odor location).

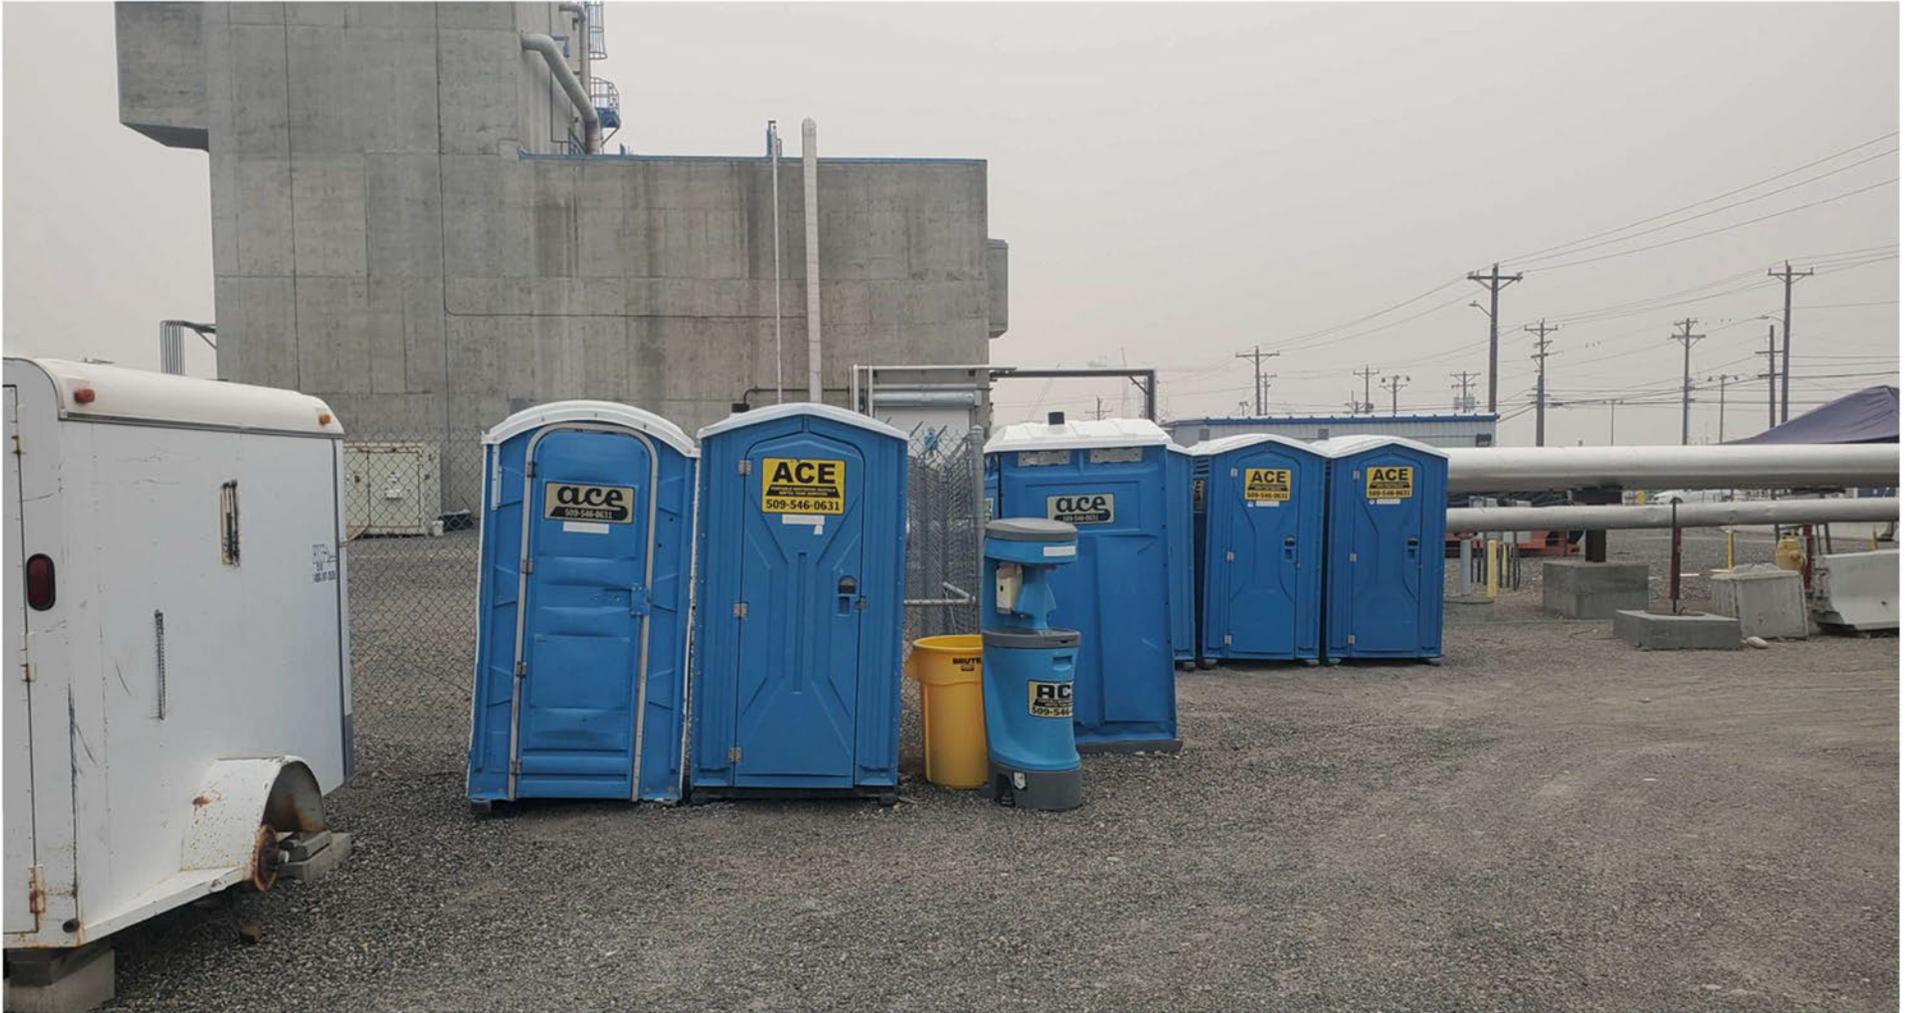
Figure 9. Portable toilets adjacent to 242-A Facility (located East of reported odor location).

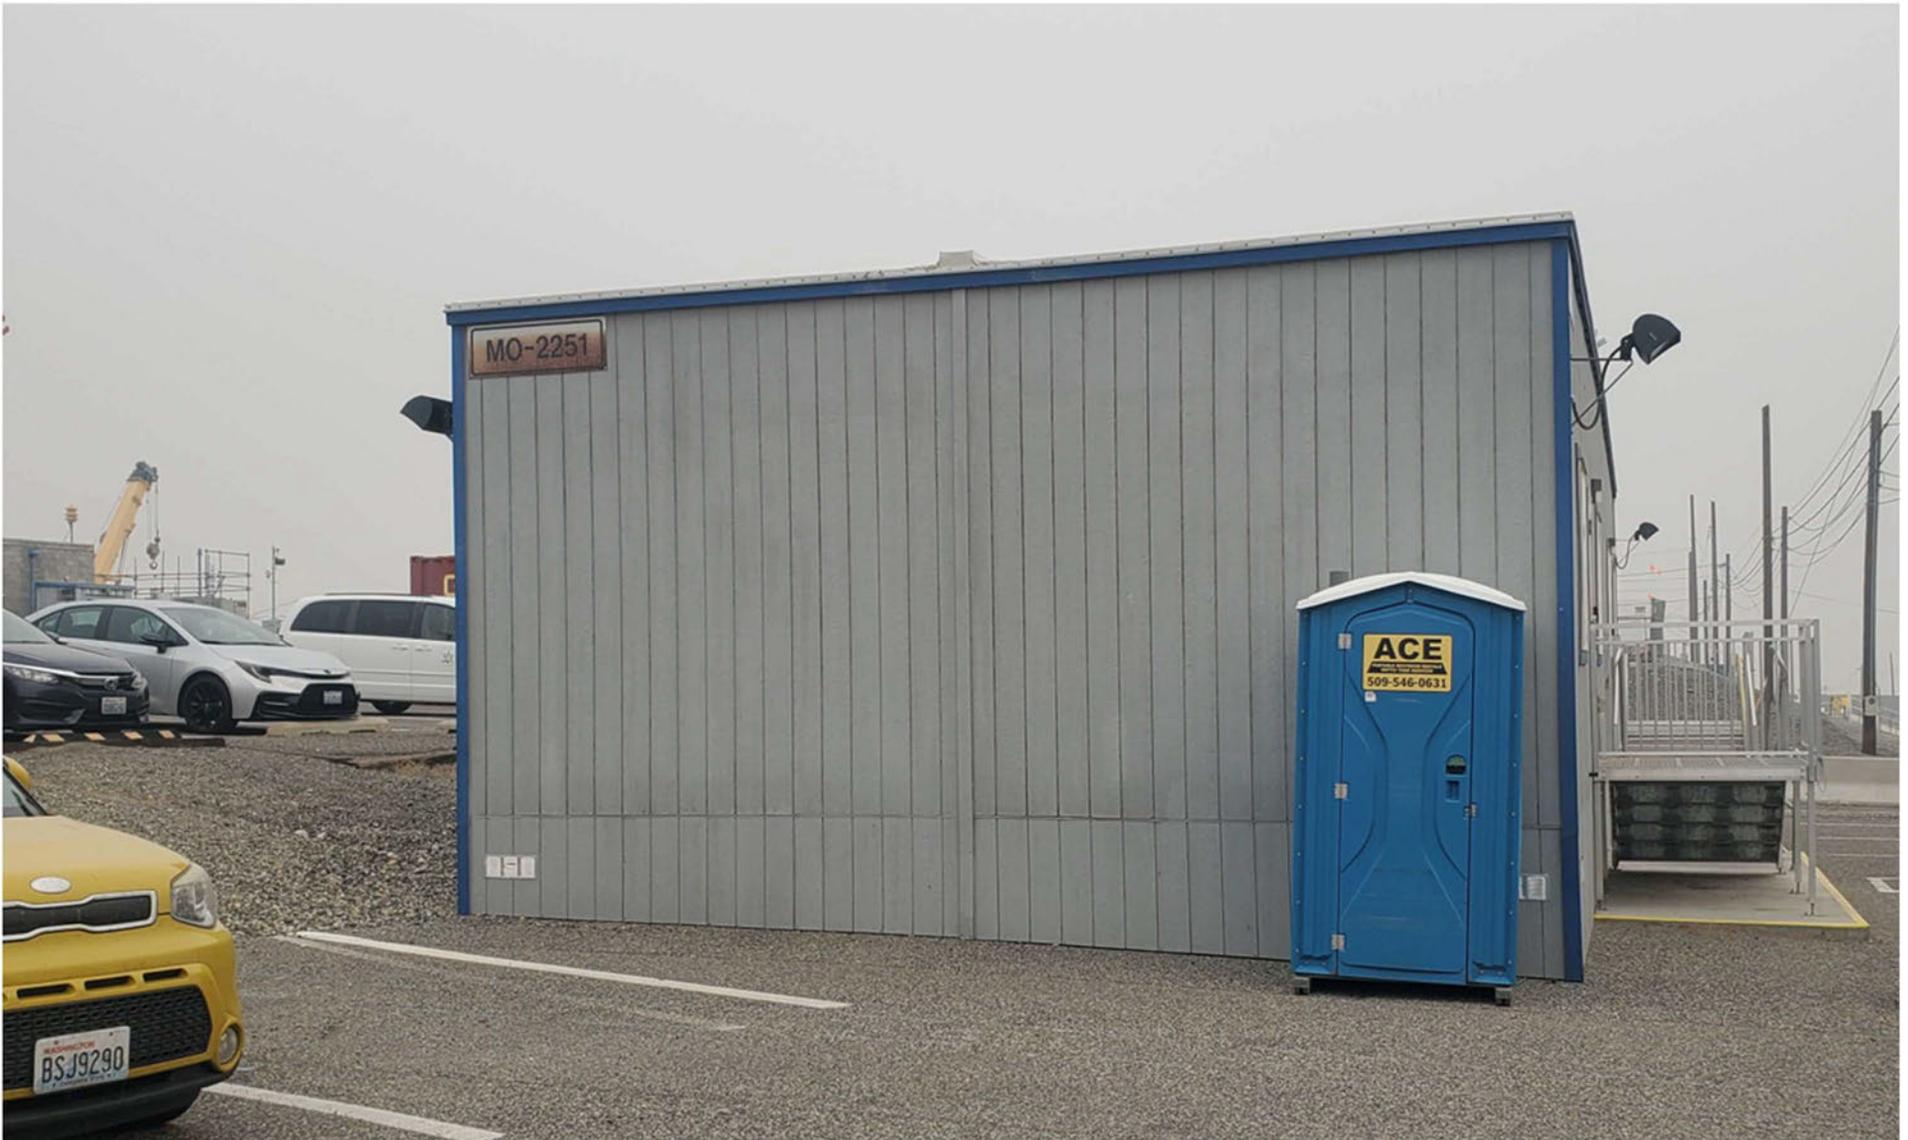
Figure 10. Portable toilet adjacent to 242-A Facility (located West-Southwest of reported odor location).
