C-67 Event Investigation Reports (Redacted) EIR-2023-063 C-67 (08/18/2023)

Project: Production Operations/242A Evaporator

EIR Number: EIR-2023-063

Washington River Protection Solutions
INDUSTRIAL HYGIENE EVENT INVESTIGATION REPORT

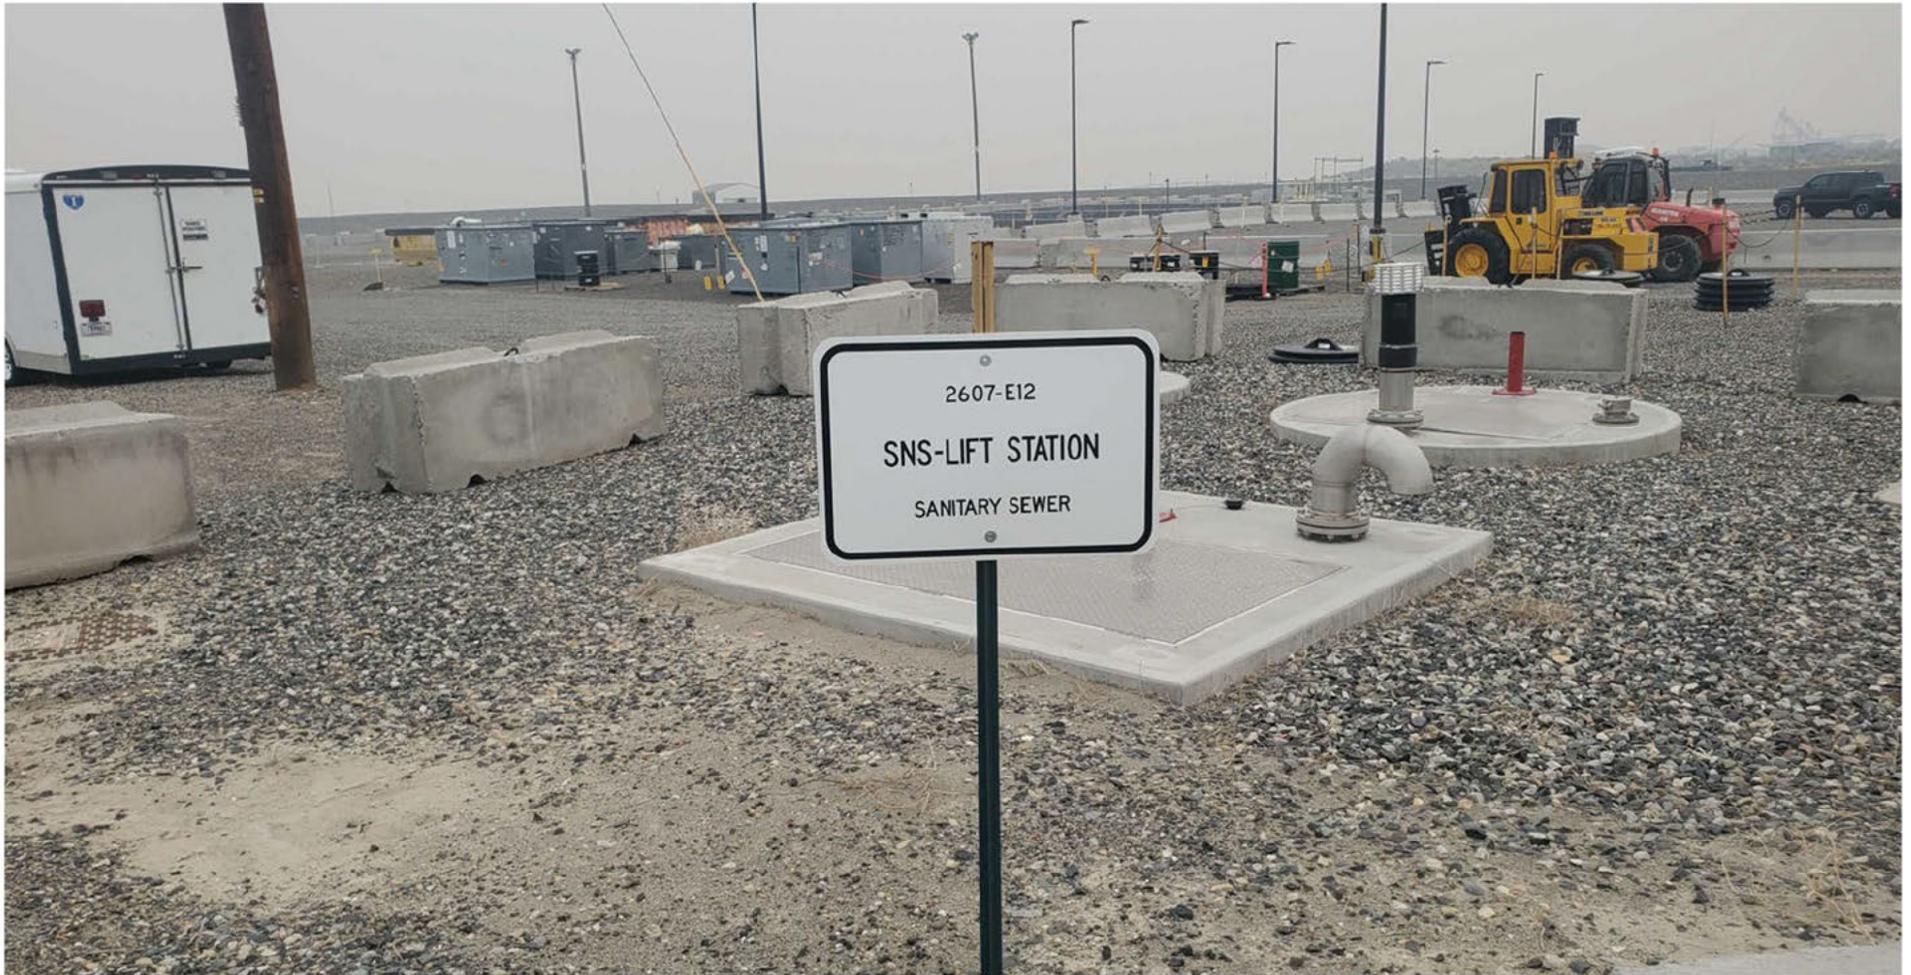
- o The 2607-E12 Sanitary Sewer Lift Station is located to the Southwest of the odor location and has historically been associated with similar odors, especially before the lift station was upgraded from a septic waste storage tank system in 2019. Although the legacy tank system was pumped to the extent possible before conversion, the tanks were abandoned in place and may be subject to meteoric or ground water intrusion.

Figure 11. 2607-E12 Sewage lift station (located West-Southwest of reported odor location).

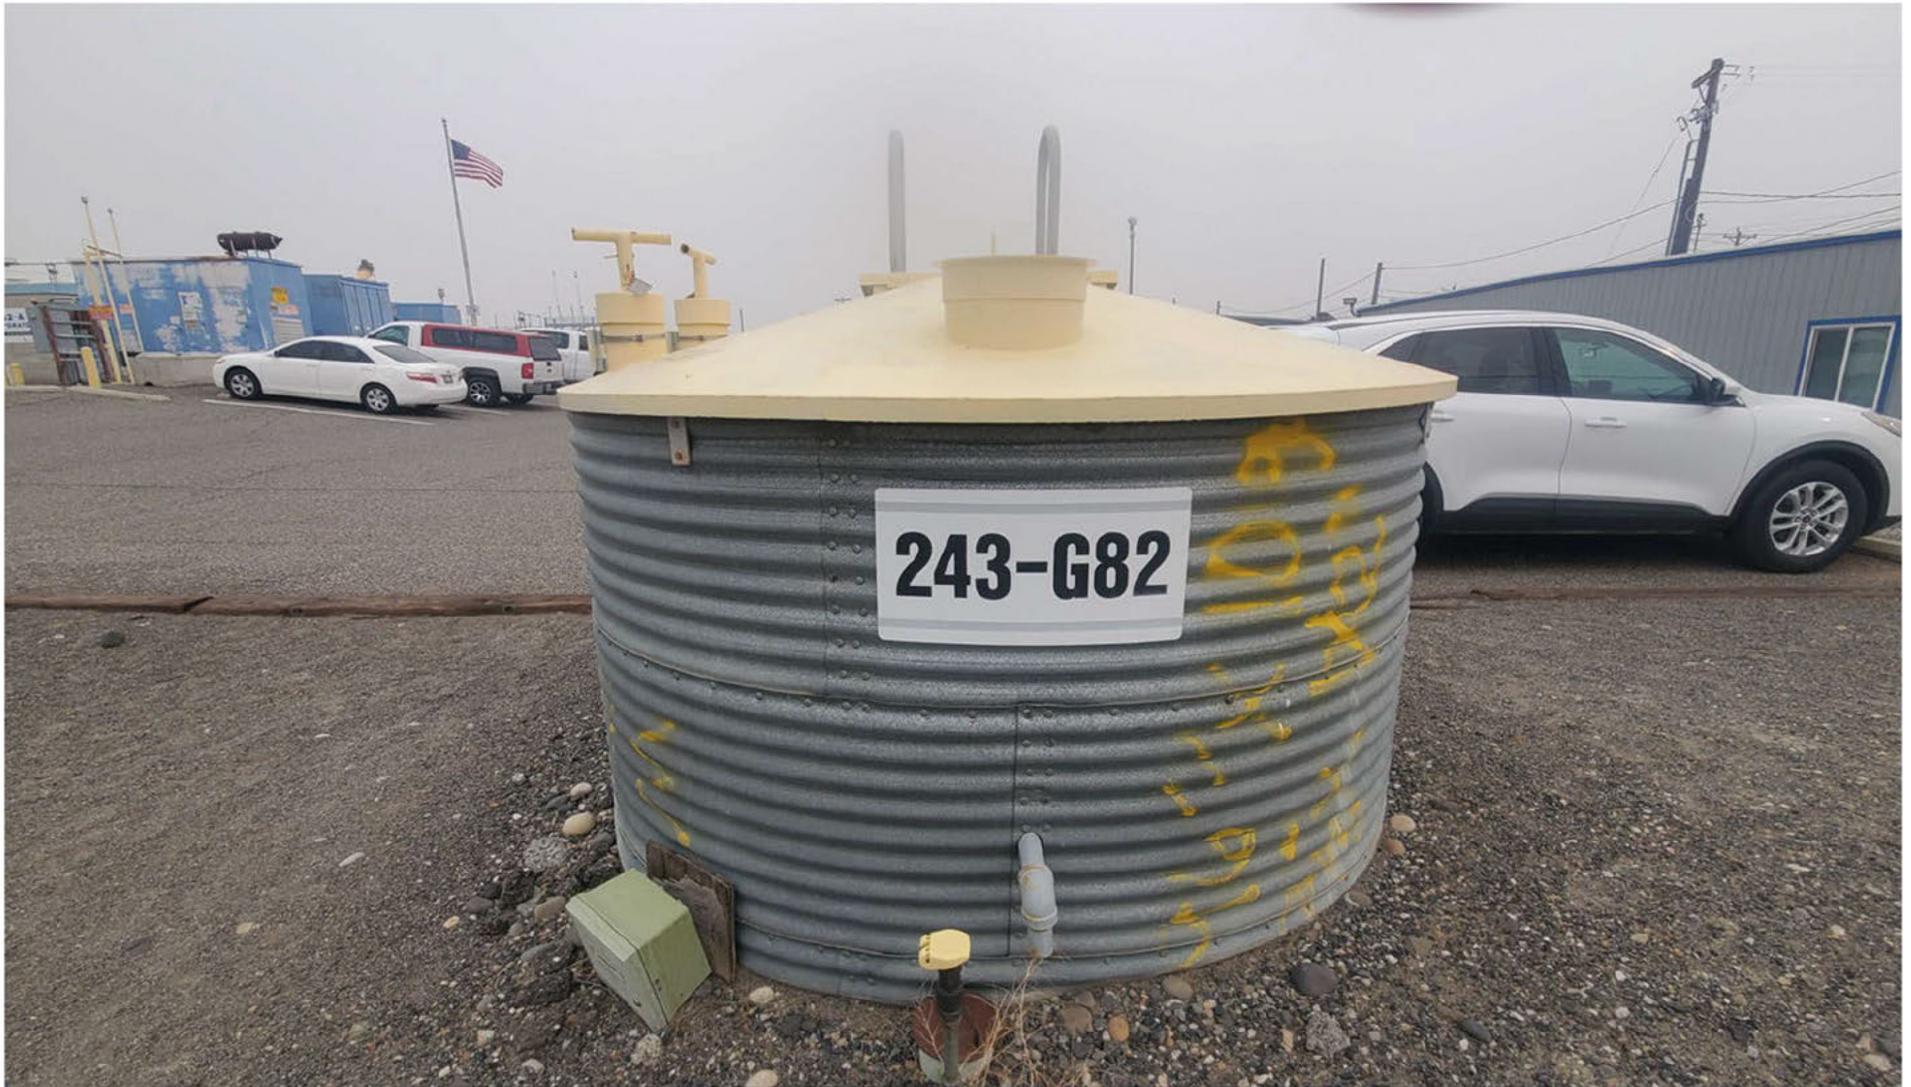
- Potential stagnant water sources -
 - o The 243-G82 Pressure Reducing Valve Pit is a 8 feet diameter 10.5 feet deep corrugated culvert pipe with a compacted gravel floor located to the South-Southwest of the reported odor location. The pit contains service water piping which may be a source of standing or interstitial (within the gravel and soil) water source if the water service piping/fittings are leaking.

Figure 12. 243-G82 Service water pressure-reducing-valve encasement (located Southwest of reported odor location).

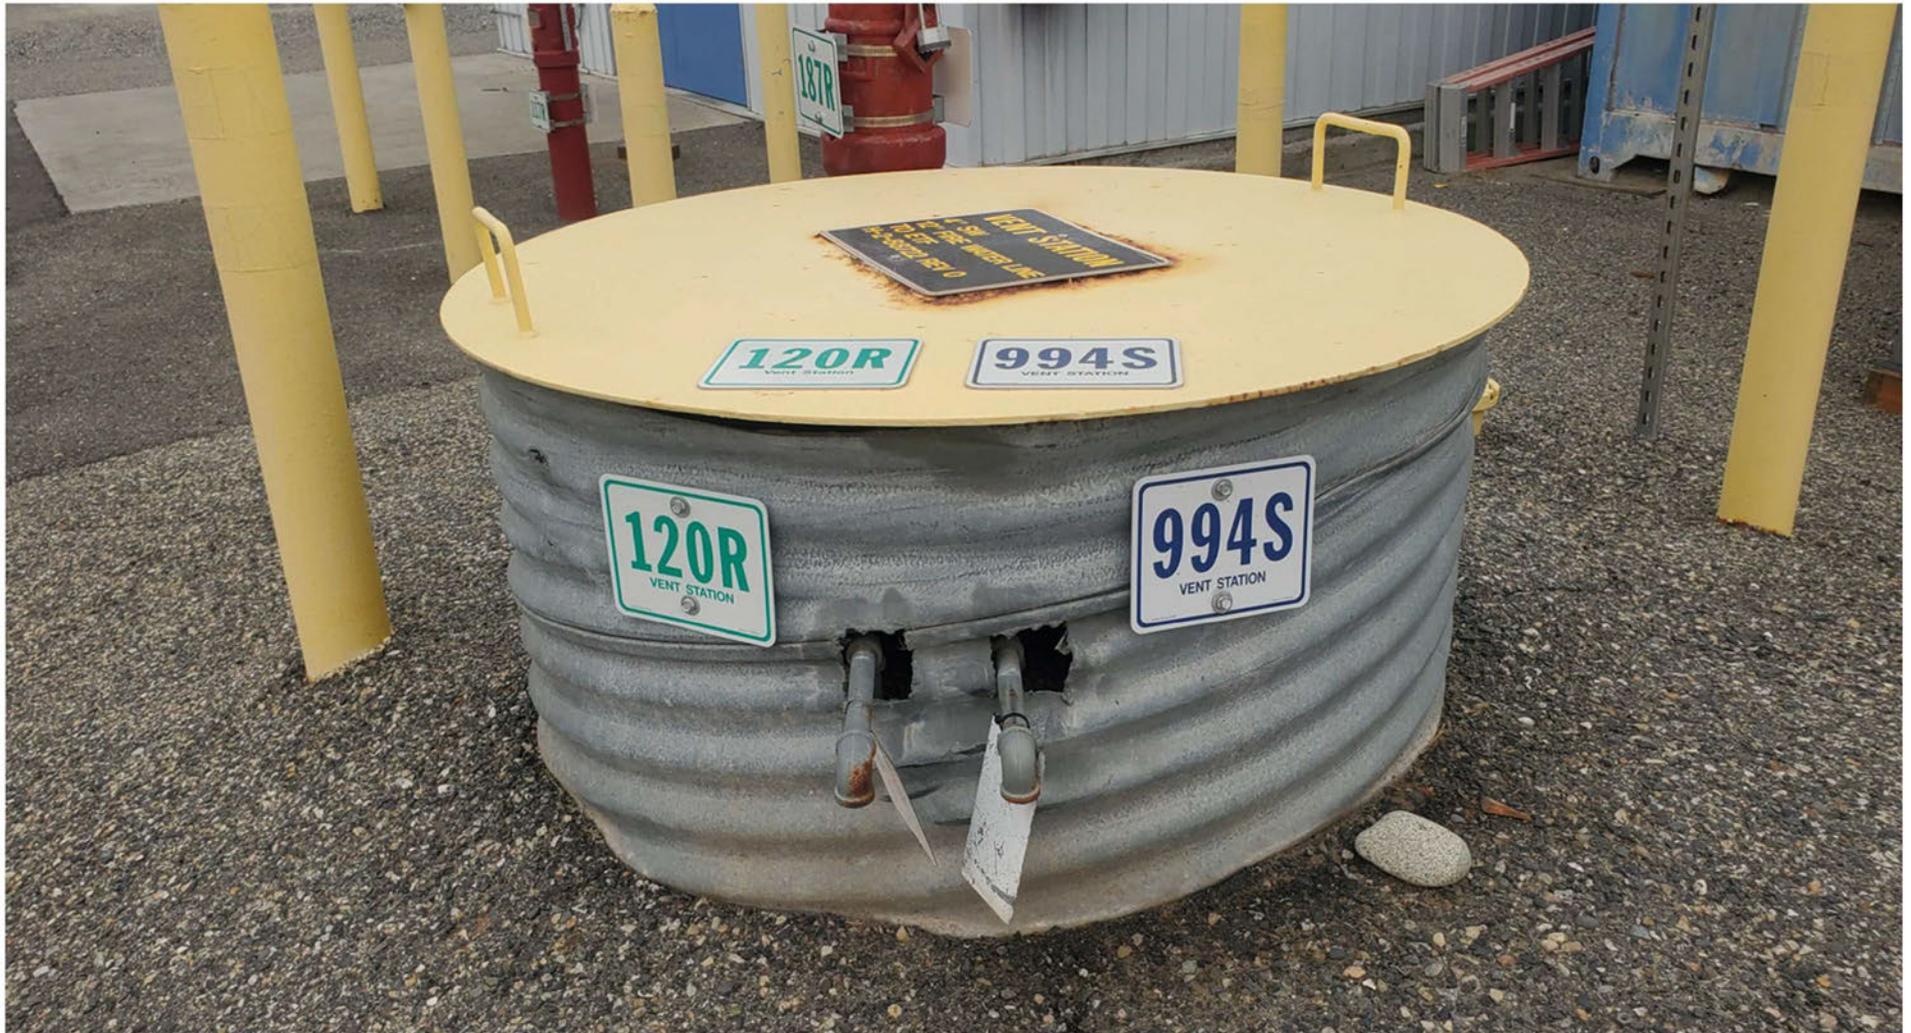
- o The 120R/994S vent station culvert is a corrugated steel culvert containing vents for the 120R and 994S Effluent Treatment Facility (ETF) influent water lines located immediately South of the reported odor location. The water lines could contain large quantities of standing water which are vented to atmosphere at this location.

Figure 13. 120R/994S ETF influent vent station (located South of reported odor location).
