Washington River Protection Solutions  
**EVENT SUMMARY**

3. **Investigation Title:** C-67 Odor Response

4. **Investigation Report Number:** EIR-2024-009

7. **Area / Building / Location:** 200E/2750E/C-105

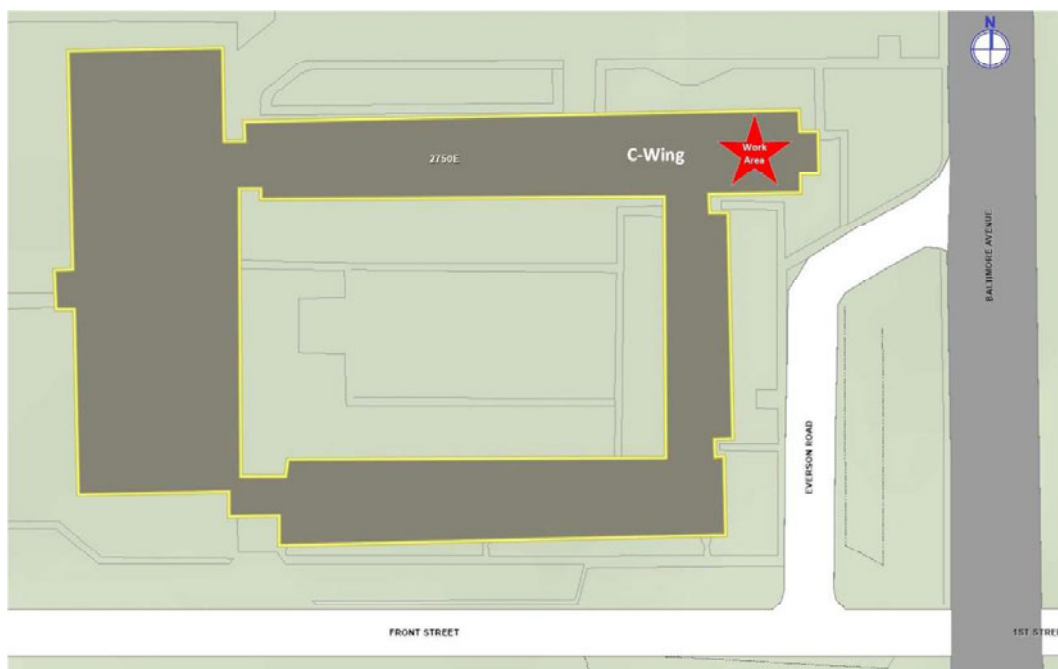
Figure 1 - 2750E Layout

First and second floors of C-Wing in 2750E (Refer to Figure 1)

C-105(lunchroom) shares the same HVAC unit as the work area and the HVAC was operational at the time of the event. Painters used 2 carbon filter blowers to remove odors stationed at opposite ends of the work area (East - west). A stairway door at the east end of the C-wing was shut and marked with barrier tape. Painters were not

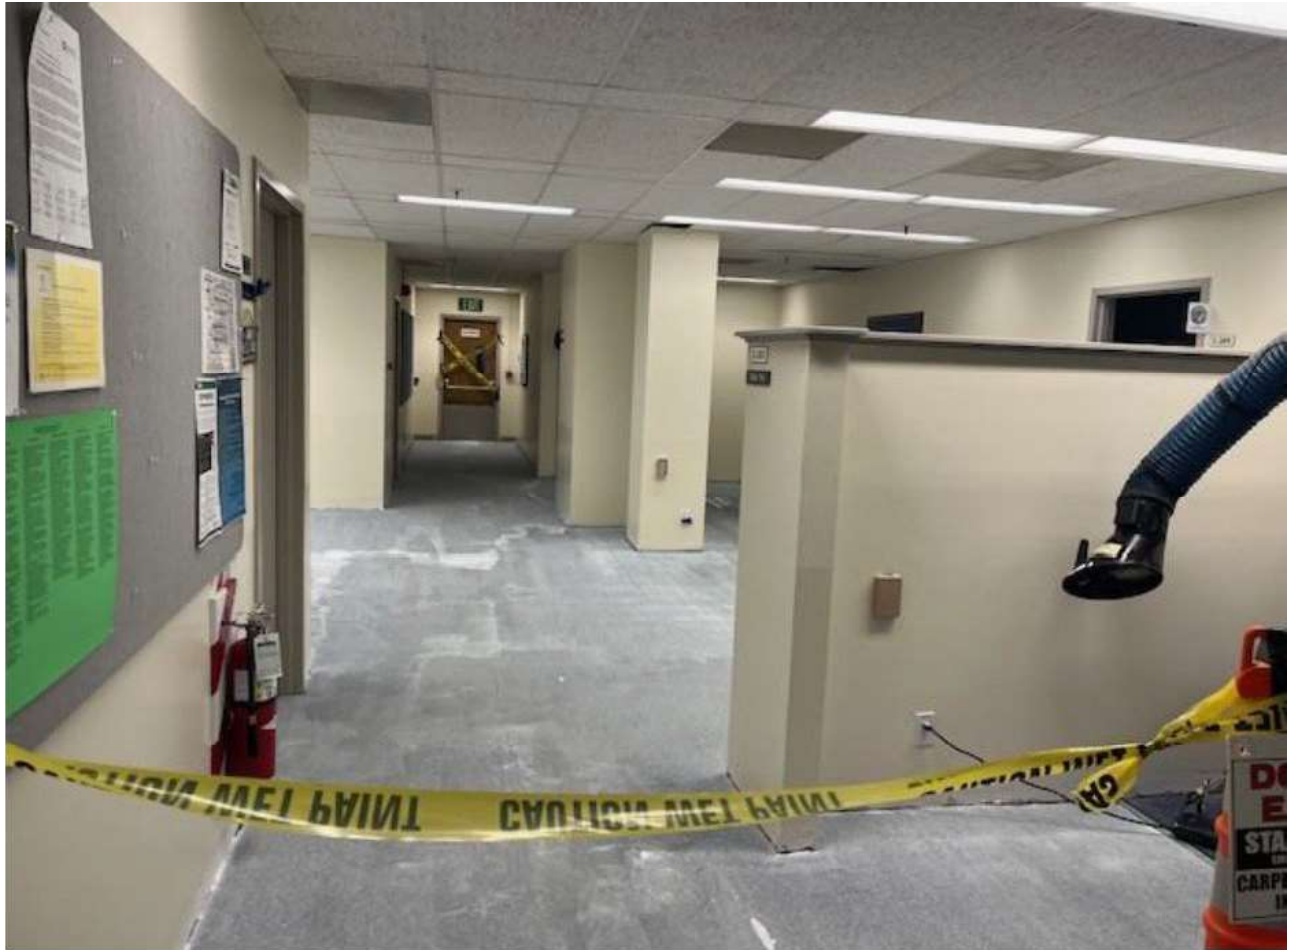
Figure 2 - Work Area

- (2) Although two portable smoke-eaters equipped with carbon filters were set up in the immediate work area to control vapors, the 2750 HVAC system was operational and transferred the odor to the first floor of C-wing. See Figure 2.
