# **C-67 Event Investigation Reports (Redacted) EIR-2024-013 C-67 (02/14/2024)**

3. **Investigation Title:** C-67 Odor Response on 4<sup>th</sup> St.

4. **Investigation Report Number:** EIR-2024-013

Washington River Protection Solutions  
**INDUSTRIAL HYGIENE EVENT INVESTIGATION REPORT (IHIR)**

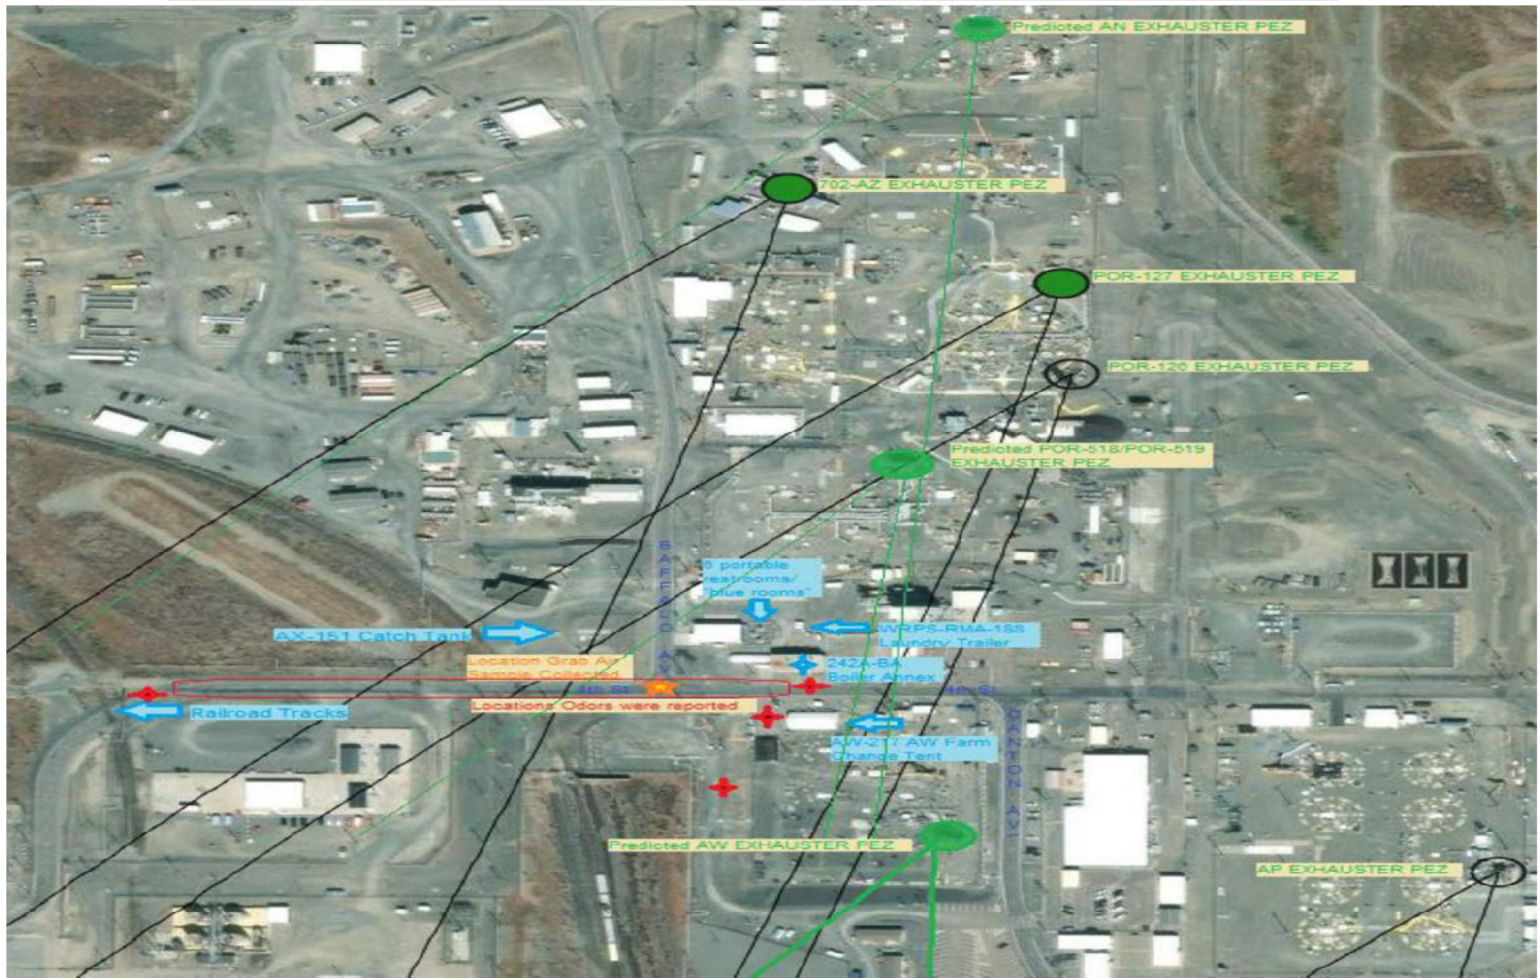
Attachment 1- DFAS Exhauster Potential Exposure Zones, Reported Odor Locations, and Potential Odor Sources

To summarize the conclusion of IHIR-00089, "TFC-OPS-OPER-C-67 Response 4<sup>th</sup> St. and Buffalo Ave", investigation and DRI monitoring could not readily identify the the source of the reported odors. However, it was determined the potential odor source(s) were most likely resultant of:

- 6 portable restrooms/"blue rooms" located ~200 feet northeast of the affected area.
- Bleach utilized to disinfect the WRPS-RMA-188 laundry trailer located ~225 feet north/northeast of the affected area.

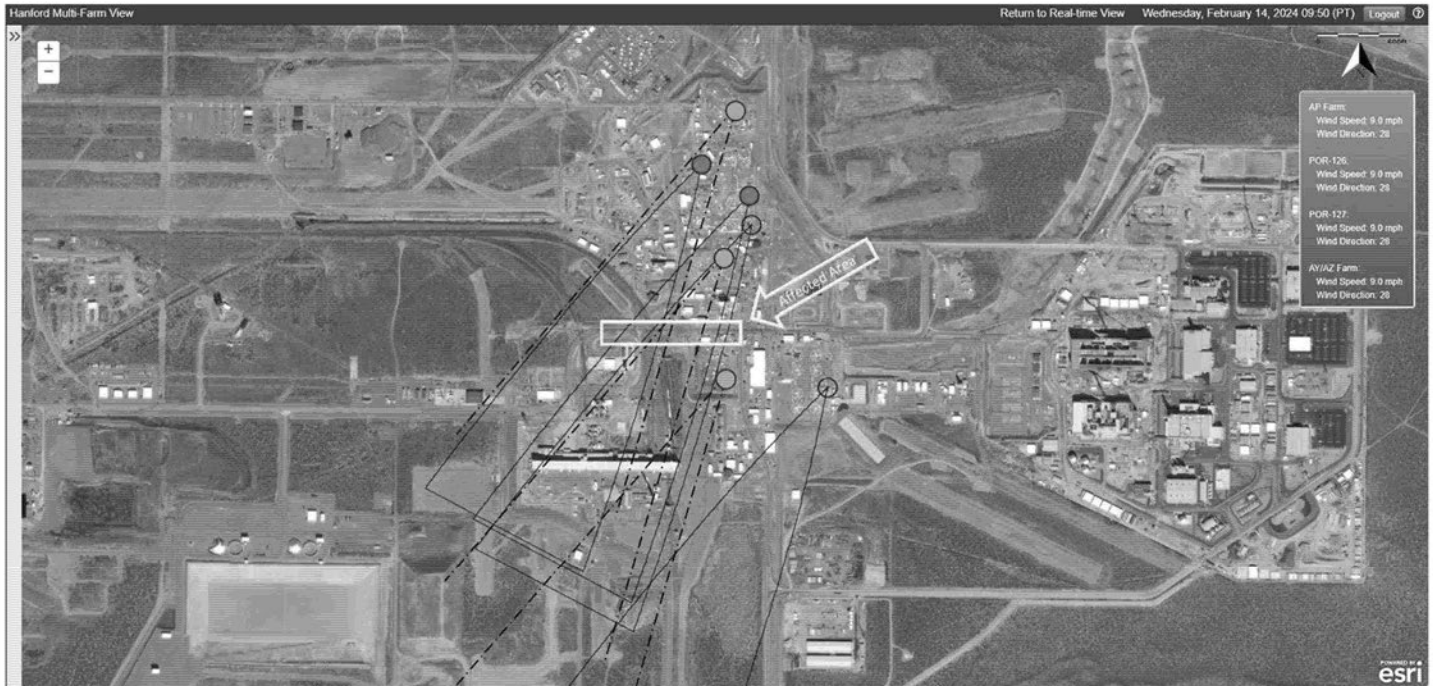
Figure 1. 200-East Area (with 241-AW, 241-AP, 241-AN, 241-AY/AZ, 241-AX, 241-A Farm projected plume models) at 0950 02/14/2024 from DFAS application, powered by SmartSite™.

NOTE: 241-AN, 241-A, 241-AW Farm Exhausters are not connected to the DFAS; however, an approximate exhauster plume was added for each based on other modeled plumes.

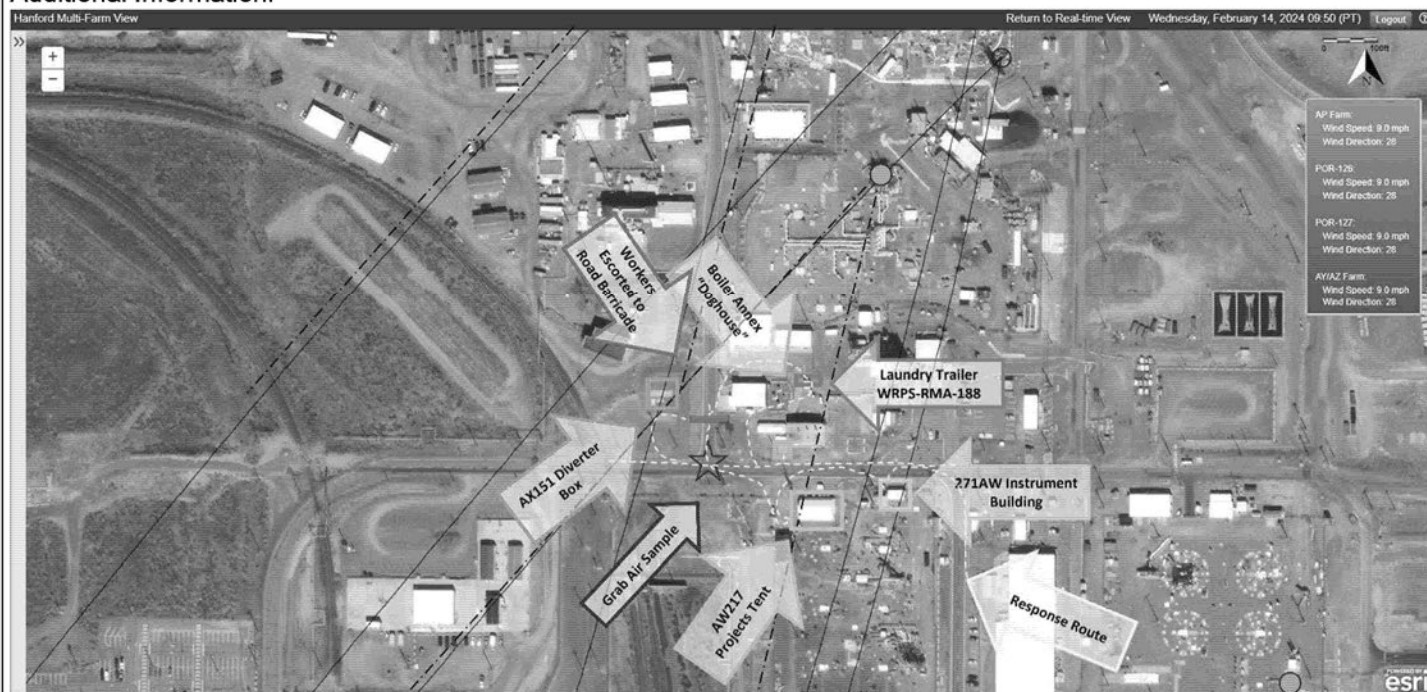
Figure 2. 200-East Area (with 241-AW, 241-AN, 241-AY/AZ, 241-AX, 241-A Farm projected plume models) at 0950 02/14/2024 from DFAS application, powered by SmartSite™.

NOTE: 241-AN, 241-A, 241-AW Farm Exhausters are not connected to the DFAS; however, an approximate exhauster plume was added for each based on other modeled plumes.

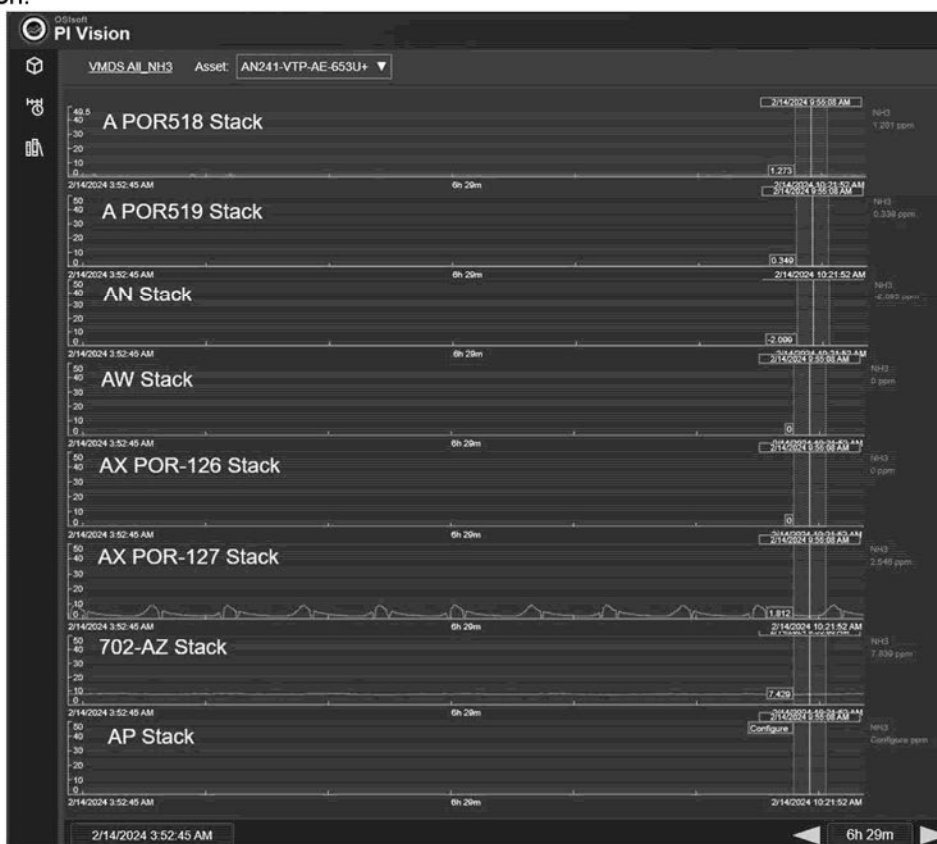
The exhauster high level alarm conservatively established for A Complex (excluding A farm) is 460 ppm. According to the Vapor Monitoring and Detection System (VMDS), the ammonia concentration observed at the time of event occurrence was 0 ppm at the 241-AW exhauster, -2.09 ppm at the AN exhauster, 0 ppm at the POR-126 exhauster, 2.505 ppm at the POR-127, and 7.823 ppm at 702-AZ exhauster. The AP exhauster is not currently connected to VMDS; therefore, readings are acquired once per calendar day in accordance with TF-OPS-IHT-037 when ammonia stack monitoring via VMDS is unavailable. The highest ammonia concentrations observed between 02/08/2024 and 02/14/2024 was 8 ppm at the AP Exhauster. Conservatively utilizing the higher ammonia concentration observed in the AP exhauster, a predicted ground receptor ammonia concentration of 0.043 ppm (or 0.17% of the established Occupational Exposure Limit for ammonia) would be expected if AP, AN, AY/AZ, AX, or AW farm exhauster emissions were present.

The exhauster high level alarm conservatively established for A farm is 160 ppm. According to the Vapor Monitoring and Detection System (VMDS), the ammonia concentration observed at the time of event occurrence was 1.285 ppm at the POR-518 exhauster and 0.338 ppm at the POR-519 exhauster. Conservatively utilizing the higher ammonia concentration observed in the POR-518 exhauster, a predicted ground receptor ammonia concentration of 0.020 ppm (or 0.08% of the established Occupational Exposure Limit for ammonia) would be expected if A tank farm exhauster emissions were present.

Figure 7. OSisoft Pi Vision VMDS Ammonia Concentrations for 0955 02/14/2024.

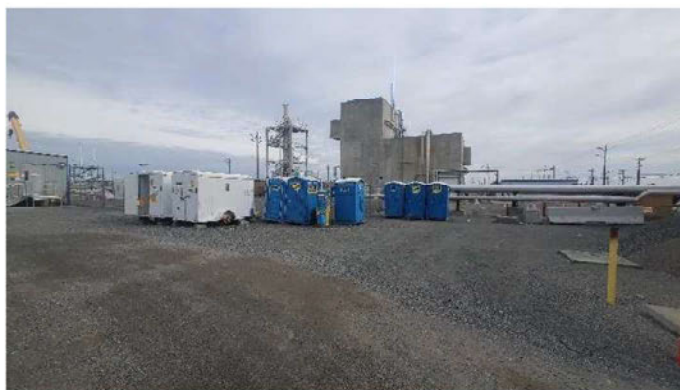
- (1) Six portable restrooms/"blue rooms" were located ~200 feet upwind of the affected area at the time of the reported odors. Due to the proximity to the affected area and wind direction at the time of the reported odors (out of North/Northeast), in addition to utilization of standard cleaning chemicals (including deodorizers and blue dye bacterial inhibitors); the six portable restrooms/"blue rooms" located north of the 242-A Boiler Annex were determined to be a potential odor source. A portable restroom maintenance truck was observed driving south on Canton Ave shortly before the reported odors, however, the maintenance subcontractor confirmed the 6 portable restrooms/"blue rooms" located north of the 242-A Boiler Annex were not serviced prior to the event occurrence. Nonetheless, IHTs noted an observable odor in the general areas north of the 242-A Boiler Annex during TFC-OPS-OPER-C-67 response. Observed odors were described as "sweet/cologne-like" and being "similar to blue room additives".

The event response DRI results were less than detectable in the Affected Area for hydrogen sulfide, ammonia, and VOCs. A portable restroom maintenance truck was observed driving south on Canton Ave shortly before the event. It is possible that recent portable restroom maintenance including pumping and standard cleaning chemicals were used upwind of the Affected Area around the time of the event. Due to the proximity and wind direction, the portable restrooms were a potential odor source.

Figure 8. Portable restrooms upwind of Affected Area

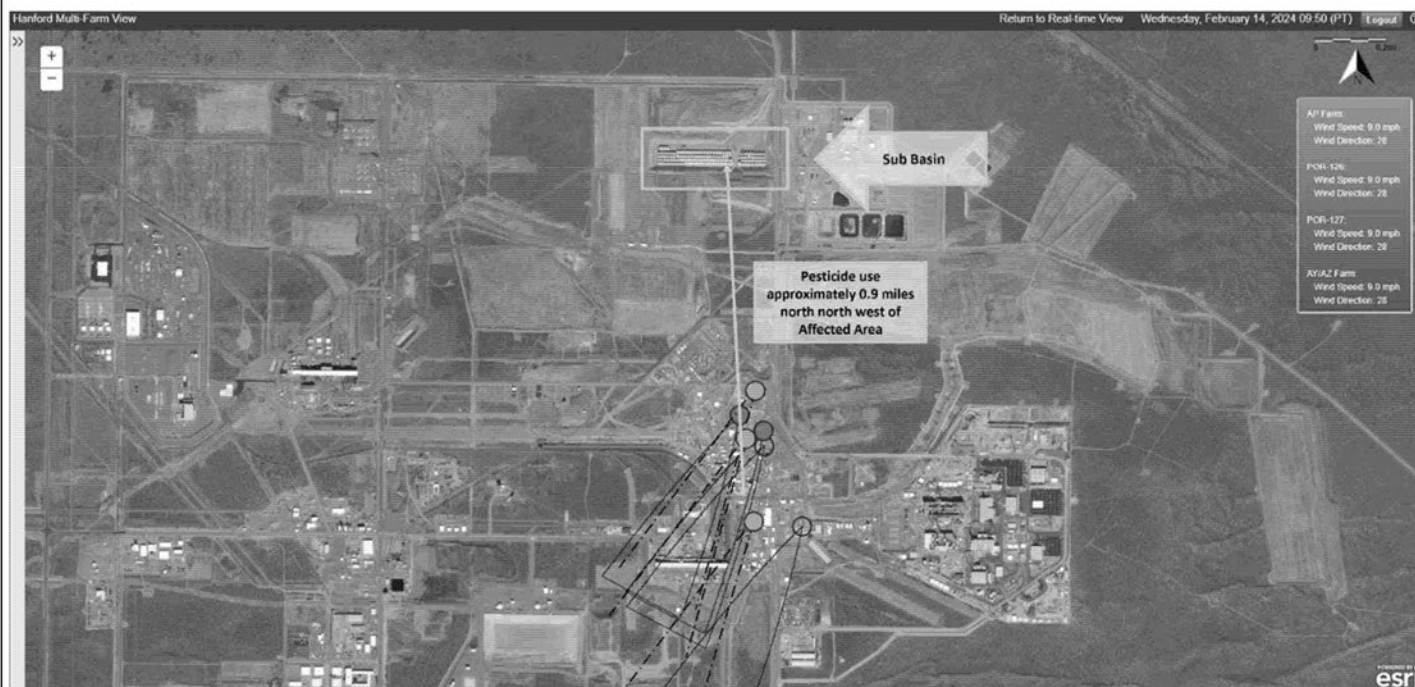
- (11) Though reported herbicide application was occurring around Trench 94; it was determined to be an unlikely potential source of the reported odors due to the significant distance between Trench 94 and the affected area (~1 mile).

At the time of the event DFAS shows winds blowing at 9 mph from north northeast to south southwest. Though it was noted that herbicide application had occurred at the Sub Basin, the basin was approximately 1 mile directly north of the Affected Area and due to significant distance is an unlikely source of the odor.

Figure 9: Location of herbicide use in relation to Affected Area

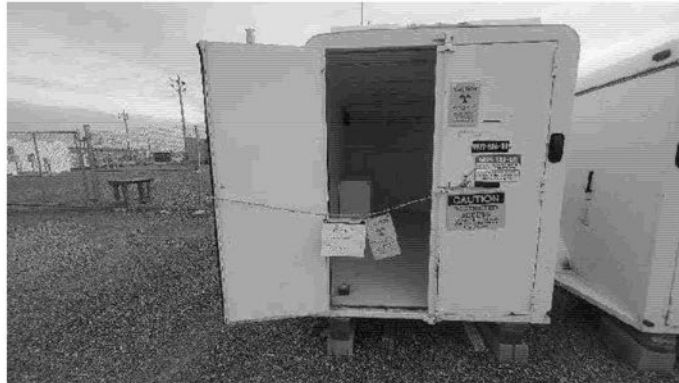
- (2) On 02/13/2024, bleach was used to clean and disinfect the inside of the WRPS-RMA-188 laundry trailer to remedy Mold growth and preparation for painting activities. Following bleach application, a door was left open to ventilate the WRPS-RMA-188 laundry trailer which remained open at the time odors were reported. The WRPS-RMA-188 laundry trailer was located ~250 feet upwind of the affected area at the time of the reported odors. Due to the proximity to the affected area and wind direction at the time of the reported odors, the WRPS-RMA-188 laundry trailer was determined to be a potential odor source. In addition, IHTs noted the WRPS-RMA-188 laundry trailer still contained an observable "fresh and bleach-like" odor during TFC-OPS-OPER-C-67 response.

Bleach had been used to disinfect a laundry trailer, WRPS-RMA-188, 02/13/2024 approximately 225 feet directly north northeast of the Affected Area. It had been left open to ventilate. Due to the proximity and wind direction it was a potential odor source. The response team noted it had a "fresh bleach" odor.

Figure 10. Laundry Trailer WRPS-RMA-188. Sign indicates bleach disinfection in progress

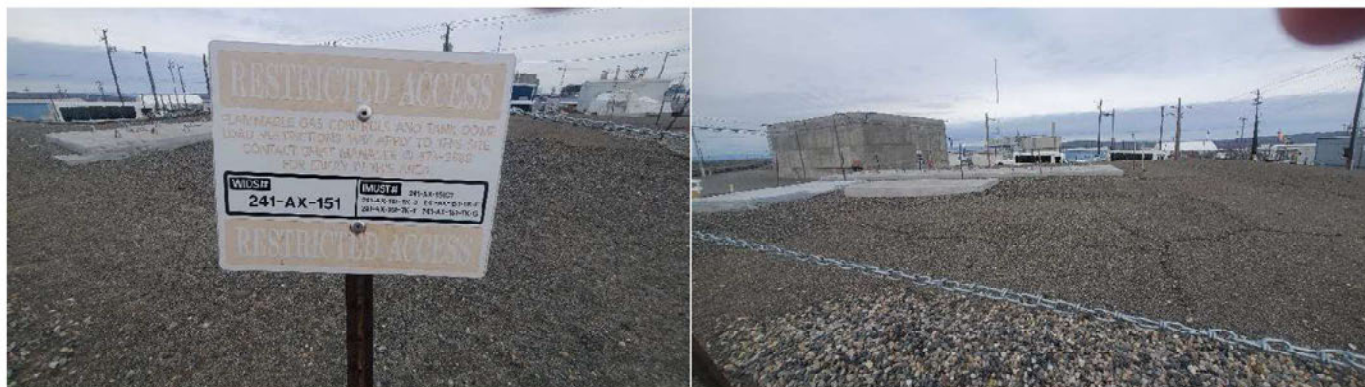
Figures 11 and 12. 241-AX-151

- (10) The 241-AX-151 diverter station catch tank was considered as a potential odor source due to the proximity of the affected area at the time of the reported odors (~160 feet North/Northwest), in addition to potential odors that could result when the passively ventilated 241-AX-151 catch tank undergoes barometric breathing. Due to the wind direction at the time of the reported odors (out of North/Northeast) and a steady barometric pressure (therefore, barometric breathing of passively ventilated tanks unlikely to occur); the 241-AX-151 catch tank was determined to be an unlikely source of the reported odors.

When outside air pressure changes, there is a small pressure imbalance between the headspace of a passively ventilated tank and the outside air. This imbalance pushes air into the tank or draws it out (barometric breathing). 241-AX-151 may have unsealed emission points that could result in odors through barometric breathing. At the approximate time of the event, the barometric pressure was steady. Due to wind direction and steady barometric pressure it is an unlikely odor source. Furthermore, the response team noted a "chemical, floral, pleasant" fleeting odor near 241-AX-151. The odor description is inconsistent with Tank Waste Chemical Vapors.

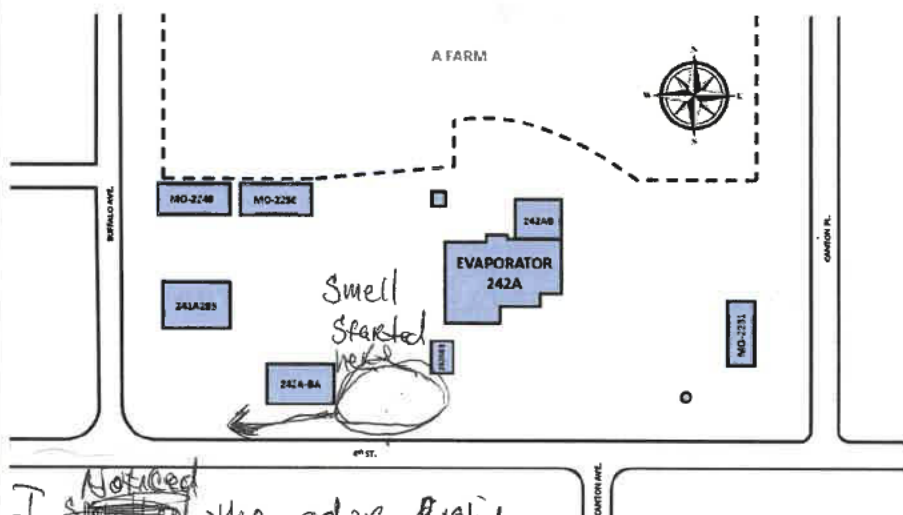
4th ST.  
I ~~stayed~~<sup>Noticed</sup> the odor right before the train tracks

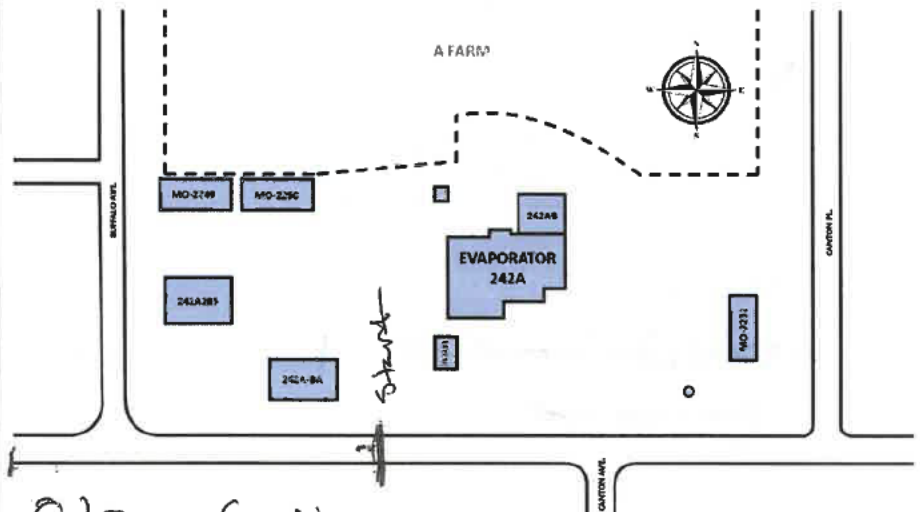
*Odor Continue up to the train tracks*

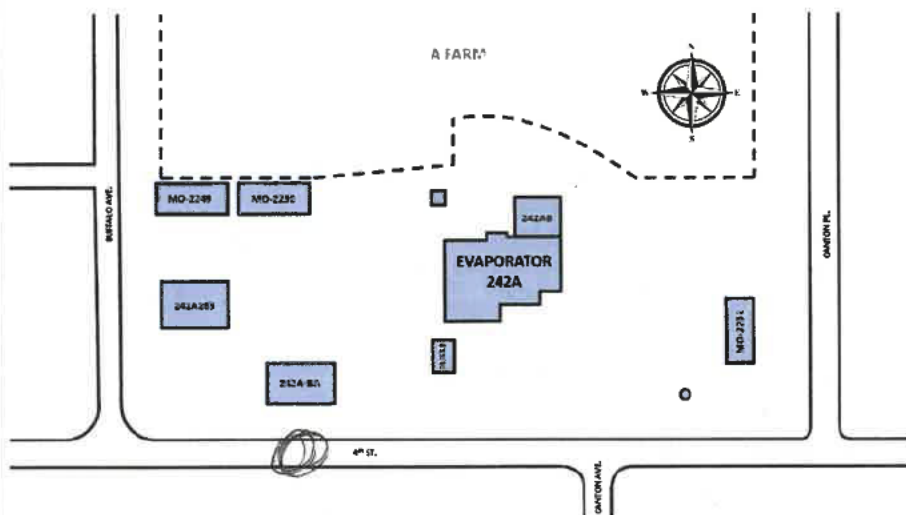
A: Odor starting ⊙ at the boiler annex and continuing up to the train tracks near Purac

B: Was driving on 4th street at the time, unsure of wind direction.
