Washington River Protection Solutions  
**EVENT SUMMARY**

3. **Investigation Title:** Maintenance Activities

4. **Investigation Report Number:** EIR-2025-019

7. **Area / Building / Location:** 200E/242A-81 (Water Service Building)

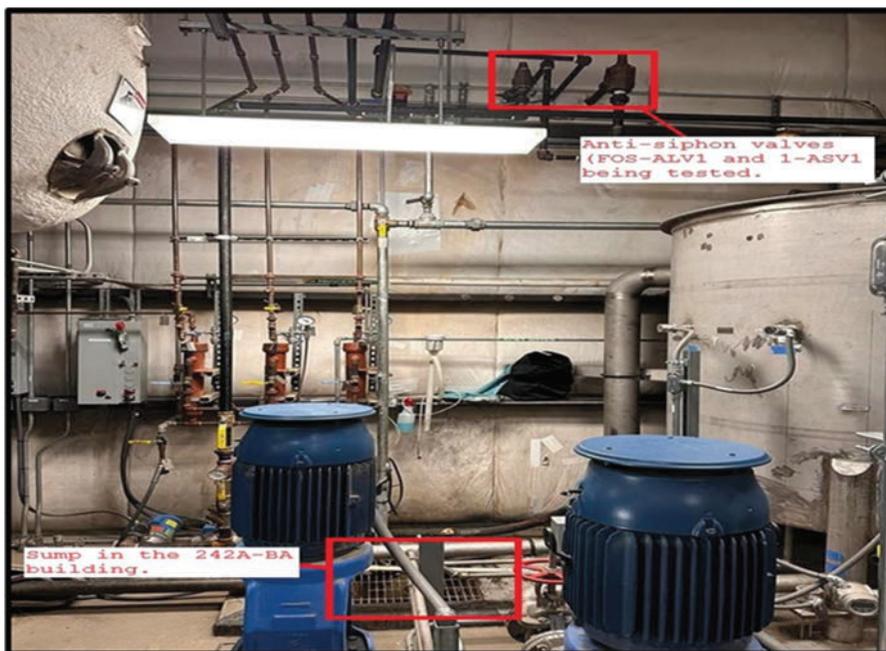
Figure 1 - Location Where Anti-Siphon Valves Were Being Tested In The 242A-BA Building

(1) On 12/04/2024, 2 pipefitters performed testing activities on the 242A-BA Boiler Fuel System per WO# 1181824, *242A-BA Test Boiler Fuel System*. Testing activities consisted of determining if the 2 Boiler Fuel System anti-siphon valves (FOS-ALV1 and 1-ASV1) were causing pressure issues for the 10 lbs and 90 lbs boilers during start-up. The 2 anti-siphon valves and associated diesel system piping were disconnected during testing activities, which are located slightly above the 242A-BA sump (Refer to Figure 1 below). Spill containment (consisting of two buckets containing absorbent pads) were placed underneath each anti-siphon valves during this work evolution. An absorbent pad was also placed underneath the piping that was directly above the 242A-BA sump.

While containment was utilized for this work evolution, it is anticipated small amounts of diesel likely entered the 242A-BA sump while performing this work evolution. The 242A-BA Process Boiler Operator/ Stationary Operating Engineer (PBO/SOE) Supervisor did indicate they noticed a small amount of diesel on the concrete directly below the two anti-siphon valves and applied absorbent material onto the diesel. The 242A-BA PBO/SOE Supervisor estimated that less than 1 gallon of diesel fuel had inadvertently entered the 242A-BA sump. During the work evolution, it was not recognized that diesel had likely spilled into the sump.

(4) Evaluate and implement methods to ensure diesel fuel cannot enter 242A-BA sump.

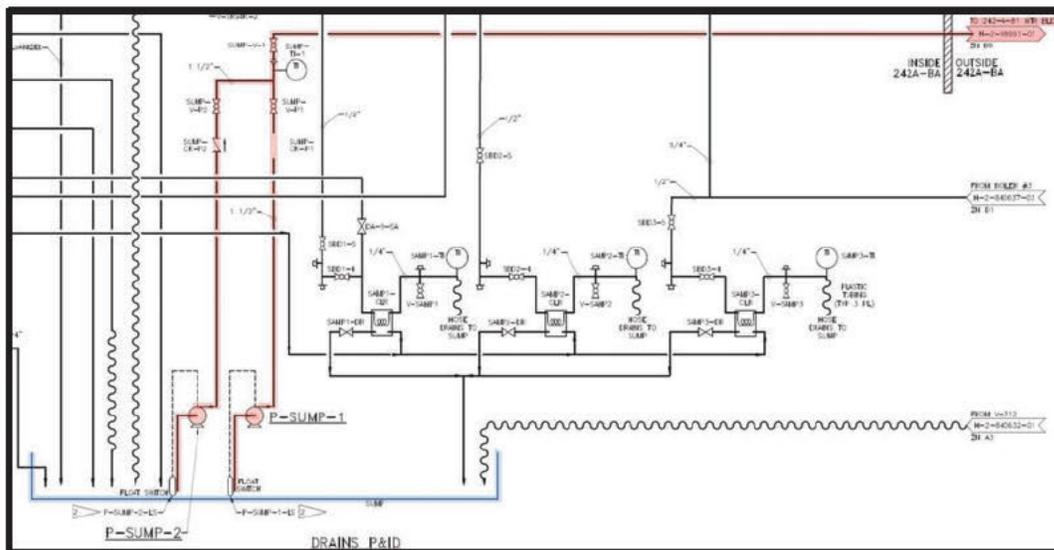
Figure 2 - Effluent Pathway from the 242A-BA Sump To The 242A-81 Water Service Building Sump

It was identified a violation of the State Waste Discharge Permit# ST0004502 for 200 Area Treated Effluent Disposal Facility (TEDF) occurred when diesel fuel was sent to TEDF via the 242A-BA sump effluent pathways, which is not approved per the permit. When the 242A-BA sump reaches the max sump liquid level, the effluent transfers to the 242A-81 Water Service Building sump and then to TEDF for final disposal.

On 12/05/2024, the 242A-BA boilers were started. When the boilers are in operation the process creates additional effluents from the steam system that drain into the 242A-BA sump. The 242A-BA sump reaches the max sump liquid level, 2 float switches associated with pumps P-SUMP-1 and P-SUMP-2 automatically initiate pumping the 242A-BA sump effluents to the 242A-81 Water Service Building sump via 1 ½ inch pipe (Refer to Figure 2).

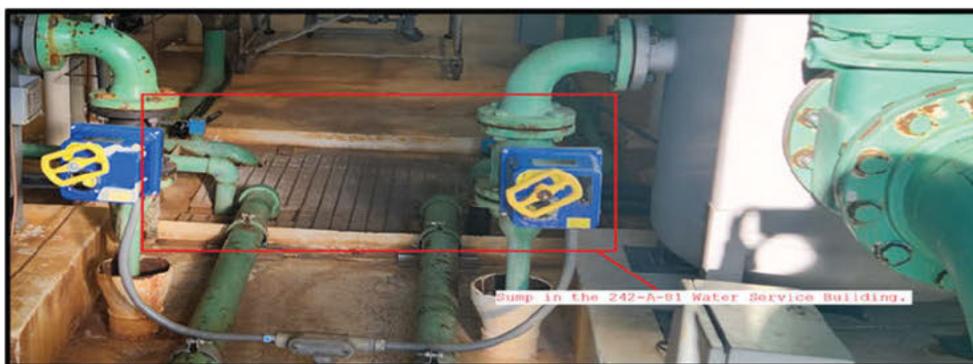
Figure 3 - Sump in the 242A-81 Water Services Building

On 12/06/2024, when the affected workers entered or were near the 242A-81 Water Service Building, the odors associated with the diesel fuel intermixed within the effluent in the 242A-81 Water Service Building was likely being released through the grating openings of the 242A-81 sump (Refer to Figure 3).

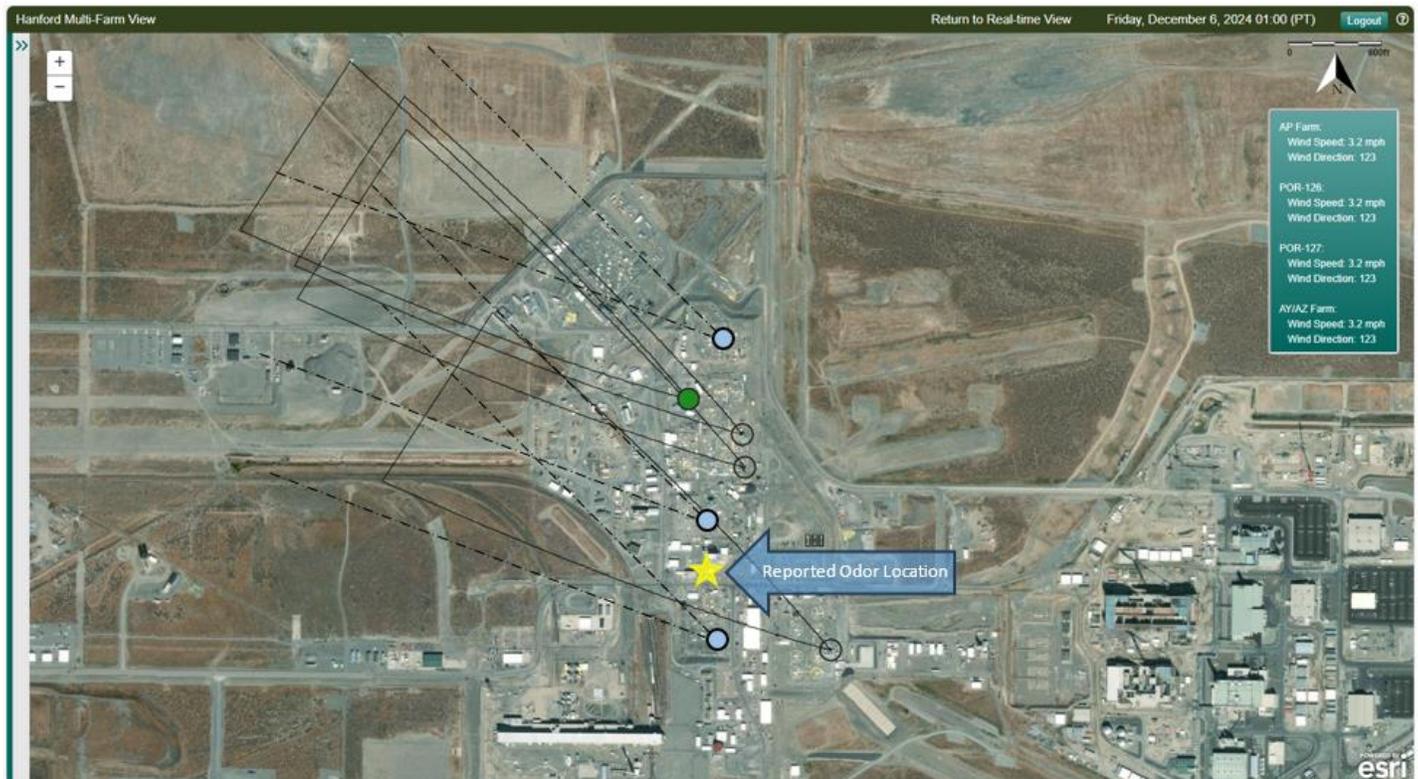
Figure 1. 200-East Area (with 241-AW, 241-AP, 241-AN, 241-AY/AZ, 241-AX, 241-A Farm projected plume models) at 0100 12/06/2024 from Data Fusion and Advisory System (DFAS) application, powered by SmartSite™ (Approximate Time of Initiating Event).

(3) The atmospheric stability at the time of the event was neutral to slightly stable conditions and the mixing height was 140 feet above grade. These atmospheric conditions typically do not result in ground level exposures from the exhausters. Additionally, Vapor Monitoring and Detection System (VMDS) exhauster ammonia readings for the approximate time of the event were below levels that could result in ground level exposures above action limits. Therefore, the cause of the odor is unlikely to be from Tank Farm Exhauster emissions.

- Wind Speed: 3.2 mph (15-minute average)
- Wind Direction: 123° (out of East Southeast)
- Mixing Height: 140 feet above grade
- Stability Class: D (neutral conditions)

NOTE: 241-AN, 241-A, 241-AW Farm Exhausters are not connected to the DFAS; however, an approximate exhauster plume was added for each based on other modeled plumes.

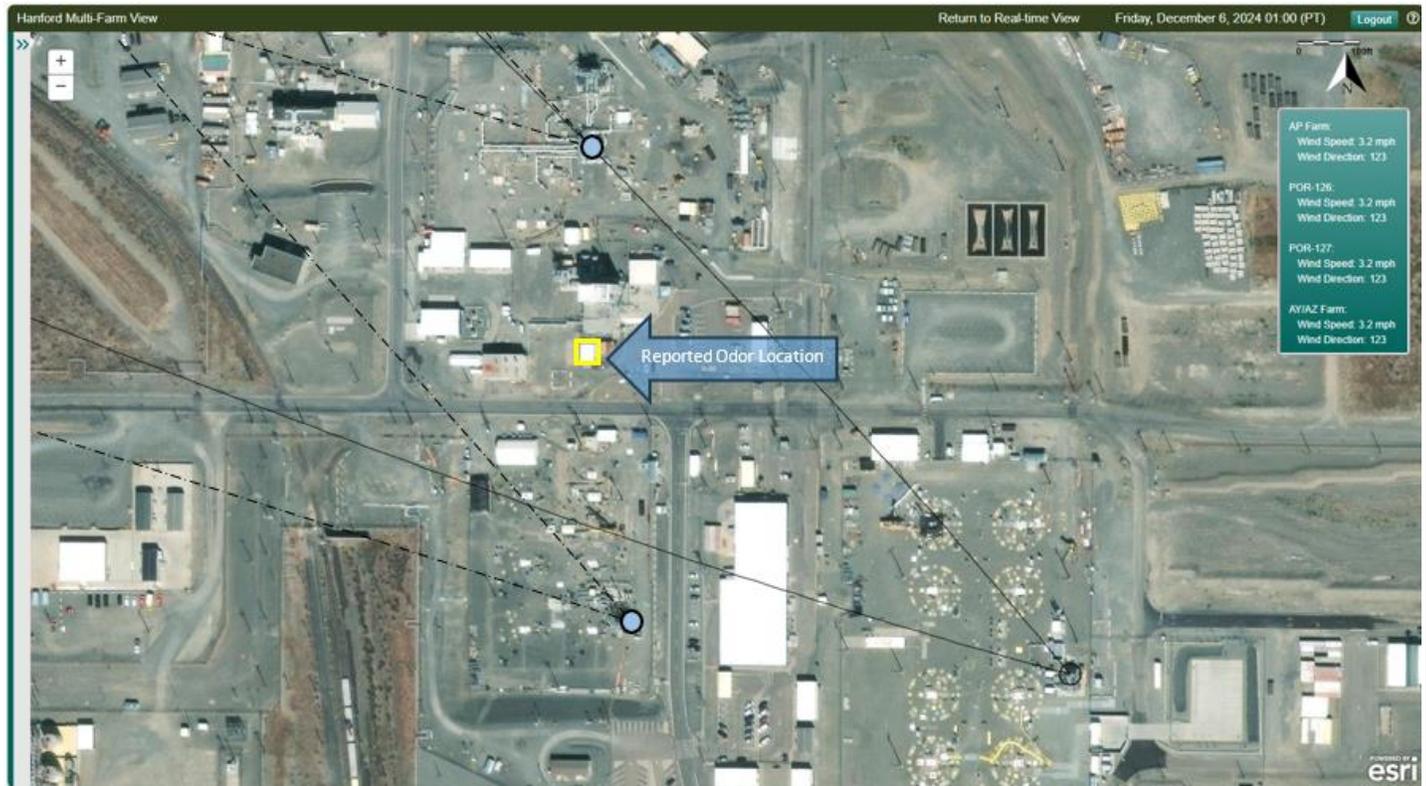
Figure 2. 200-East Area (with 241-AW, 241-AP, 241-A Farm projected plume models) at 0100 12/06/2024 from Data Fusion and Advisory System (DFAS) application, powered by SmartSite™ (Approximate Time of Initiating Event).

NOTE: 241-A and 241-AW Farm Exhausters are not connected to the DFAS; however, an approximate exhauster plume was added for each based on other modeled plumes.

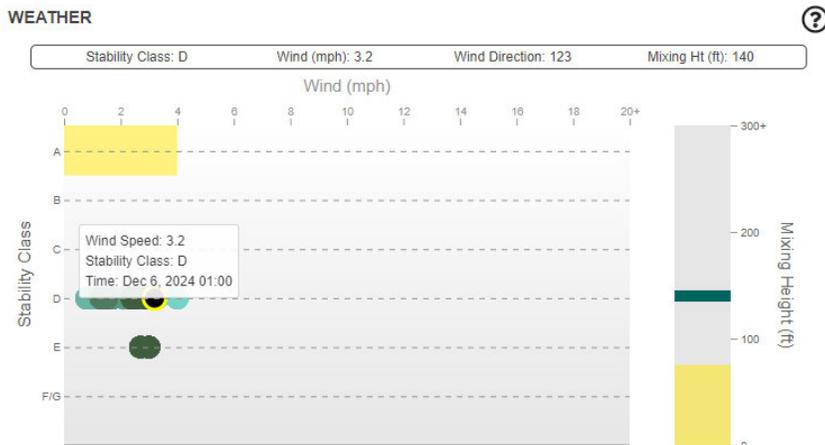
Figure 3. 241-AP Farm Weather Data from Data Fusion and Advisory System (DFAS) application, powered by SmartSite™ at 0100 12/06/2024 (Approximate Time of Initiating Event).

NOTE: 241-A, 241-AX, and 241-AY/AZ Farms Weather Data for Stability Class, Wind Speed, Wind Direction, and Mixing Height are the same.

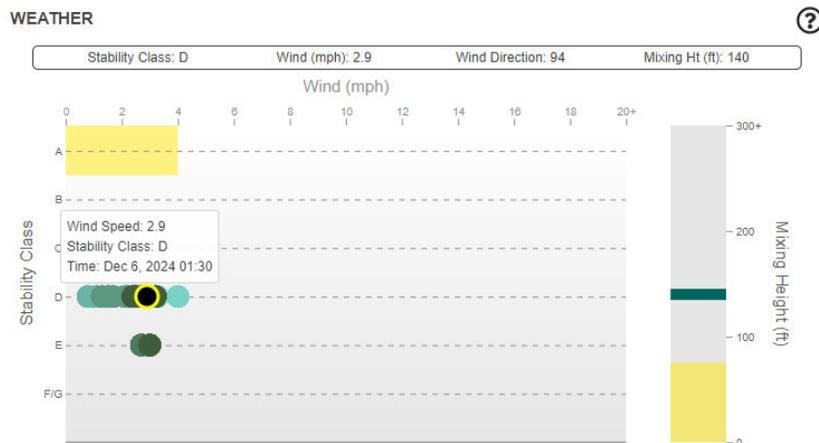
Figure 4. 241-AP Farm Weather Data from Data Fusion and Advisory System (DFAS) application, powered by SmartSite™ at 0130 12/06/2024 (Development of Response Actions).

- Wind Speed: 2.9 mph (15-minute average)
- Wind Direction: 94° (out of East)
- Mixing Height: 140 feet above grade
- Stability Class: D (neutral conditions)

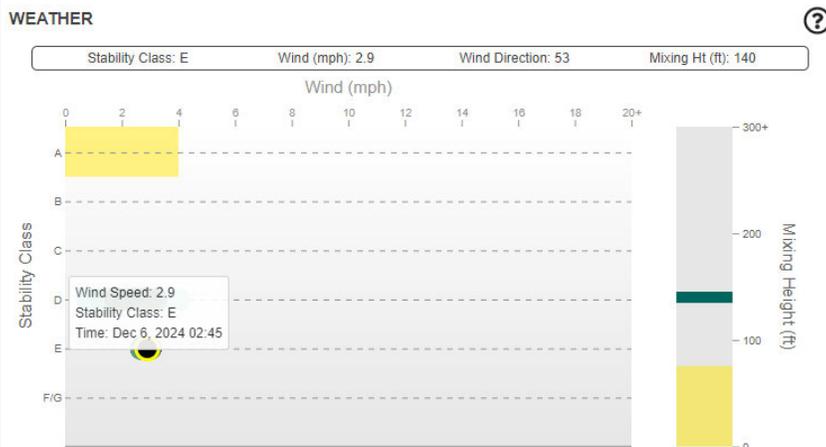
Figure 5. 241-AP Farm Weather Data from Data Fusion and Advisory System (DFAS) application, powered by SmartSite™ at 0245 12/06/2024 (Response Actions).

- 12/06/2024 @ 0245 (weather data for Response actions):
- Wind Speed: 2.9 mph (15-minute average)
  - Wind Direction: 53° (out of Northeast)
  - Mixing Height: 140 feet above grade
  - Stability Class: E (slightly stable conditions)

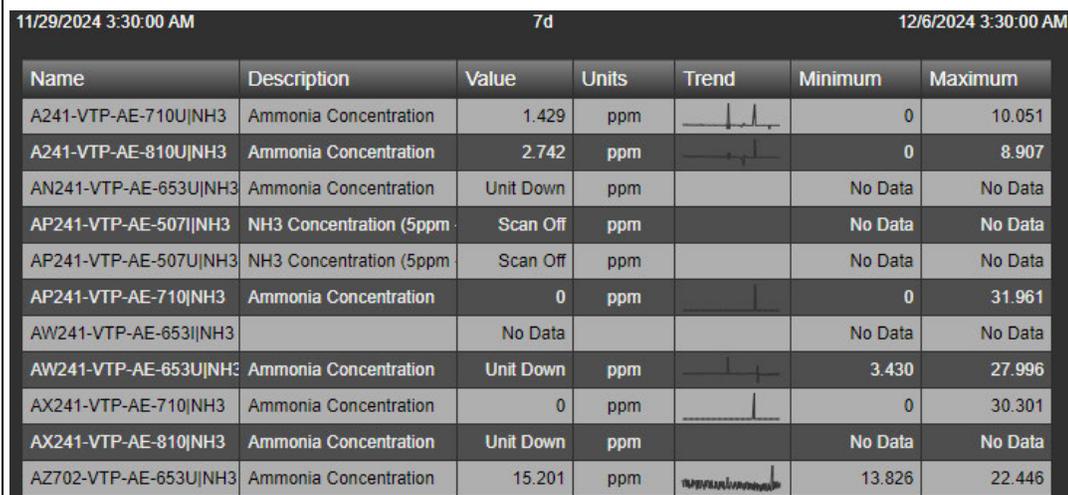
Figure 7. OSIsoft Pi Vision VMDS Ammonia Concentrations from 11/29/2024 at 0330 to 12/06/2024 at 0330.

Odor descriptors provided by Affected Workers are inconsistent with Tank Vapors. Additionally, review of the DFAS application, powered by SmartSite™, Weather Details dashboard and VMDS exhauster ammonia readings for the approximate time of the Event, indicate the cause of the odor is unlikely to be from Tank Farm Exhauster emissions. This is consistent with the known/likely source provided by the Affected Workers and PBO/SOE.
