Hanford Tank Waste Operations and Closure
EVENT SUMMARY

3. **Investigation Title:** C-67 and TF-AOP-015 Response at MO-2259

4. **Investigation Report Number:** EIR-2025-028

7. **Area / Building / Location:** 200E/MO-2259/AP Change Trailer

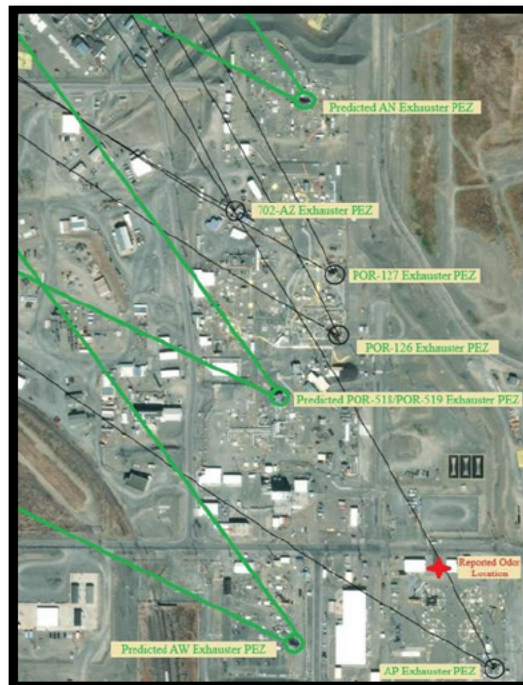
Figure 1: Exhauster Potential Exposure Zone Model regarding the Odor location

The DFAS dashboard provides an Exhauster Potential Exposure Zone (PEZ) Model of the exhaust plumes at the reported time of the vent based on the wind speed, wind direction, mixing height and stability class. The location where the odor was encountered appeared to be within the PEZ of AN Exhauster, 702-AZ Exhauster, POR-127 Exhauster, POR-126 Exhauster, POR-518/POR-519 Exhauster, AW Exhauster and AP Exhauster (Refer to Figure 1). The approximate distances MO-2259 is located from these are:

AN Exhauster:1500 feet
702-AZ Exhauster:1200 feet
POR-127 Exhauster:950 feet
POR-126 Exhauster:850 feet
POR-518/POR-519 Exhauster:650 feet
AW Exhauster:500 feet
AP Exhauster:350 feet

The approximate location and distance where the odor was encountered from the Tank Farm exhauster provides additional indication the odor source was unlikely to be resultant of Tank Farm emissions.

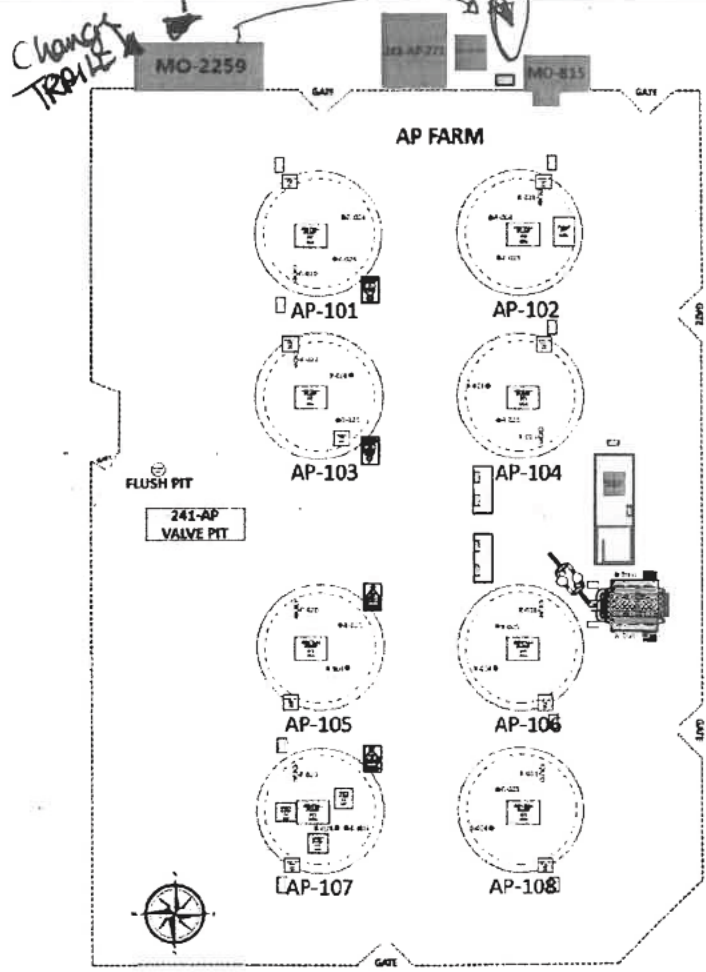
Alarms HAPPENED HERE

TRUCK WAS HERE/odor HAPPENED HERE
