Washington River Protection Solutions
EVENT SUMMARY

1. **Project:** Maintenance Craft Support 2. **Report Date:** 03/03/2025
3. **Investigation Title:** C-67 Response West of 241-AW1
4. **Investigation Report Number:** EIR-2025-029
5. **Responsible Manager:** [REDACTED]
6. **Event Investigator:** [REDACTED]
7. **Area / Building / Location:** 200E/Northwest of 241-AW Farm
8. **Date and Approximate Time of Event:** **Date:** 02/13/2025 **Time (military):** 0723 hours
9. **Associated Action Request (AR) Number:** ITDC-AR-2025-1043
10. **Associated Occurrence Report Number (if applicable):** N/A
11. **Event Investigation Meeting Held:** Yes [] or No [X] **Date:** N/A **Time (military):** N/A

Washington River Protection Solutions
INDUSTRIAL HYGIENE EVENT INVESTIGATION REPORT (IHIR)

Event Title: TFC-OPS-OPER-C-67 Response Northwest of 241-AW Farm		IHIR Number: IHIR-00115
		IHEI Number: N/A
Date: 02/13/2025	Time: 0723	Location: Gravel area Northwest of AW Farm

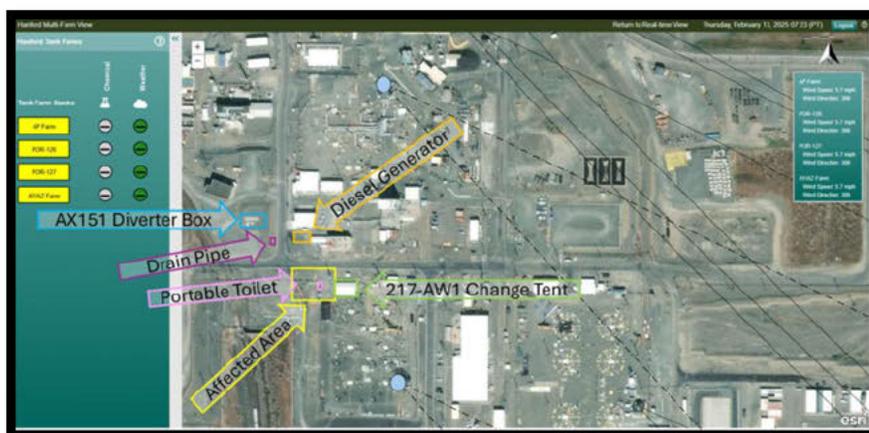
Figure 2. 200-East Area (with 241-AW, 241-AN, 241-AY/AZ, 241-AX, 241-A Farm projected plume models) at 0723 02/13/2025 from DFAS application, powered by SmartSite™.

NOTE: 241-A and 241-AW Farm Exhausters are not connected to the DFAS; however, an approximate exhauster plume was added for each based on other modelled plumes.

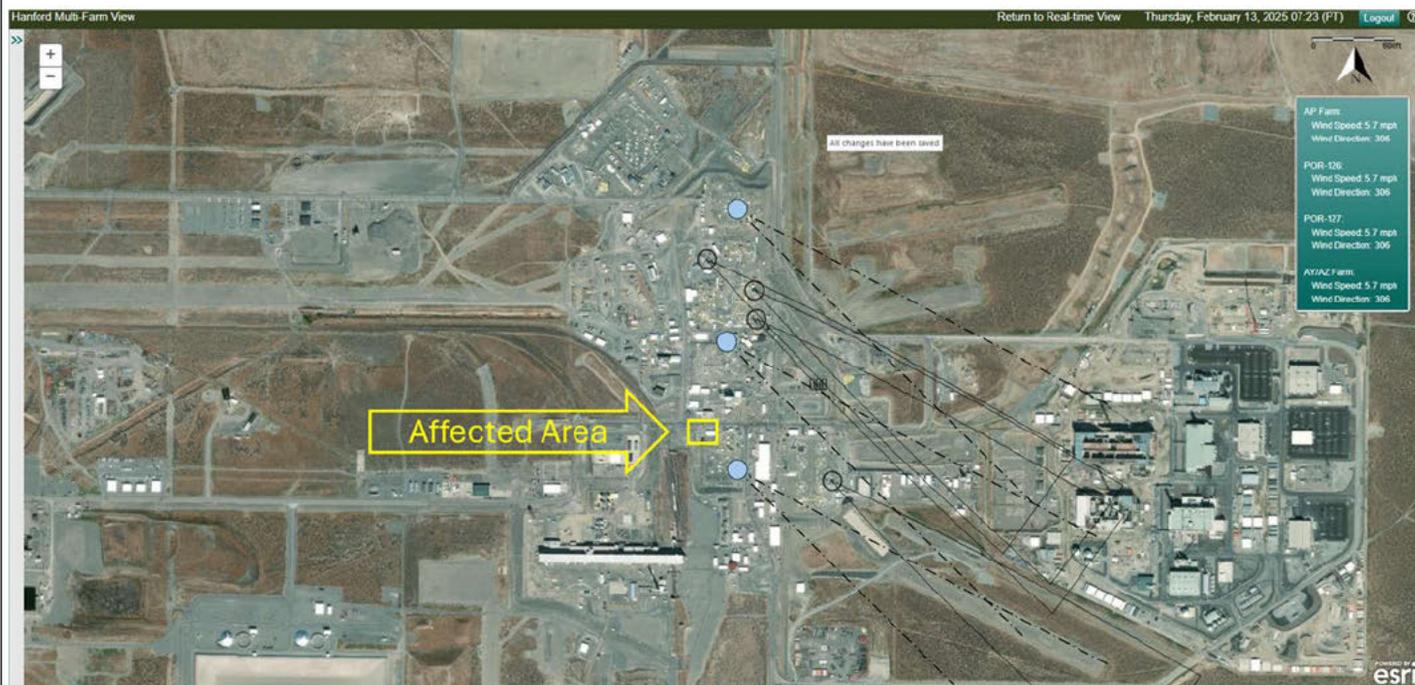
Figure 1. 200-East Area (with 241-AW, 241-AP, 241-AN, 241-AY/AZ, 241-AX, 241-A Farm projected plume models) at 0723 02/13/2025 from DFAS application, powered by SmartSite™.

NOTE: 241-AN, 241-A, 241-AW Farm Exhausters are not connected to the DFAS; however, an approximate exhauster plume was added for each based on other modeled plumes.

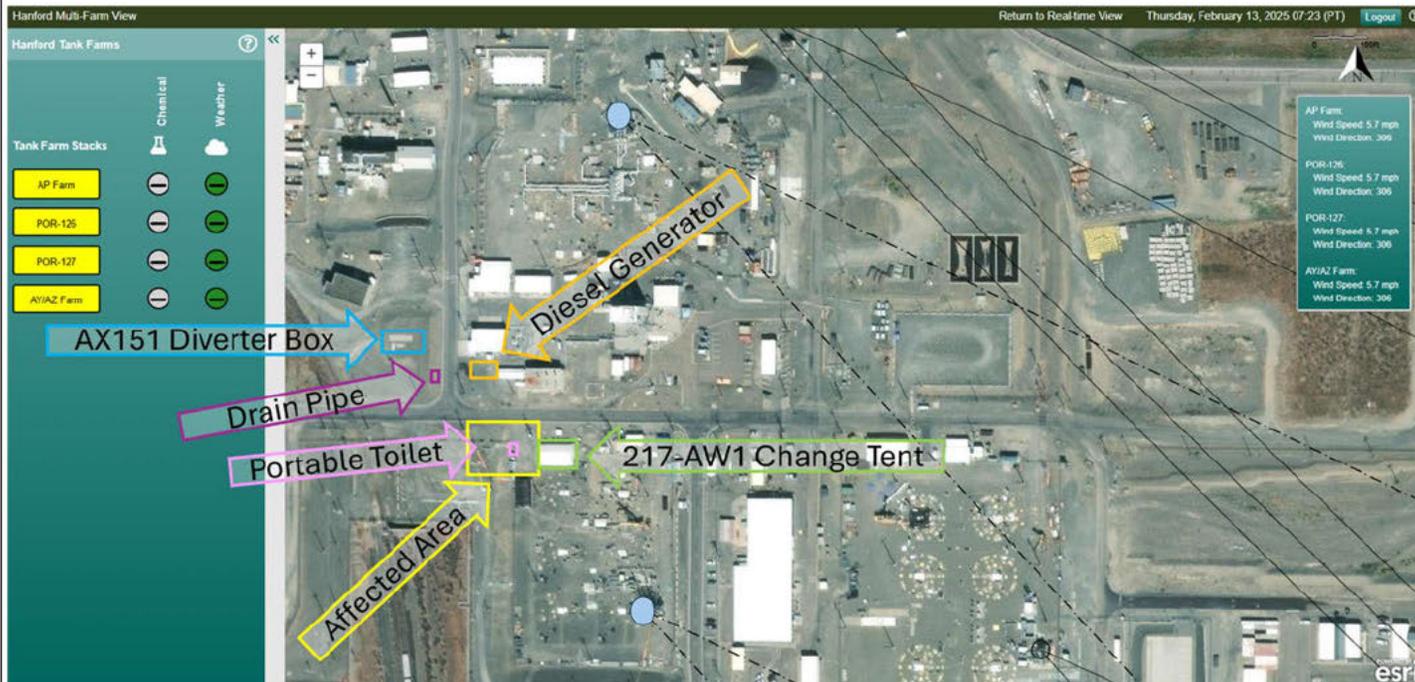
Figure 2. 200-East Area (with 241-AW, 241-AN, 241-AY/AZ, 241-AX, 241-A Farm projected plume models) at 0723 02/13/2025 from DFAS application, powered by SmartSite™.

NOTE: 241-A and 241-AW Farm Exhausters are not connected to the DFAS; however, an approximate exhauster plume was added for each based on other modeled plumes.

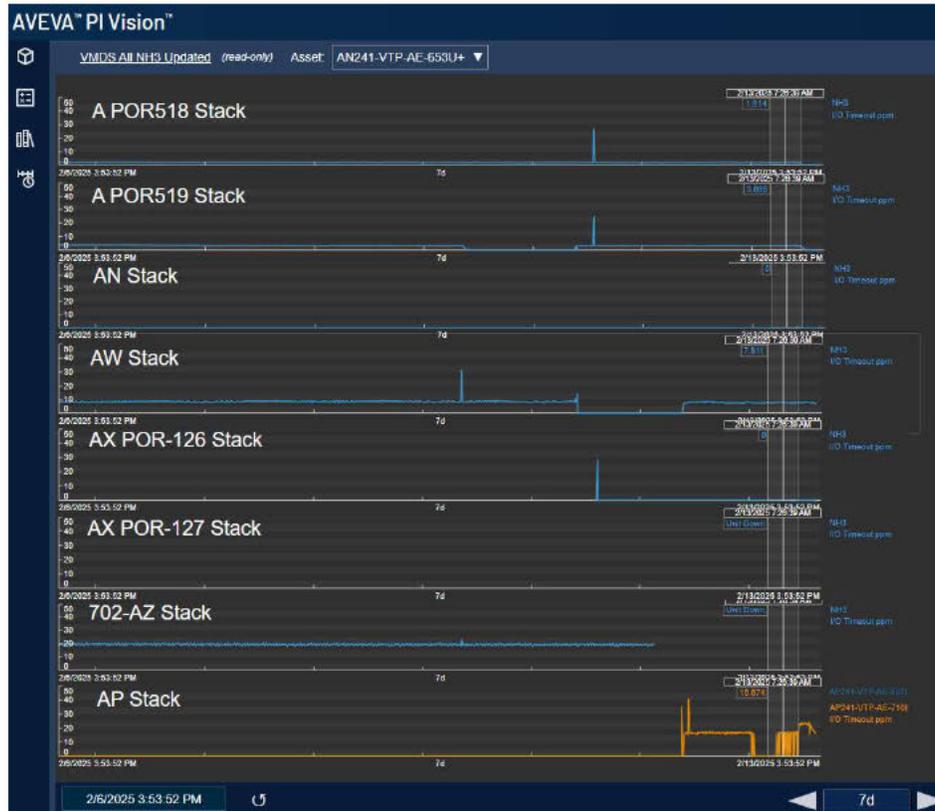
Figure 3. AVEVA PI Vision VMDS Ammonia Concentrations for 0726 02/13/2024.

Maximum reading includes maintenance activities. Peaks on 02/10/2025 and 02/11/2025, see Figure 3, are indicative of VMDS routine maintenance verification checks. Further investigation including discussion with the applicable Maintenance Field Work Supervisors would be required to verify the peaks were caused by maintenance activities.

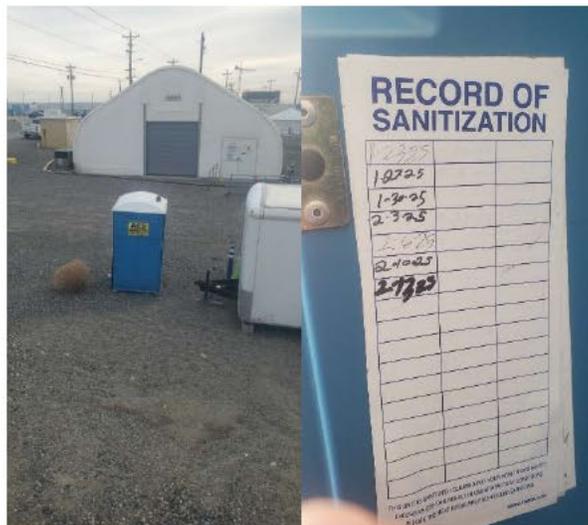
The Affected Area has a long history of similar odors or odors that have been found to be associated with sources other than Tank Farm vapor source emissions, such as septic tank gaseous emissions which are known to change odor profile across a gradient when diluted by ambient atmosphere with distance from a point source. The initiating event was a stronger than normal odor which the worker described as "sulfur/rotten eggs". These odors are indicative of nearby septic related equipment. The closest septic equipment was a portable toilet, "blue room", located within the Affected Area, immediately north of several "horse trailers". The cleaning record in the portable toilet indicated it had been serviced sometime during the morning of 02/13/2025.

The event response DRI results were less than detectable in the Affected Area for hydrogen sulfide, ammonia, and VOCs. It is possible that recent portable restroom maintenance including pumping and standard cleaning chemicals were used within the Affected Area around the time of the event. Due to the proximity and wind direction, the portable restroom was a potential odor source.

Figures 4 and 5. Portable restroom within Affected Area and associated sanitization record.

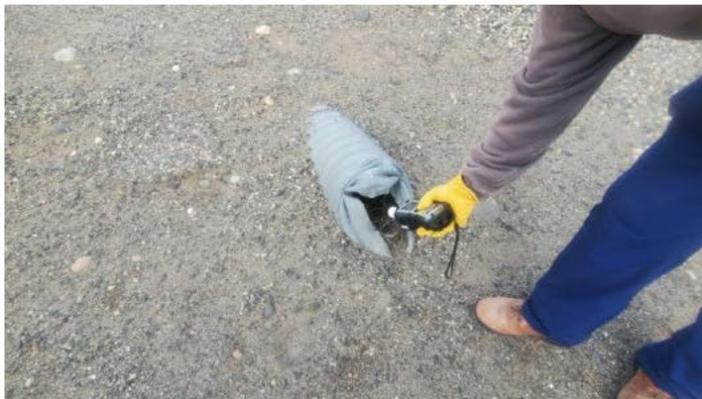
Another potential nearby source of hydrogen sulfide was a drainpipe approximately 200 ft northwest of the Affected Area. The drainpipe has the potential for standing water, and in the past a carcass was discovered and removed (circa 2016). The event response DRI results were less than detectable at the drainpipe for hydrogen sulfide, ammonia, and VOCs. The response team did not note any stronger than normal odors in the area of the drainpipe.

Figure 6. Drain Pipe.

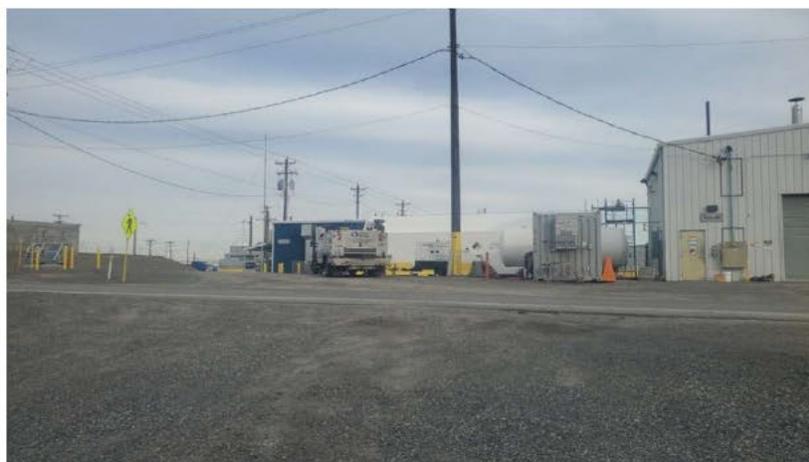
Several diesel heaters and generators were approximately 120 feet north of the Affected Area. Due to wind direction and location this was a potential odor source. However, diesel combustion type odors do not correspond with the reported odor and the response team did not observe unusual odors at the location, so it is unlikely that it is the source. The event response DRI results were less than detectable downwind of the generator for hydrogen sulfide and ammonia. VOC DRI result were 0.030 ppm, which is expected near a combustion source.

Figure 7. Diesel truck and generators.

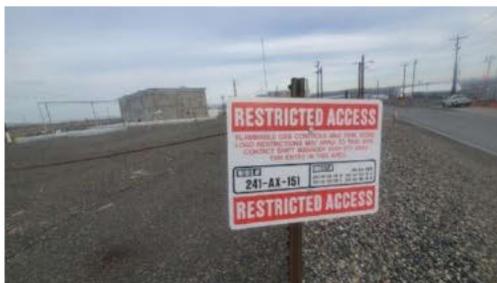
- When outside air pressure changes, there is a small pressure imbalance between the headspace of a passively ventilated tank and the outside air. This imbalance pushes air into the tank or draws it out (barometric breathing). 241-AX-151 may have unsealed emission points that could result in odors through barometric breathing.

- At the approximate time of the event, the barometric pressure was decreasing. As the outside air pressure was decreasing at the time of the event, passively ventilated tanks push air out of the tank ("breathing-out"). Due to wind direction and decreasing barometric pressure AX-151 is a possible odor source. However, the odor description from the Affected Worker of "sulfur/rotten eggs" description is inconsistent with Tank Waste Chemical Vapors. The response team did not note any stronger than normal odors in the area of AX-151. The event response DRI results were less than detectable at AX-151 for hydrogen sulfide, ammonia, and VOCs.

Figure 8. 241-AX-151, view from South
