Hanford Tank Waste Operations & Closure
EVENT SUMMARY

1. **Project:** Maintenance Facilities 2. **Report Date:** 07/09/2025
3. **Investigation Title:** C-67 Response at M02522
4. **Investigation Report Number:** EIR-2025-054
5. **Responsible Manager:** [REDACTED]
6. **Event Investigator:** [REDACTED]
7. **Area / Building / Location:** 200E/MO-2522
8. **Date and Approximate Time of Event:** **Date:** 06/24/2025 **Time (military):** 1317 hours
9. **Associated Action Request (AR) Number:** ITDC-AR-2025-2226
10. **Associated Occurrence Report Number (if applicable):** N/A
11. **Event Investigation Meeting Held:** Yes [] or No [x] **Date:** N/A **Time (military):** N/A

INDUSTRIAL HYGIENE EVENT INVESTIGATION REPORT (IHIR)

Event Title: TFC-OPS-OPER-C-67 Response at MO2522	IHIR Number: IHIR-00118
	IHEI Number: N/A

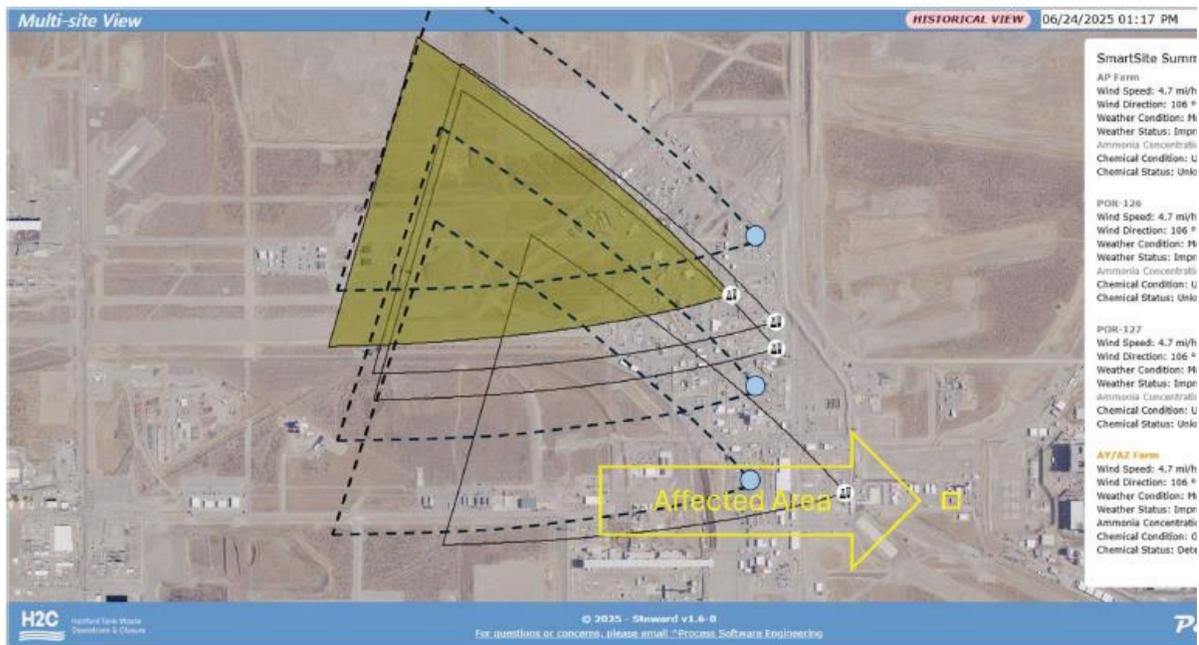
Figure 1- DFAS Exhauster Potential Exposure Zones and Reported Odor Location

- 1) The DFAS dashboard provides an Exhauster Potential Exposure Zone (PEZ) Model of exhaust plumes at the reported time of the event based on wind speed, wind direction, mixing height, and atmospheric stability class (Refer to Figure 1). Evaluation of the weather details determined the cause of the odor event was unlikely to be resultant of Tank Farms exhauster emissions based on the location of the reported odors and mixing height (1400 feet above grade).

Figure 1 illustrates 200 East Area (with 241-AW, 241-AP, 241-AN, 241-AY/AZ, 241-AX, 241-A Farm projected plume models) at 1317 06/24/2025 from DFAS application, powered by SmartSite™. NOTE: 241-AN, 241-A, 241-AW Farm Exhausters are not connected to the DFAS; however, an approximate exhauster plume was added for each based on other modeled plumes.

Investigative TFC-OPS-OPER-C-67 DRI area monitoring was performed in the general areas around the MO-2522 shower trailer. Investigative TFC-OPS-OPER-C-67 DRI area monitoring indicated peak concentrations were below action levels for ammonia (1 ppm) and VOCs (0.110 ppm), therefore, providing further indication the cause of the reported odors was unlikely to be resultant of Tank Farm exhauster emissions.

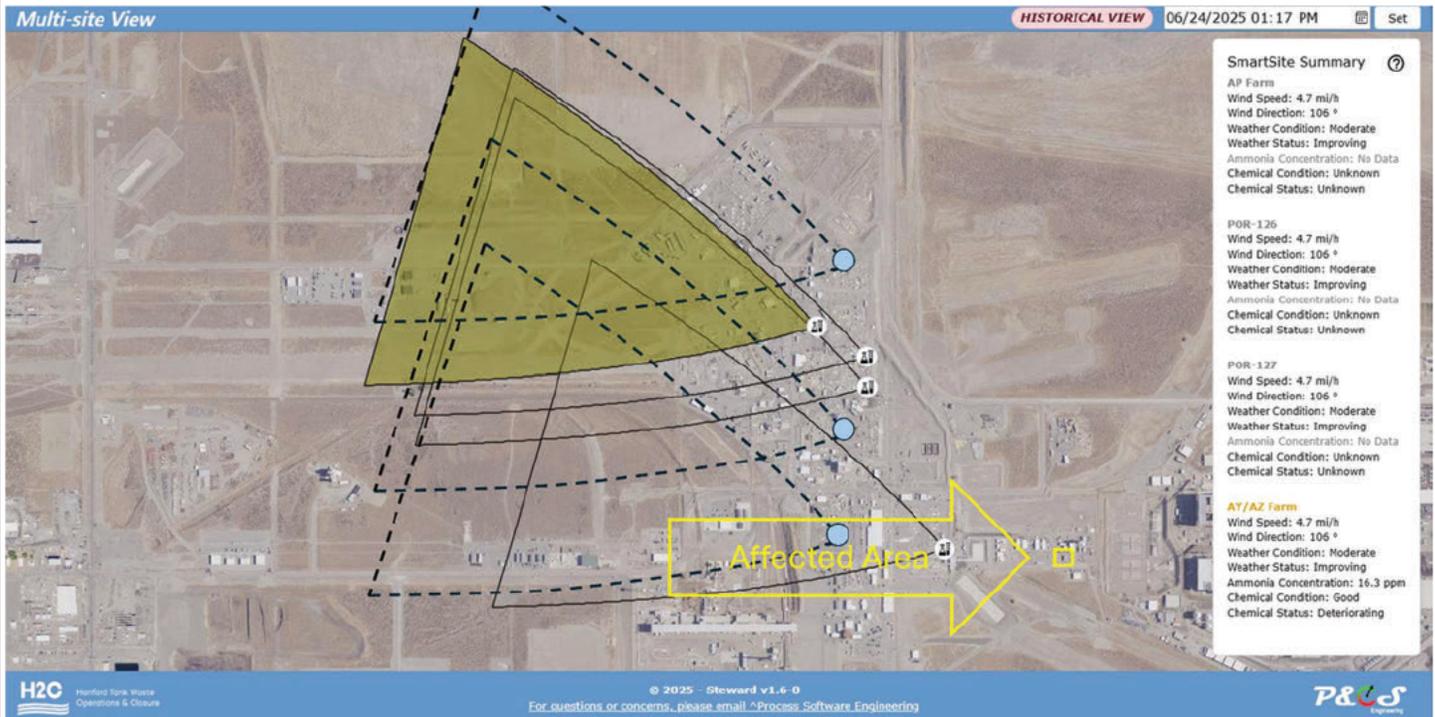
Figure 1. 200-East Area (with 241-AW, 241-AP, 241-AN, 241-AY/AZ, 241-AX, 241-A Farm projected plume models) at 1317 06/24/2025 from DFAS application, powered by SmartSite™.

NOTE: 241-AN, 241-A, 241-AW Farm Exhausters are not connected to the DFAS; however, an approximate exhauster plume was added for each based on other modeled plumes.

The event response DRI results were less than detectable in the Affected Area for hydrogen sulfide and were below action limits for hydrogen sulfide, ammonia, and VOCs. These results along with the review of the atmospheric conditions (DFAS application, powered by SmartSite™, and those provided by On-Duty Forecaster) outside of Affected Area around the reported time of the event indicate the cause of the odor is unlikely to be from Tank Farm emissions. The Atmospheric Stability Class at 1317 was extremely unstable. The Atmospheric Mixing Height was 1400 feet above grade.

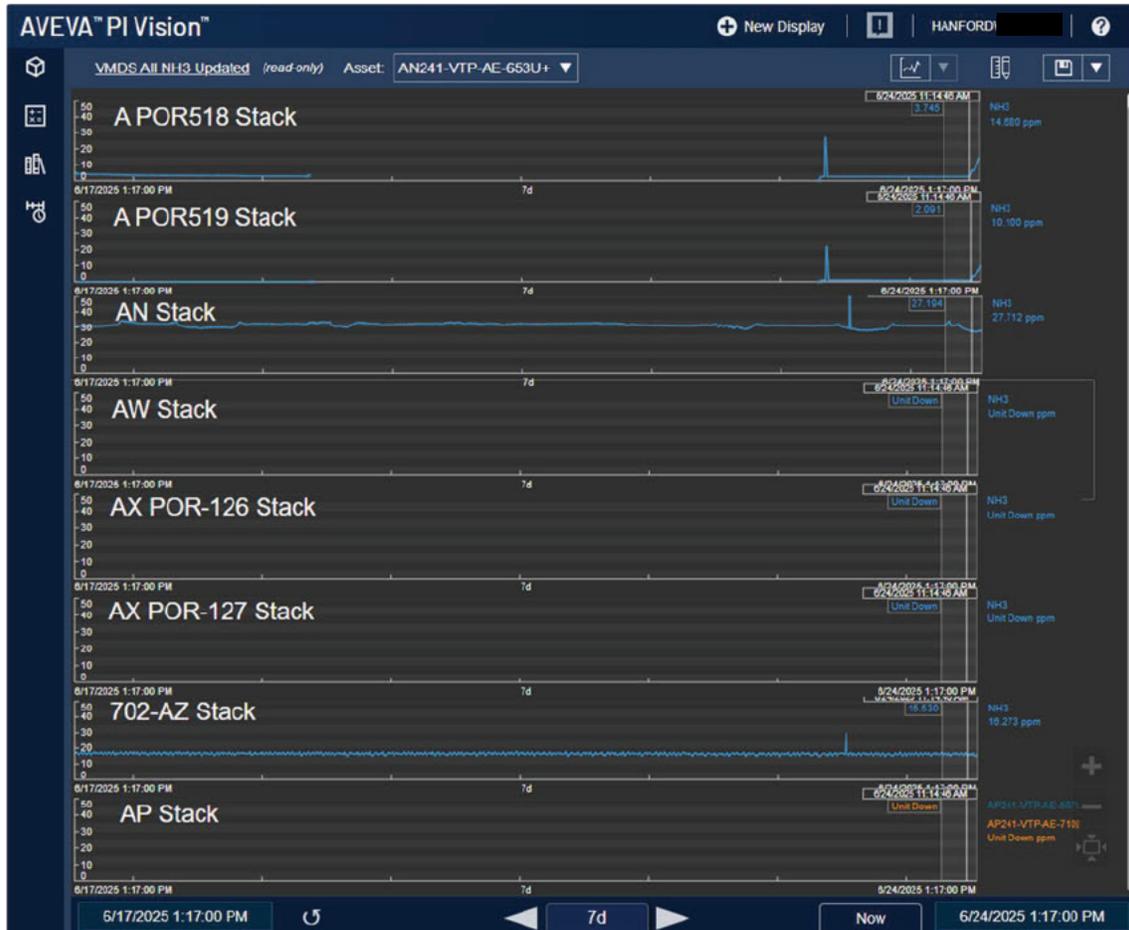
Figure 2. AVEVA PI Vision VMDS Ammonia Concentrations for 1317 06/24/2025.

- POR518 (241-A): 14.680 ppm
- POR519 (241-A): 10.100 ppm
- 241-AN: 27.712 ppm
- 241-AW: N/A
- POR126 (241-AX): N/A
- POR127 (241-AX): N/A
- 702AZ (241-AY/AZ): 16.273 ppm
- 241-AP: N/A

Maximum reading includes maintenance activities. Peaks on 06/23/2025, see Figure 2, are indicative of VMDS routine maintenance verification checks. Further investigation including discussion with the applicable Maintenance Field Work Supervisors would be required to verify the peaks were caused by maintenance activities.

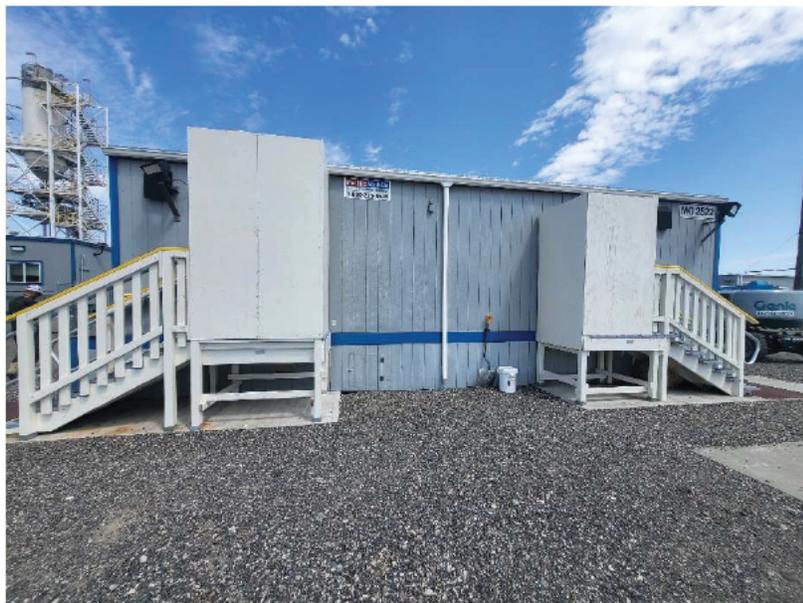
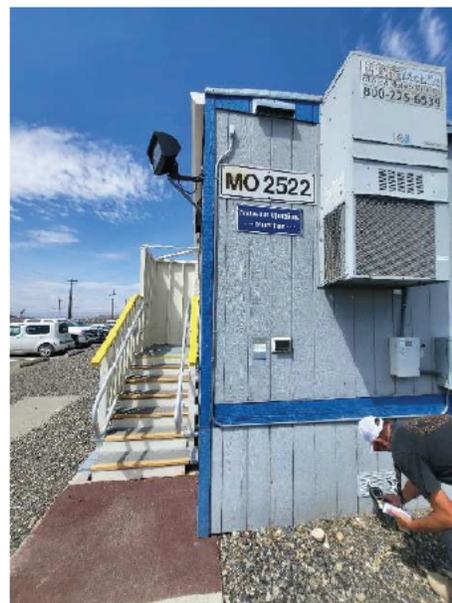
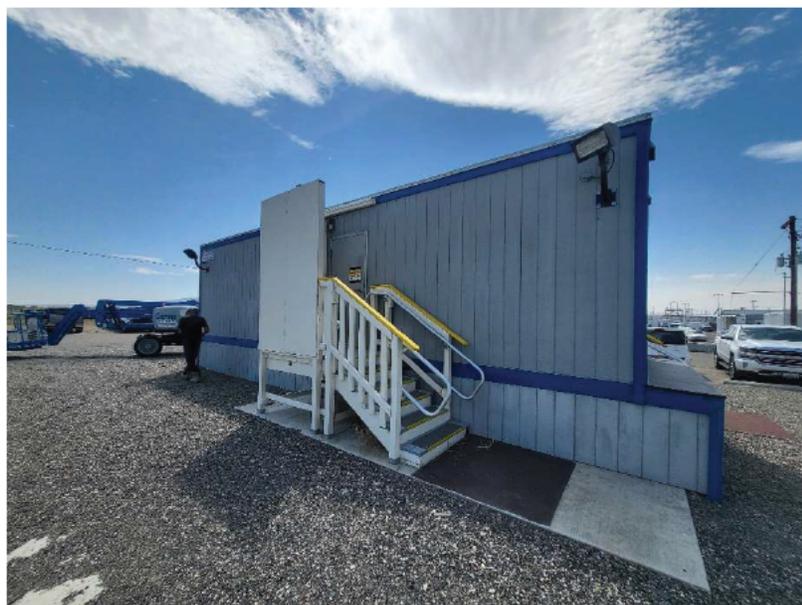
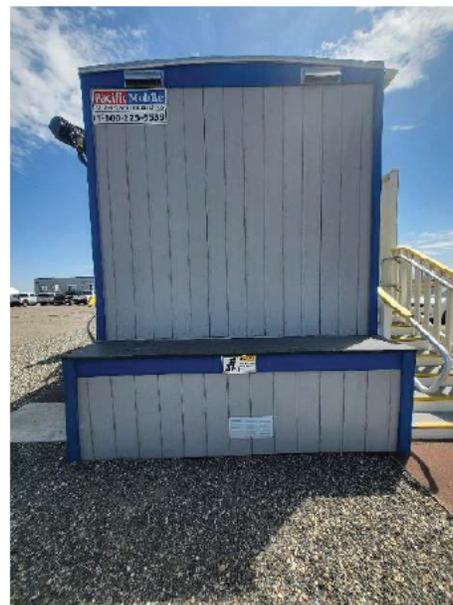
Figures 3 through 6 clockwise from top left. MO2522 West side.
MO2522 South side. MO2522 East side. MO2522 North side.

The MO2522 unit was constructed in 2008, installed in 2010, and is 360 gross square feet in size. The unit was previously installed at 200W and has recently [prior to 04/2013] been relocated at the grout facility at the east end of the 200E. The unit has electric, water, sewer, and the Heating, Ventilation, and Air Conditioning (HVAC) is provided by a Bard wall mounted heat pump on the south end. Building access is provided by two personnel doors on the west side with one door on the east side of the unit. The structure provides shower and locker space for site contractor personnel.

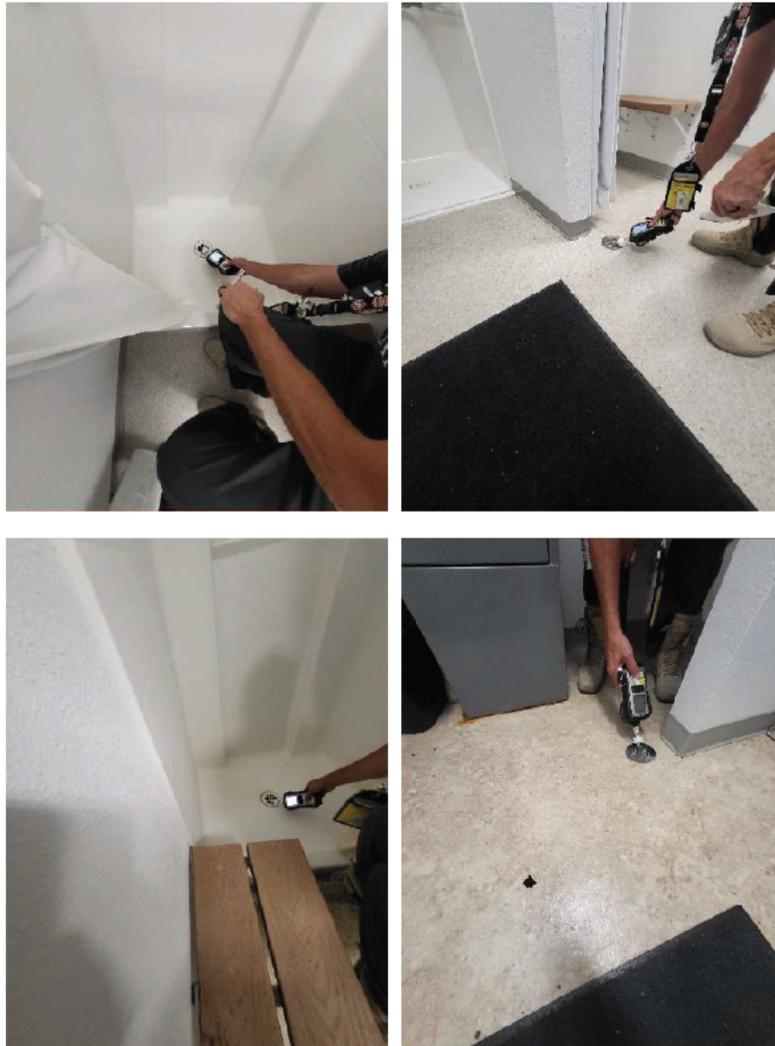
Figures 8 through 11. Various drains monitored during response

The event response DRI results were detectable in the Affected Area for ammonia and VOCs but less than action limits and associated with shower drains. These results along with the review of the atmospheric conditions (DFAS application, powered by SmartSite™, and those provided by On-Duty Forecaster) around the reported time of the event indicate the cause of the odor is unlikely to be from Tank Farm emissions.

Direct Reading Instrumentation monitoring performed during response actions did not indicate further action was necessary to protect worker safety and health. Due to remaining odor, access remained restricted until the p-traps were filled and odor had dissipated. The review of the atmospheric conditions around the reported time of the event indicates the cause of the odor is unlikely to be from Tank Farm emissions. The atmospheric mixing height was 1400 feet above grade and the VMDS/VMDS Alternate Monitoring Ammonia concentrations were well below the high alarm set points. Therefore, the cause of the odor is unlikely to be from actively ventilated tanks. The barometric pressure trend was decreasing at the time of the event, so passively ventilated tanks would be pushing air out of the tank. There were no passively ventilated tank farm tanks upwind of the Affected Area, so the cause of the odor is unlikely to be from a passively ventilated tank waste. Odors were consistent with a dried p-trap. Therefore, it is possible that the cause of the odor is from passive ventilation of sewer gases through the p-trap.

Facilities personnel filled the MO-2522 p-traps with water. The Area Dayshift Manager (ADM) walked down the affected area after water was added to the p-traps and did not detect residual odors.
