Hanford Tank Waste Operations & Closure
EVENT SUMMARY

1. Project: OPERATIONS FIELD SUPPORT 2. Report Date: 7/8/25
3. Investigation Title: Personal Ammonia Monitoring Alarm Activated- AOP-015 SY Farm
4. Investigation Report Number: EIR-2025-055
5. Responsible Manager: [REDACTED]
6. Event Investigator: [REDACTED]
7. Area / Building / Location: 200W/241SY

Event Title: Personal Ammonia Monitoring Alarm Activated - AOP-015 SY Farm	IHIR Number: IHIR-00119
	IHEI Number: IHEI-00003

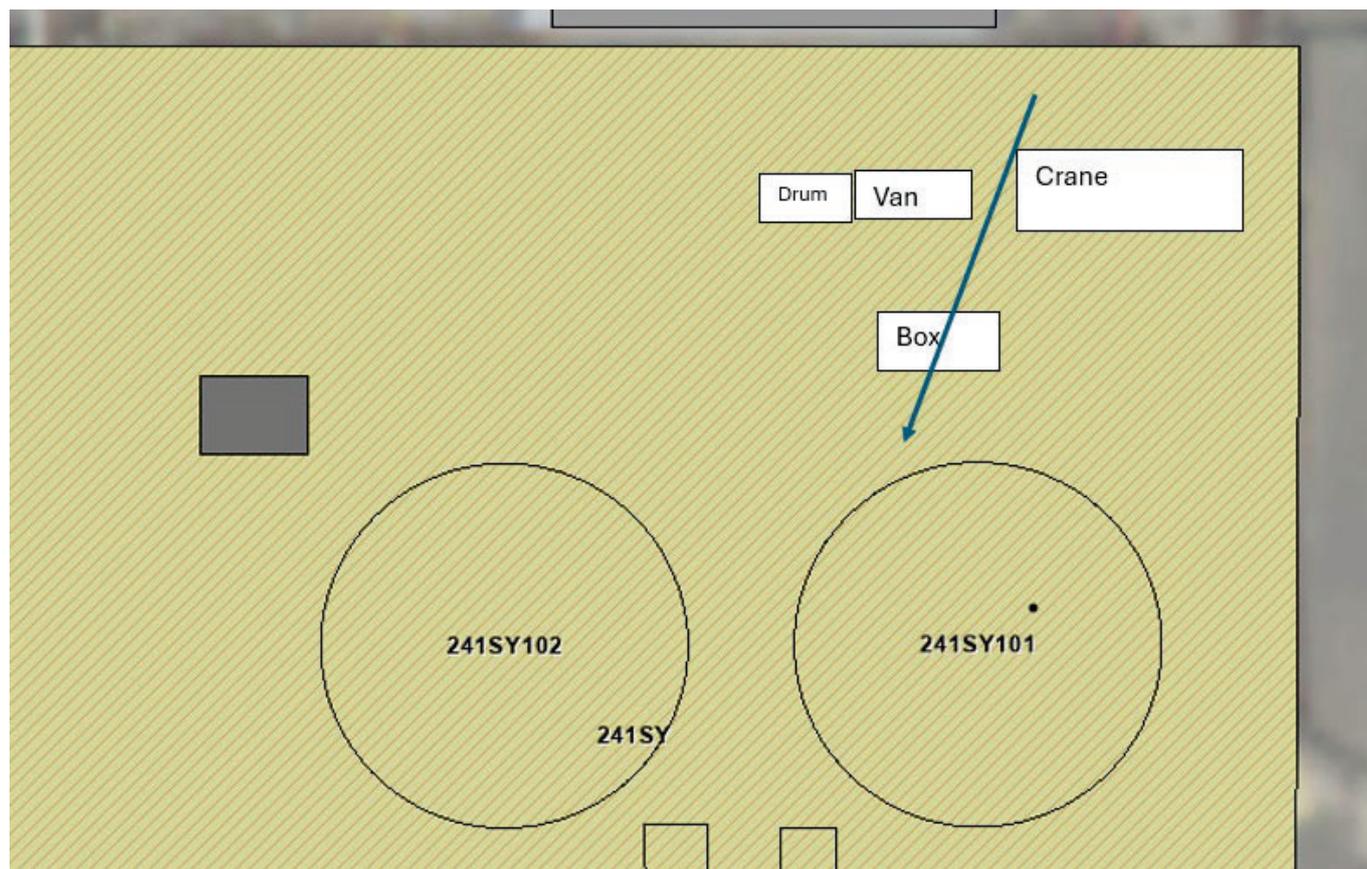
- The ammonia alarm event occurred inside a van parked between 241SY101 and M0655 inside 241-SY Farm as shown below:

The wind was coming from the NE (197 degrees). The SY exhauster would be downwind of the affect worker. There are no other tank farms in the immediate vicinity, mainly S and SX farm, which could have caused the PAM to alarm.

The waste box was located between the van and SY-101, which would have been downwind of the affected worker. The affected worker confirmed the waste box was located downwind.

The waste drum was located behind the van, which also would have been downwind of the affect worker. The affected worker confirmed the drum was behind the van and downwind.
