Hanford Tank Waste Operations & Closure (H2C)
EVENT REPORT FORM

1. Project: Effluent Treatment Facility (ETF) 2. Report Date: 03/10/2026
3. Title: C-67 Response at 2025E
4. Investigation Report Number (if applicable): EIR-2026-025 5. Revision: 1
6. Responsible Manager: [REDACTED]
7. Event Investigator: [REDACTED]
8. Area/Building/Location: 2025E/106/200E
9. Date and Approximate Time of Event: Date: 02/24/2026 Time: (military) 1030 hours
10. Associated Action Request (AR) Number: ITDC-AR-2026-1103
11. Occurrence Report Number (if applicable): N/A
12. Event Learning Meeting Held: Yes [] or No [X] Date: N/A Time: (military) N/A

INDUSTRIAL HYGIENE EVENT INVESTIGATION REPORT (IHIR)

TFC-OPS-OPER-C-67 Response at 2025E

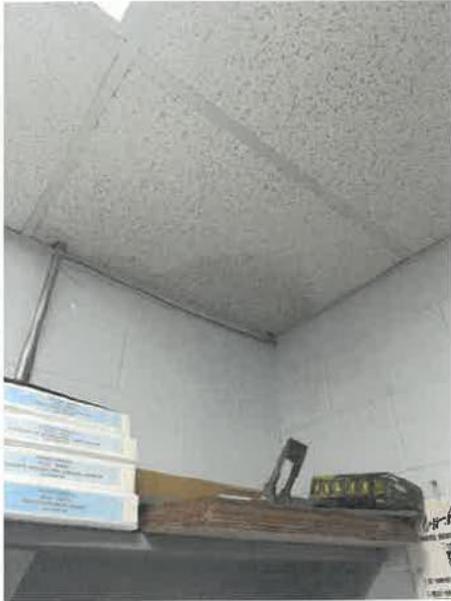
D106 Ceiling Tile

The C-67 Response Team identified that a ceiling tile was actively leaking in D106. All readings performed by the response team inside D106 were below action limits.

Although the exact identity of the odor is uncertain, IH believes it is likely related to water intrusion above the facility ceiling tiles. Rainfall had occurred intermittently the prior two days, and ETF personnel reported to IH that water was dripping directly from ceiling tiles in rooms D106 and D113.

ETF IH and TI IH both reported odors in the hallway adjacent to D106 upon entry into the facility. However, all readings in the hallway were below ALs. After monitoring their way in, IHTs monitored the interior of D106, and all members of the response team reported smelling "musty" odors inside D106. All readings were below AL inside D106; although the response team identified that a ceiling tile was actively leaking (pictured below):

- ETF management scheduled carpenters to replace the ceiling tiles and drain in D113 on 2/25/2026.
- ETF IH will perform follow-up Indoor Air Quality (IAQ) sampling per Industrial Hygiene Sampling Plan IHSP-OFS-MULTI-007.

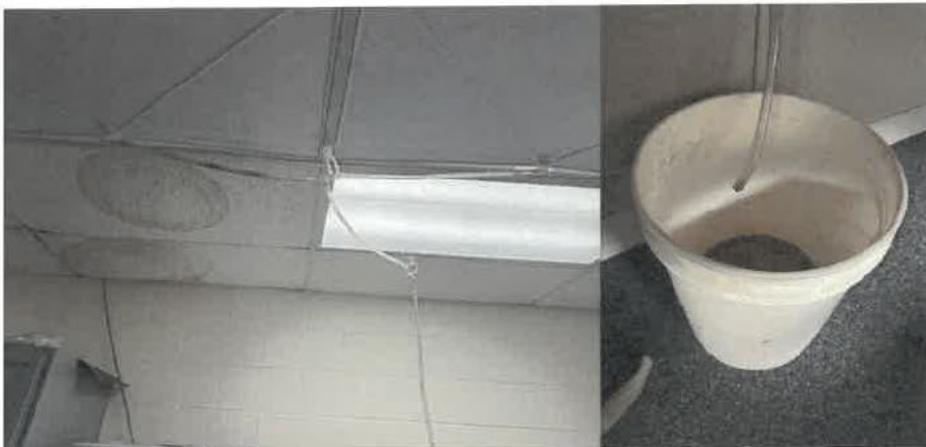
The leaking ceiling tiles had already been identified as an issue throughout the administrative area of ETF. Immediately prior to entering TFC-OPS-OPER-C-67, ETF IH had been walking down areas with bulging, leaking ceiling tiles with ETF management, including one room (D113) where discolored water was being drained into a bucket. ETF IH opted to monitor these areas, including D103 (not pictured) and D113 (pictured below) to identify whether COPCs were present above AL in either of these locations. All readings in D103 were below the limit of detection, and all readings in D113 were below AL. No odors were detected in either room.

D113 Ceiling Tile Leak and Catch Container
