Hanford Tank Waste Operations & Closure (H2C)
EVENT REPORT FORM

1. Project: Tank Farm Projects 2. Report Date: 06/11/2026
3. Title: AOP-015 Response in A-Farm
4. Investigation Report Number (if applicable): EIR-2026-044 5. Revision: 0
6. Responsible Manager: [REDACTED]
7. Event Investigator: [REDACTED]
8. Area/Building/Location: 200E/A-Farm/Near A-103
9. Date and Approximate Time of Event: Date: 05/28/2026 Time: (military) 1250
10. Associated Action Request (AR) Number: ITDC-AR-2026-1917
11. Occurrence Report Number (if applicable): N/A
12. Event Learning Meeting Held: Yes [] or No [X] Date: N/A Time: (military) N/A

INDUSTRIAL HYGIENE EVENT INVESTIGATION REPORT (IHIR)

INDUSTRIAL HYGIENE EQUIPMENT INVESTIGATION (IHEI)

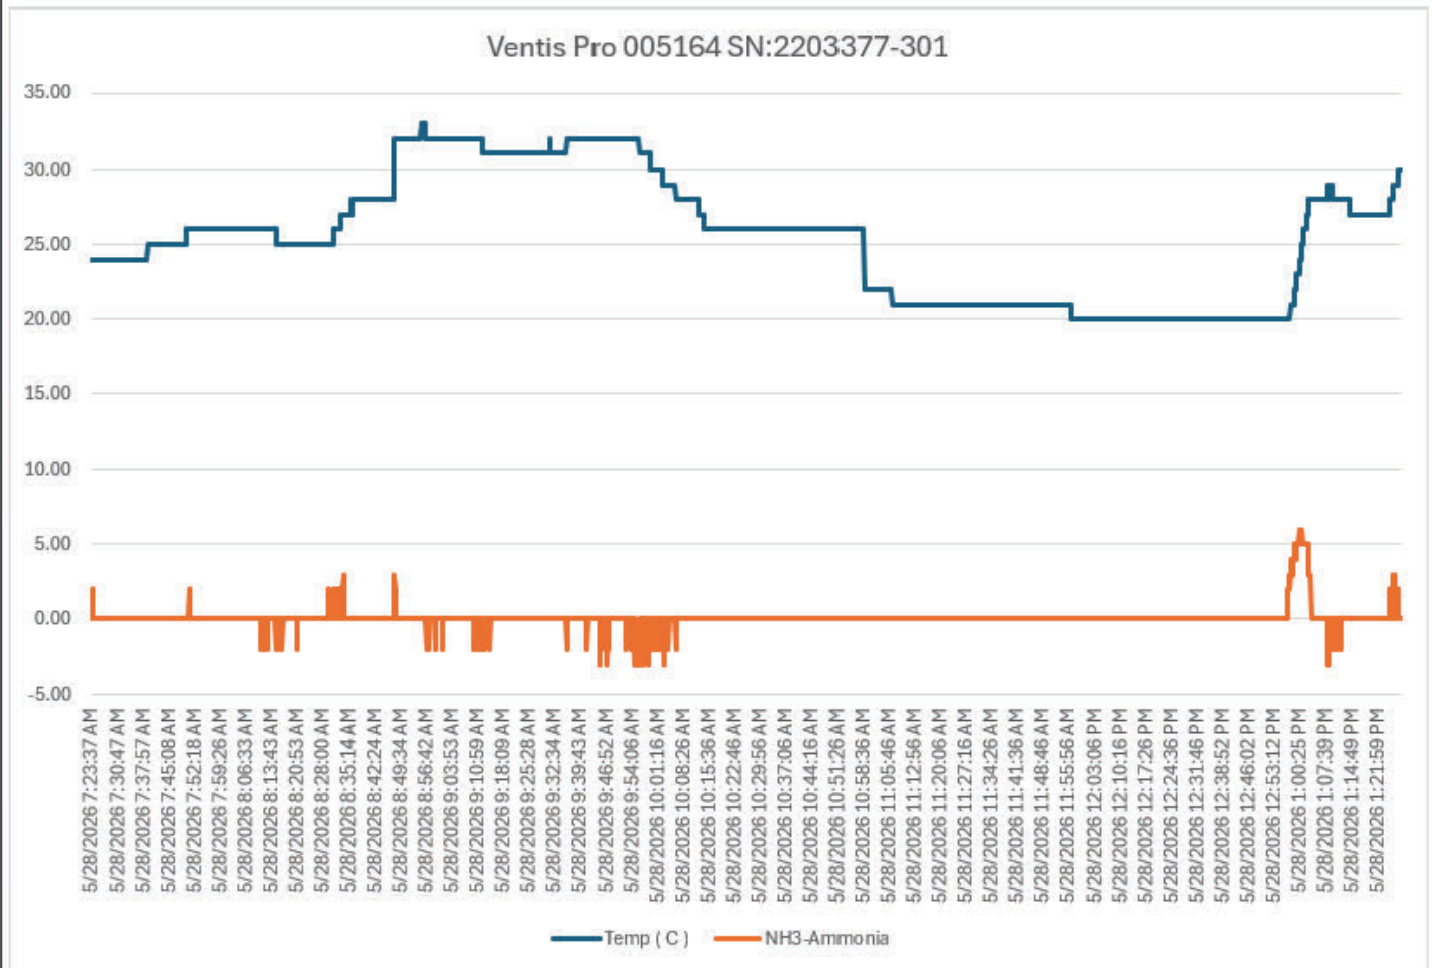
Event Data Log:

Review of the datalog reported that there were measurable readings for approximately one minute, with a maximum of 7 ppm. PAM data is recorded in 10 second increments, so it did not capture the actual peak reading of 7 ppm that occurred within of the 10 second interval reading on the

An examination of the instrument's alarm log identified several alarm events with the highest peak recorded as 7ppm at 1:00 pm for a duration of twelve seconds and again at 1:01 pm for a duration of six seconds.
