1. Project: Treated Effluent Disposal Facility (TEDF) 2. Report Date: 09//2026  
3. Title: C-67 Response at Pump Station #1 [TEDF]  
4. Investigation Report Number: EIR-2026-056 5. Revision: 0  
6. Responsible Manager: [REDACTED]  
7. Event Investigator: [REDACTED]  
8. Area/Building/Location: 200W/225W/TEDF Pump Station #1  
9. Date and Approximate Time of Event: Date: 08/12/2026 Time: (military) ~0840  
10. Associated Action Request (AR) Number: ITDC-AR-2026-2453  
11. Occurrence Report Number (if applicable): N/A

## INDUSTRIAL HYGIENE EVENT INVESTIGATION REPORT (IHIR)

| <b>Event Title:</b><br>TFC-OPS-OPER-C-67 Response at 225W | | <b>IHIR Number:</b><br>IHIR-00145 |

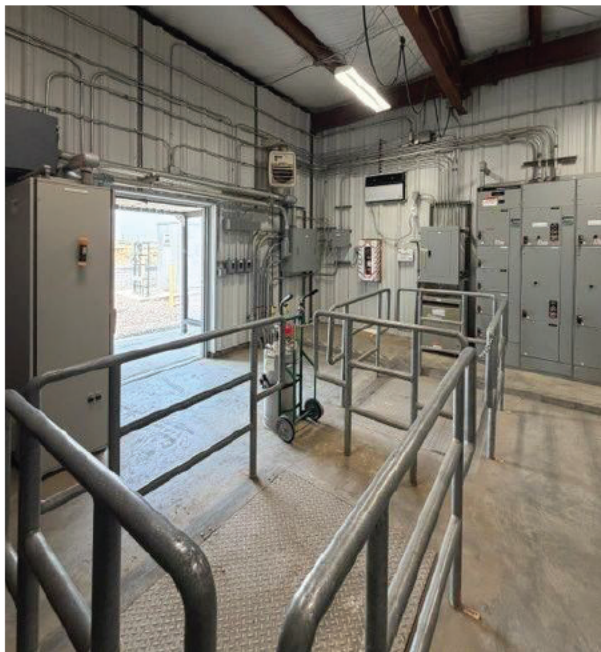
Figure 1 - 225W Upper Floor

The response team monitored their way into 225W and encountered "industrial, musty" odors upon entry. However, all DRI readings remain below the LOD throughout the entire C-67 response. No upset conditions were identified upon entry to the upper and bottom floors, pictured below:

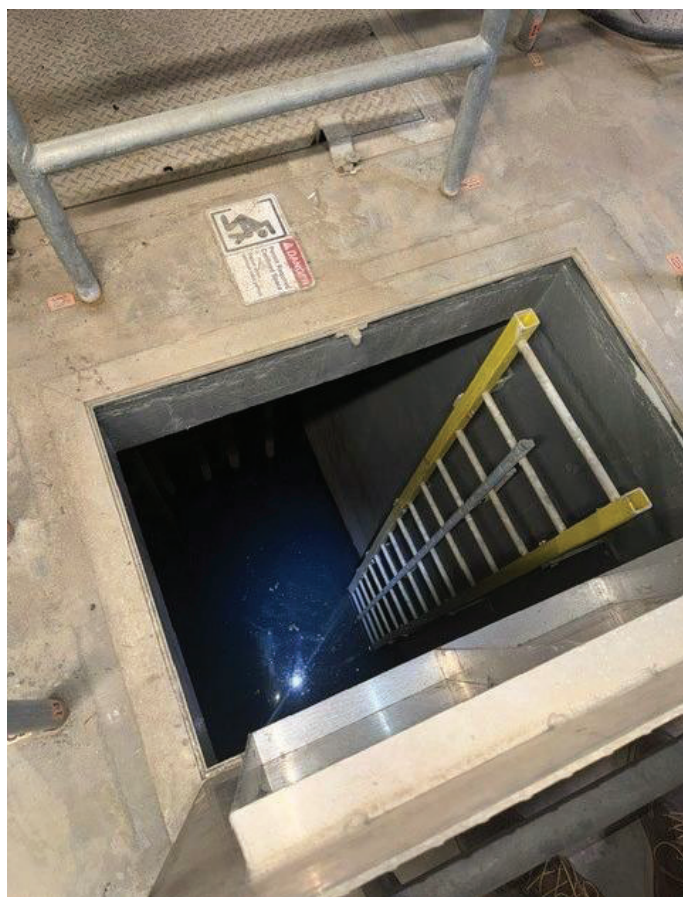
Figure 3 – 225W South Sump Tank

Whilst collecting air samples at the north and south sump tanks, the response team noticed the blue tint at the south sump tank and sludge/oil consistency in the north sump tank, as identified below in Figures 3 and 4:

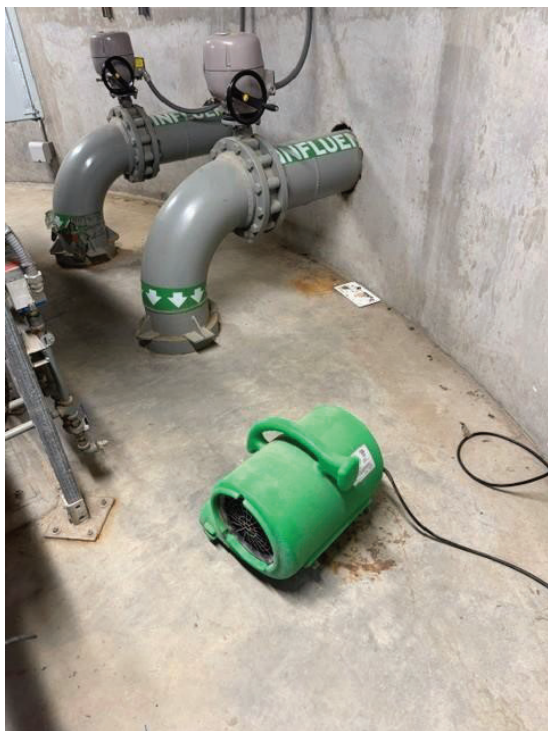
Figure 5- 225W Lower Floor Supplemental Ventilation

IH also observed that supplemental ventilation (B-Air Air Mover Model VP-33) was staged on the bottom floor next to the pumps (see Figure 5). A vent, later identified by the TEDF design authority as the air intake for the 'dry pit' (ref. H-2-140378 Sheets 1-2, H-2-140380, H-2-140381, H-2-140352), was covered by a plastic bag, as pictured below in Figure 6:

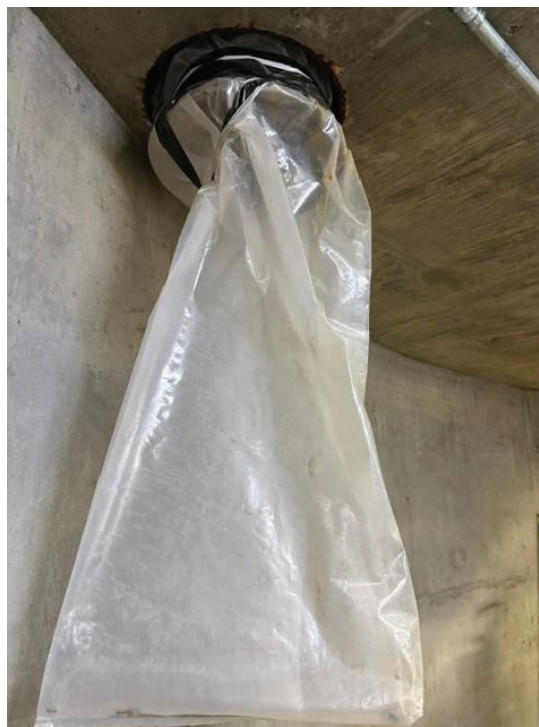
Figure 6 - 225 Lower Floor Air Intake (Dry Pit)

Air quality may also have been impacted by the fresh-air intake being covered with a plastic bag, inhibiting fresh air exchanges within the facility. IH recommends that ETF Engineering evaluate the modification made to the facility configuration to determine if access to this intake needs to be restored.

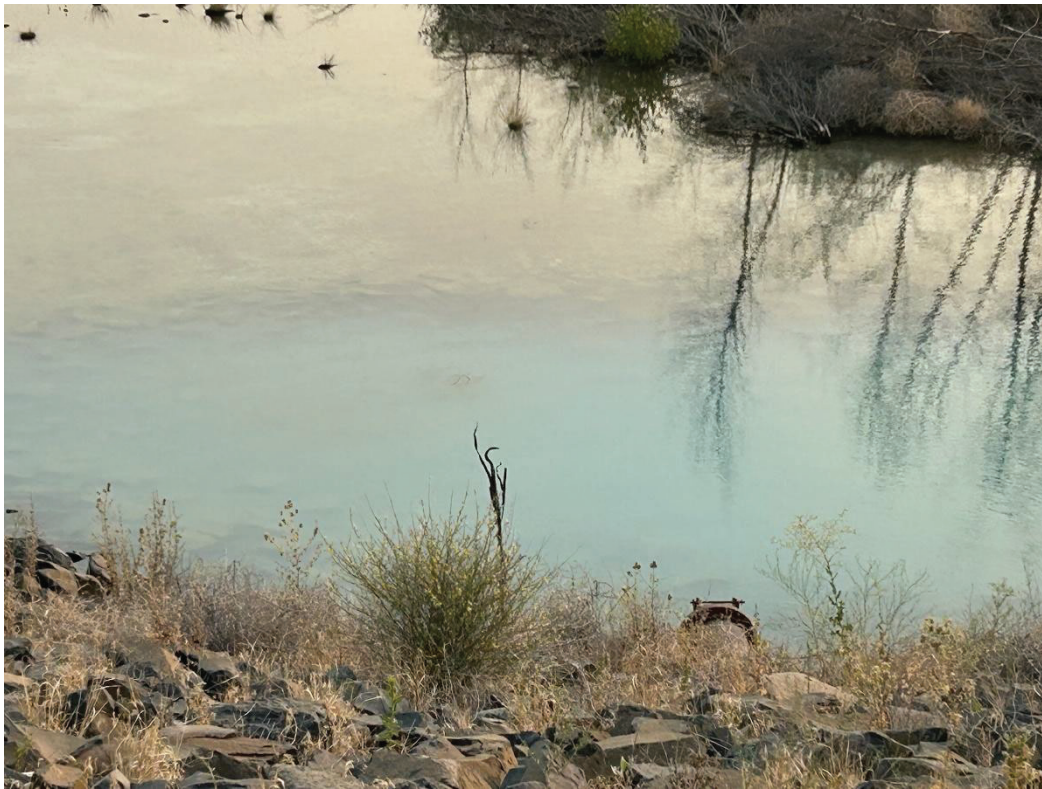
Figure 8 - TEDF Disposal Pond

While the exact source of the odor remains uncertain, it is likely connected to the discolored water observed in the 225W Sump Tanks. According to the Level 2 DFLAW/ETF Operations manager, operations received a low pH alarm at TEDF on 8/11/2026 and responded by obtaining manual readings, which confirmed the control room's reported values. Additional manual readings on 8/12 again verified low pH levels. A blue hue was noted in the disposal pond, as pictured below in Figure 7:

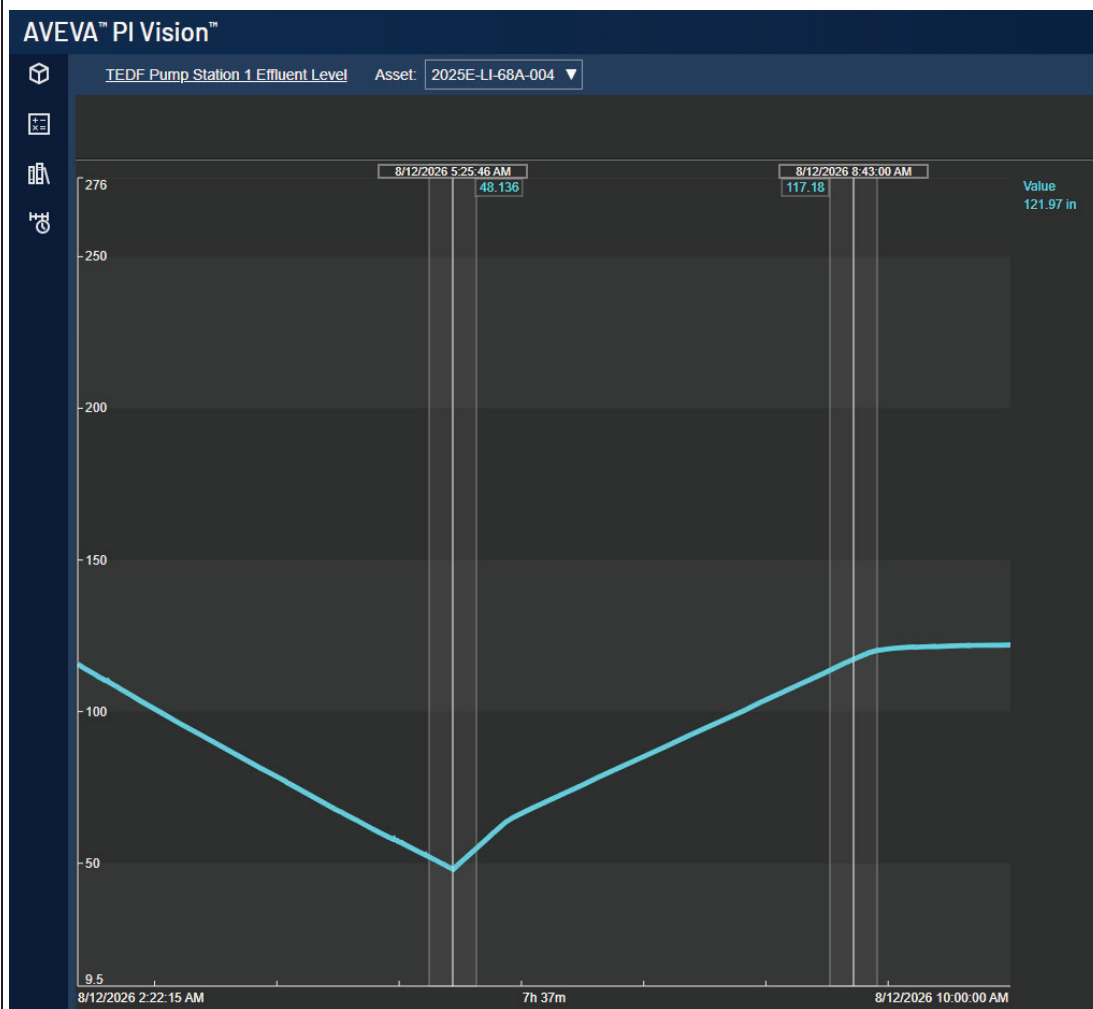
Figure 9 - 225W Effluent Levels

During event response, DFLAW IH reviewed the 225W Sump Tank levels and identified that effluent was being discharged from 225W until approximately 8/12/2026 at 0525, when 225W began again receiving effluent from HMIS until 8/12/2026 at 0843 (ref. Figure 9). The addition of liquid into the sump tanks could have potentially caused headspace displacement of any vapors in the sump tanks, leading to a release in the 225W airspace.
