# **EVENT INVESTIGATION REPORT**

# Investigation of AOP-015 at 271AP Instrument Building Event Investigation Report 2019-003

241-AP-271

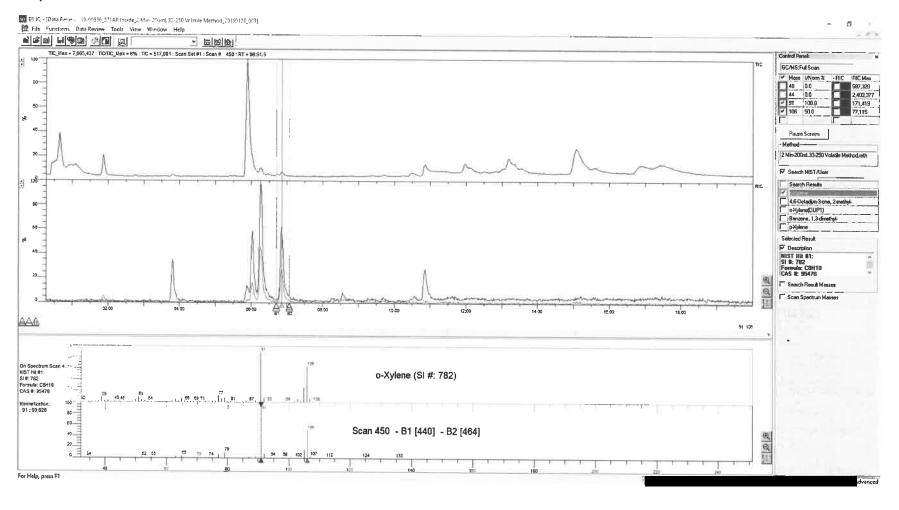
# o-Xylene

Compound	СОРС	Estimated Sample Concentration (ppb)	Typical Sample Bag Concentration (ppb)	Net Concentration (ppb
Methyl methacrylate	No	< 10	< 10	Not found
Toluene + Xylenes	No	20	20	Not Found
D-Limonene	No	10	<5	10
Aliphatic Hycrocarbons, C11 – C16	Yes	75	100	Not Found

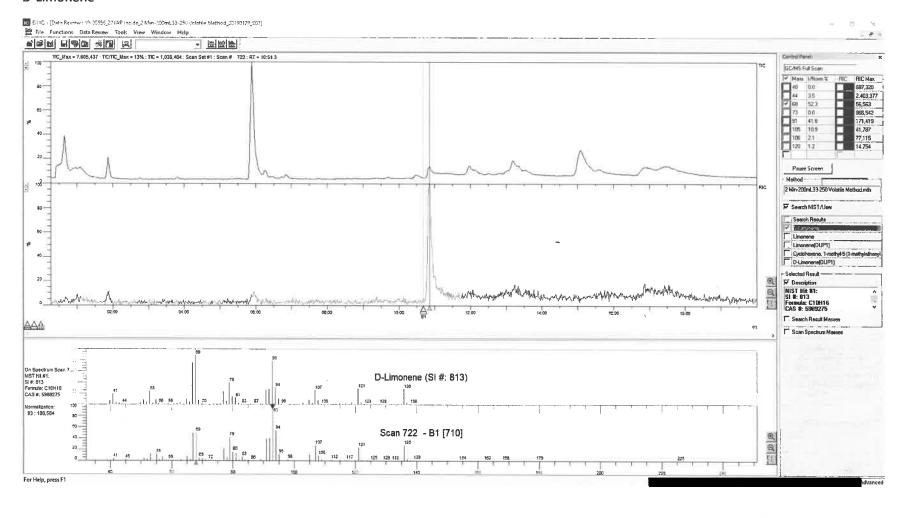
#### **D-Limonene**

D-Limonene is the primary ingredient in Simple Green©

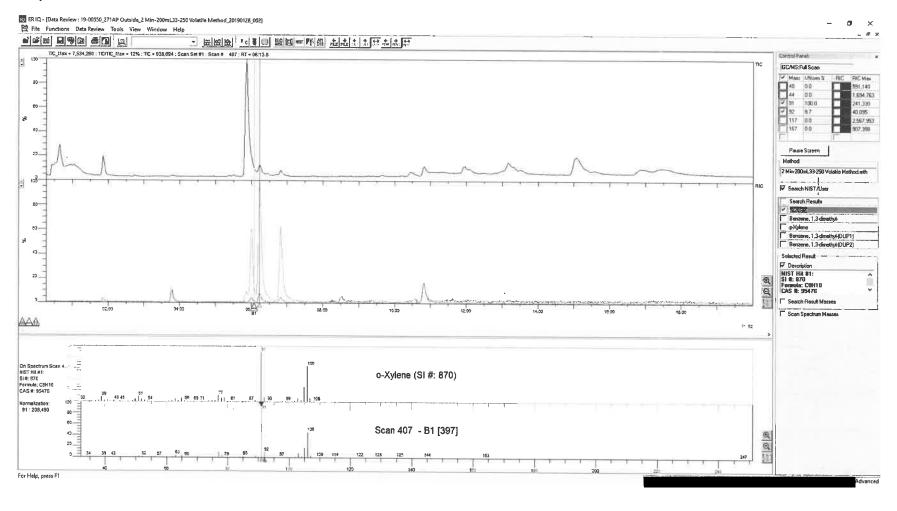
#### o-Xylene

Compound	COPC	Estimated Sample Concentration (ppb)	Typical Sample Bag Concentration (ppb)	Net Concentration (ppb
Methyl methacrylate	No	< 10	< 10	Not found
Toluene + Xylenes	No	20	20	Not Found
D-Limonene	No	10	<5	10
Aliphatic Hycrocarbons, C11 – C16	Yes	75	100	Not Found
