EVENT INVESTIGATION REPORT EIR-2019-025 & 026
WRPS-PER-2019-1170 & 1174,
AOP-015 Event Inside 242-A Evaporator, Outside MO-818 AW Change Trailer

Executive Summary

This Event Investigation Report (EIR) number EIR-2019-025 (and EIR-2019-026) is in response to Problem Evaluation Request (PER) PER-2019-1170 for the 242-A Evaporator and PER-2019-1174 for the MO-818 AW Farm Change Trailer, respectively. A meteorological report was generated using APGEMS-TF software to model the weather conditions and their effects on vapors and odors in the area of concern. This report is Attachment A. Industrial Hygiene Investigation Reports (IHIR) 19-04244, (242-A Evaporator event) and IHIR 19-04243(MO-818 AW Farm Change Trailer event), were performed independently. These two reports are Attachment B and C, respectively. EIR-2019-025, 026 investigations were performed by the Production Operations Performance Assurance team. They were initiated on the morning of 10 June 2019.

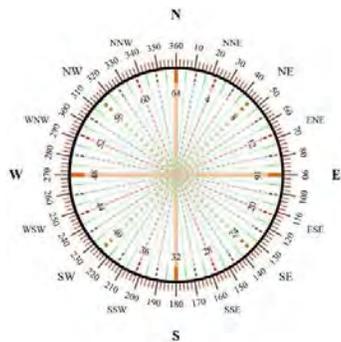
There was no rain all weekend and the winds were calm at the times of the reported odors. The wind direction varied as seen below.

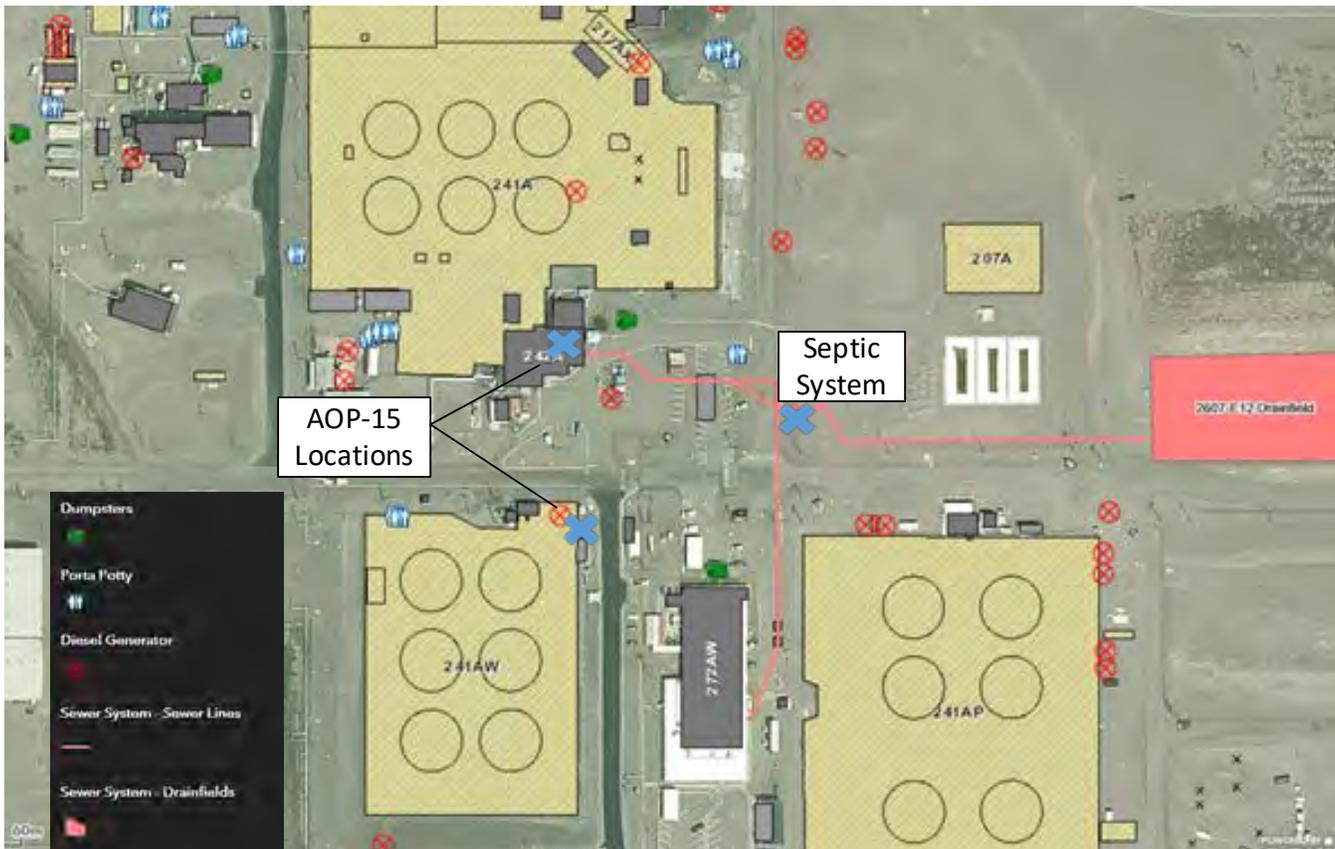
The figure below is an aerial photograph showing the location of the two AOP-015 events plus some select proximal features of interest. Areas of interest have been artificially colored for emphasis. There are three tank farms surrounding the AOP-015 events: 241-A/AW/AP. Also nearby are multiple garbage receptacles, diesel generators, portable toilets, and an underground septic system to the east/northeast of the two AOP-015 events.

Approximately 90 to 100 meters to the east/southeast of the two event sites there exists an active, semi-dysfunctional septic system. An MSA subject matter expert was consulted regarding the septic system. The septic system collects sewage waste from local facility plumbing in two cascading process tanks (15,000 gal. total capacity) before discharge to a manifold 15-branch drain field. The septic system functions with passive ventilation through shallow vadose zone interaction. Additionally, it is reported that the system has damage between the tanks exit and the branched discharge lines. Periodic tanker truck evacuation of this system is performed to help mitigate malfunctioning conditions until another more permanent fix may be implemented.

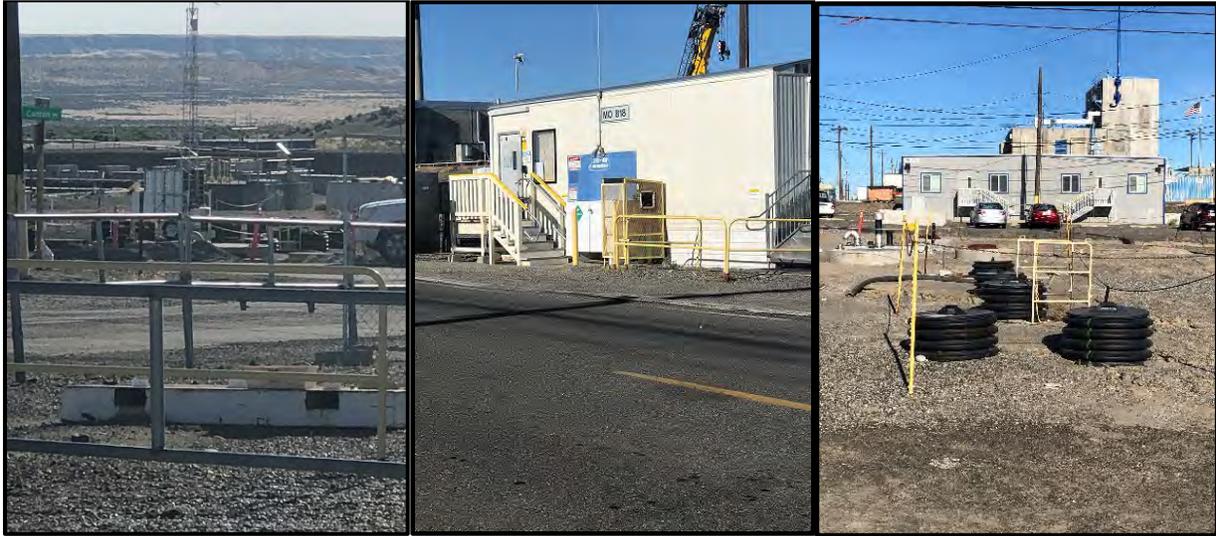
The figure below shows three photographed views to depict the proximity of the event locations relative to the septic system (from left to right): east side of MO-818 near the AW Tank Farm looking northeast toward septic system, MO-818 looking southwest from the septic system area, 242-A Evaporator in the background looking west from the septic system.

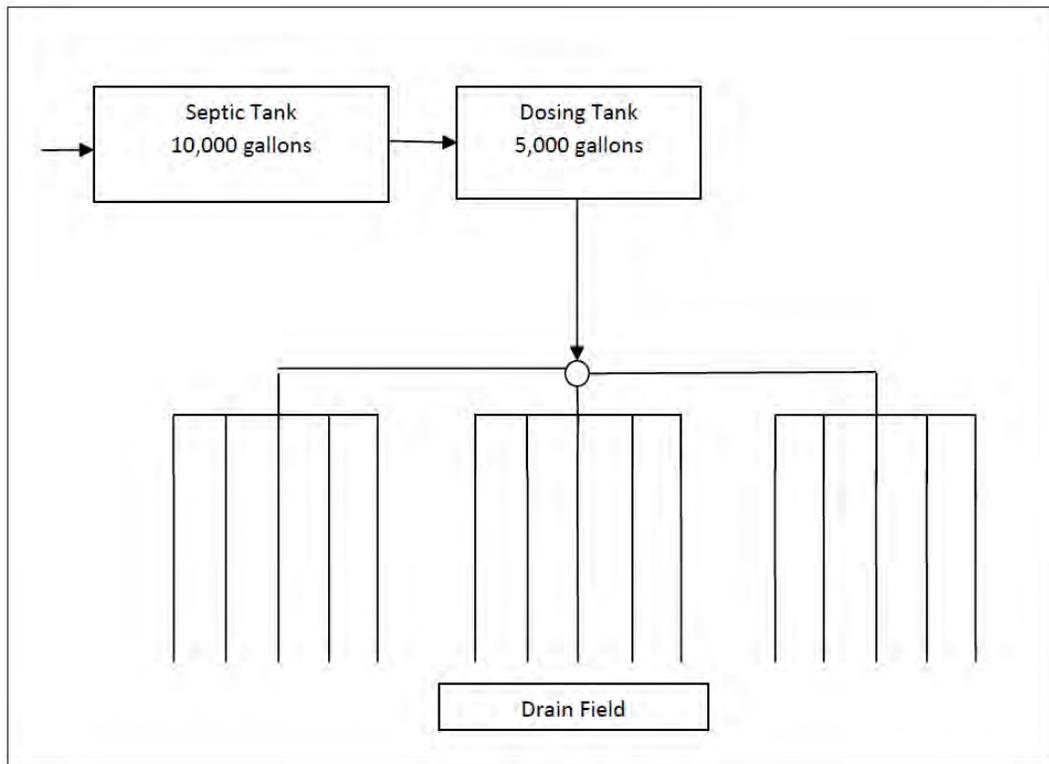
The figure below is from Operations and Maintenance Manual for Septic System 2607-E12 (from WHC-SD-W172-OMM-001) detailing the underground configuration of sewage SSCs in the area of concern.

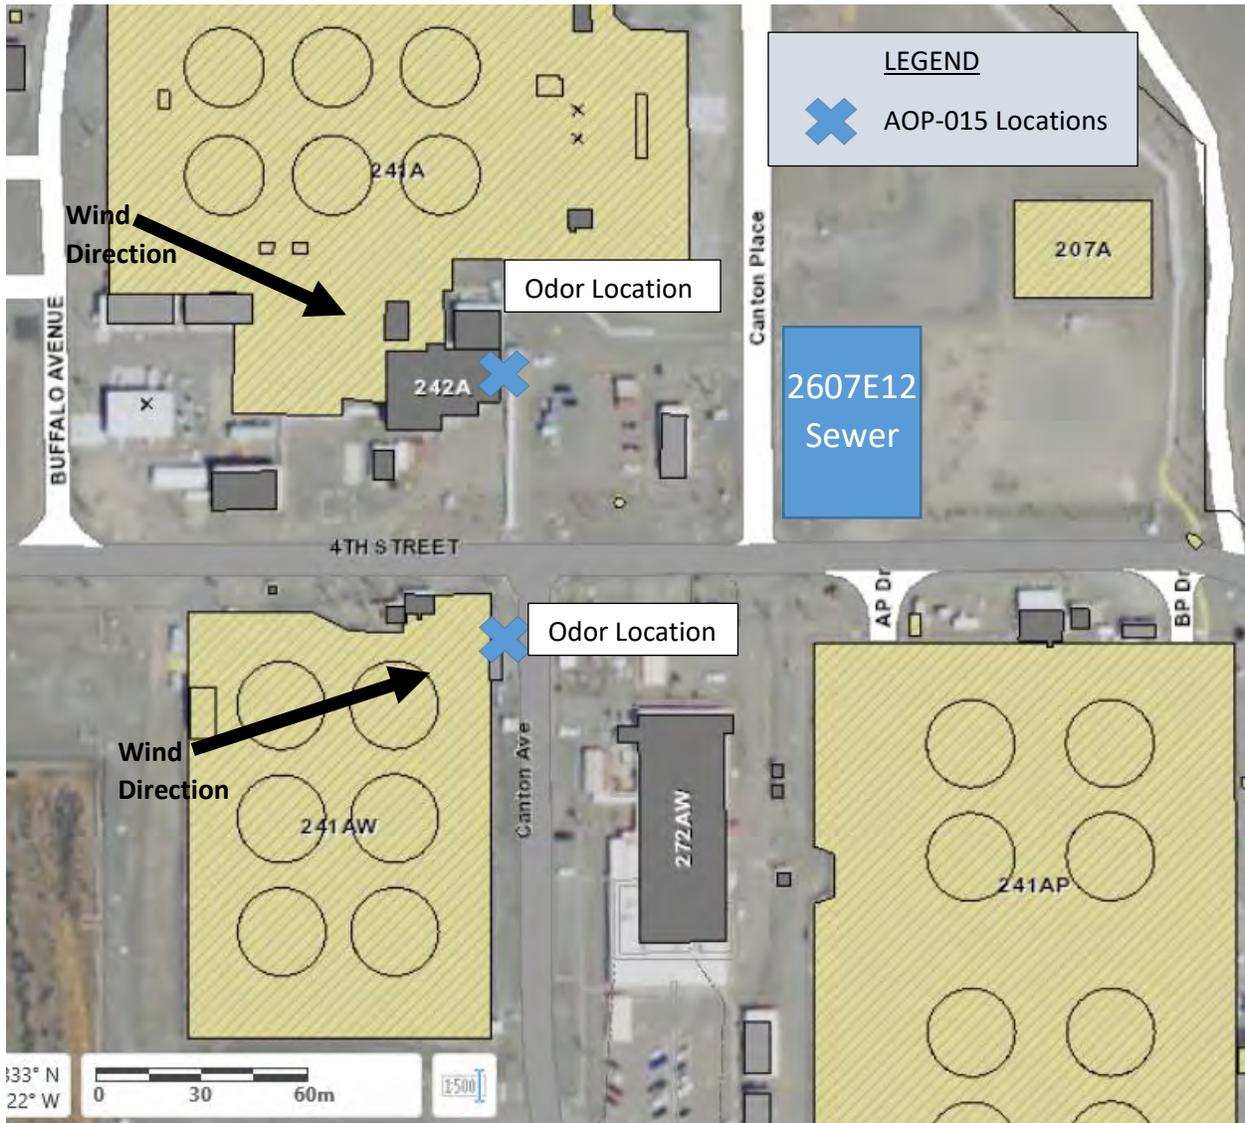
Figure 1. Location of the Odor Events and Nearby Sewer Source.

An AOP-015 event was reported on June 9, 2019 in and immediately outside the 242-A Evaporator (main hallway, kitchen, hallway leading to the control room, and outside building on 1st and 2nd level) and on the exterior stairs of the MO-818 AW Change Trailer. The odors in the 242-A Evaporator reported at 08:10 - 08:16 were described as musty, wet, sewage, or something had died. The odors at the MO-818 AW Change Trailer reported at 09:17 were described as ammonia/sulfur odor. No symptoms were reported and all workers declined medical evaluation. Workers also reported musty/mold and sewage smells in the 242-A Evaporator hallway in the two days prior to the reported event. See Figure 1 for the AOP-015 locations and a nearby sewer.

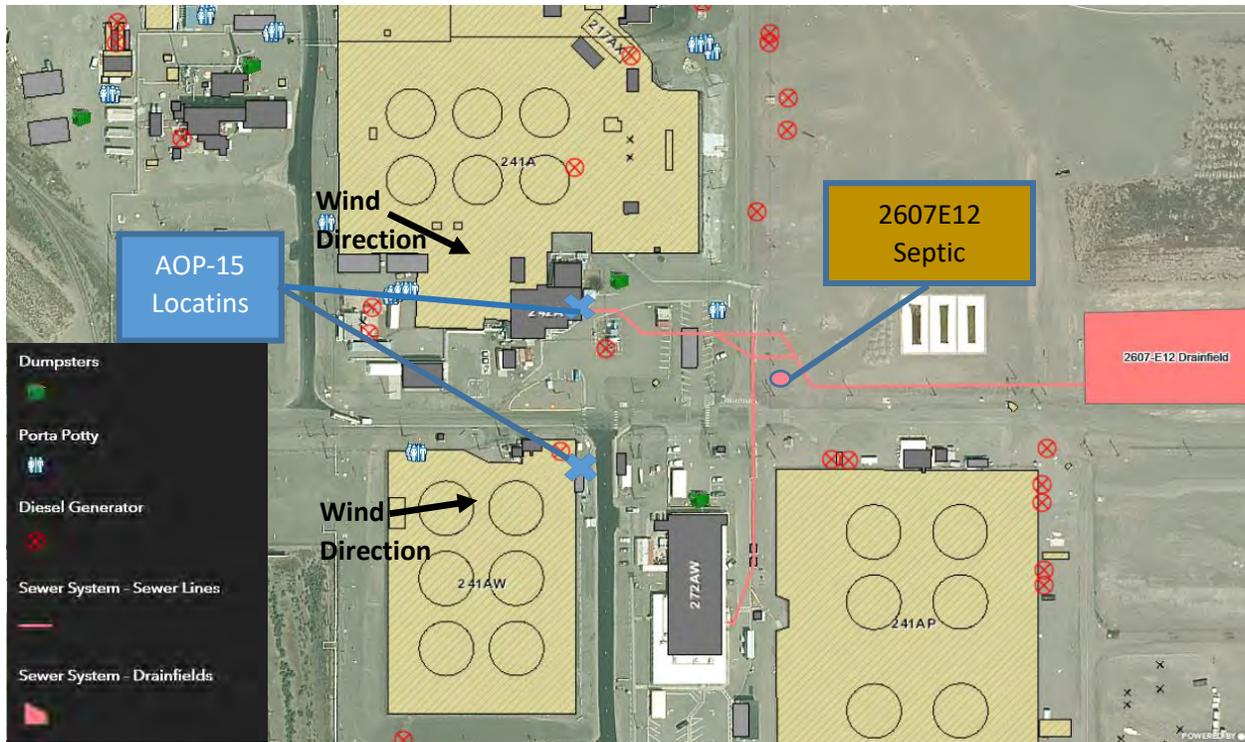
Figure 2. AOP-15 Locations in Relation to Potential Vapor Sources.

At 8:15 AM PDT on 6/09/19, the Hanford meteorological tower located at the 200E area (Station 6) had an average wind speed of 3.7 mph and wind direction from the WNW (302 deg from north). At 9:15 AM PDT on 6/09/19, the average wind speed was 2.9 mph and wind direction from the WSW (240 deg from north). One would expect relatively low levels of mixing due to the low wind speeds, and horizontal plume widths would be relatively broad due to light and variable winds. The stability class was neutral, so vertical mixing is expected to be moderate. See Figure 2 for a map of modeled vapor sources around the AOP-015 Location.

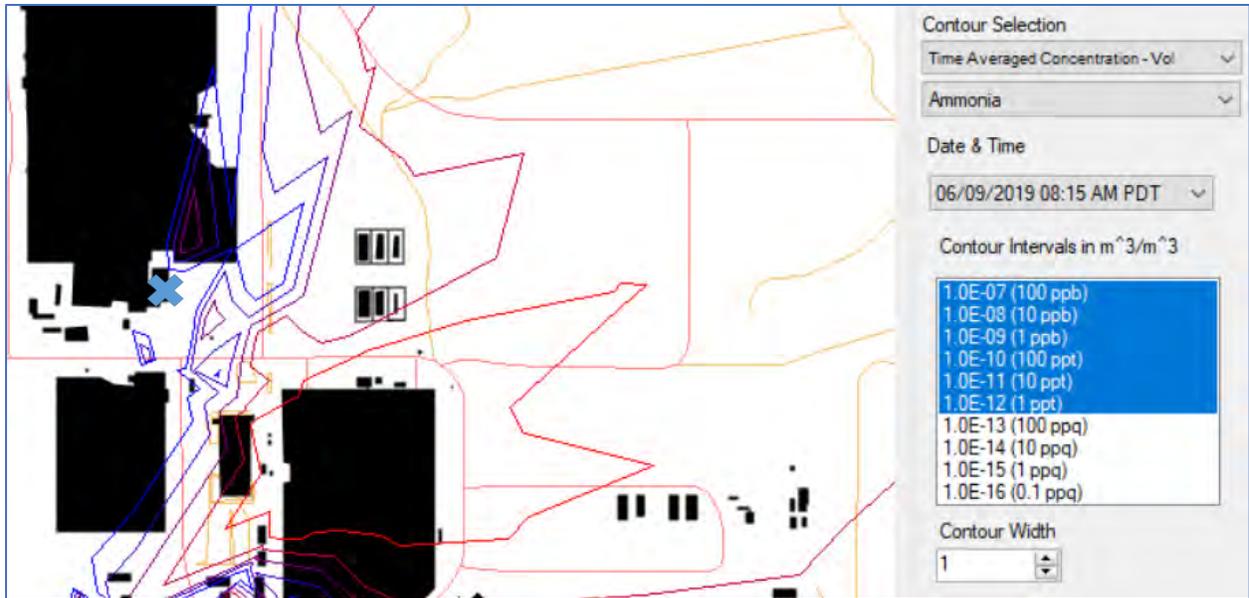
Based on the model (see Figures 3 and 4), the highest concentration of ammonia from tank vapors at the AOP-015 locations was between 10 and 100 ppb or 3 orders of magnitude below the OEL. The odor threshold for ammonia is approximately 5 ppm, which is 2 orders of magnitude above predicted ammonia concentration at MO-818, which had reported ammonia odors. Therefore, it is unlikely that the ammonia odors came from tank vapors.

Figure 3. APGEMS-TF Modeling of Combined Release from A-Farm PBFs and AW-Stack at time of 242A Evaporator Vapor Event, Predicted Ammonia Concentration outdoors at AOP-015 Location is below 1 ppt (7 orders of magnitude below its OEL)

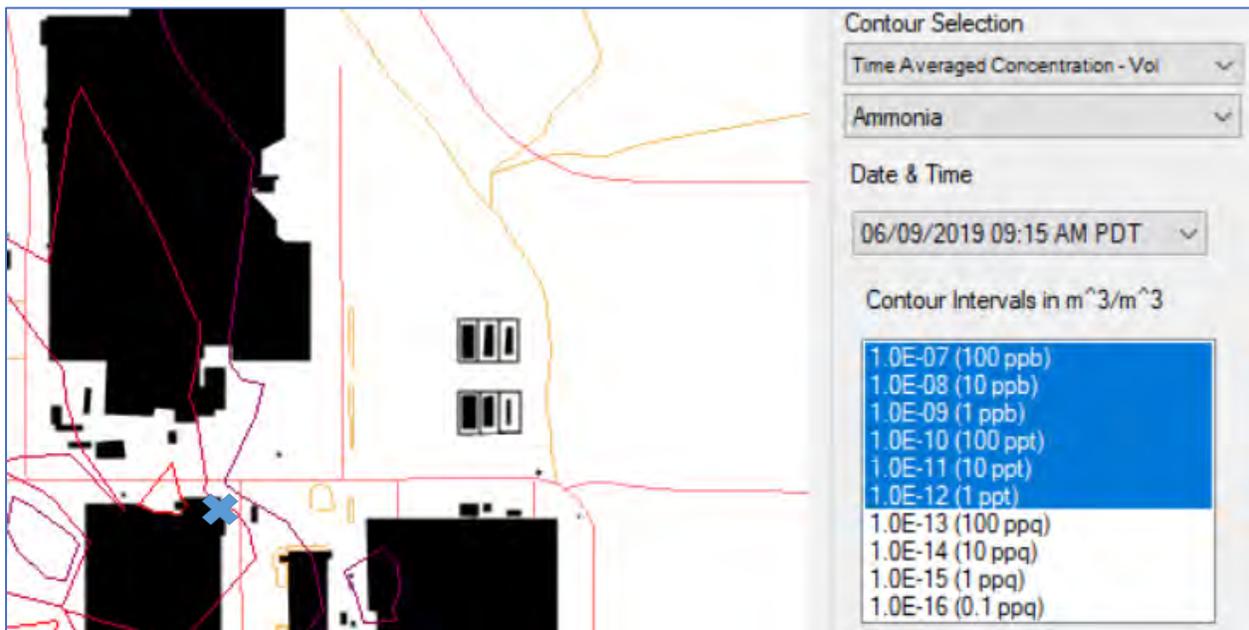
Figure 4. APGEMS-TF Modeling of Combined Release from A-Farm PBFs and AW-Stack at time of MO-818 Vapor Event, Predicted Ammonia Concentration at this AOP-015 Location is between 10 and 100 ppb (3 orders of magnitude below its OEL or 2 orders of magnitude below its odor threshold)

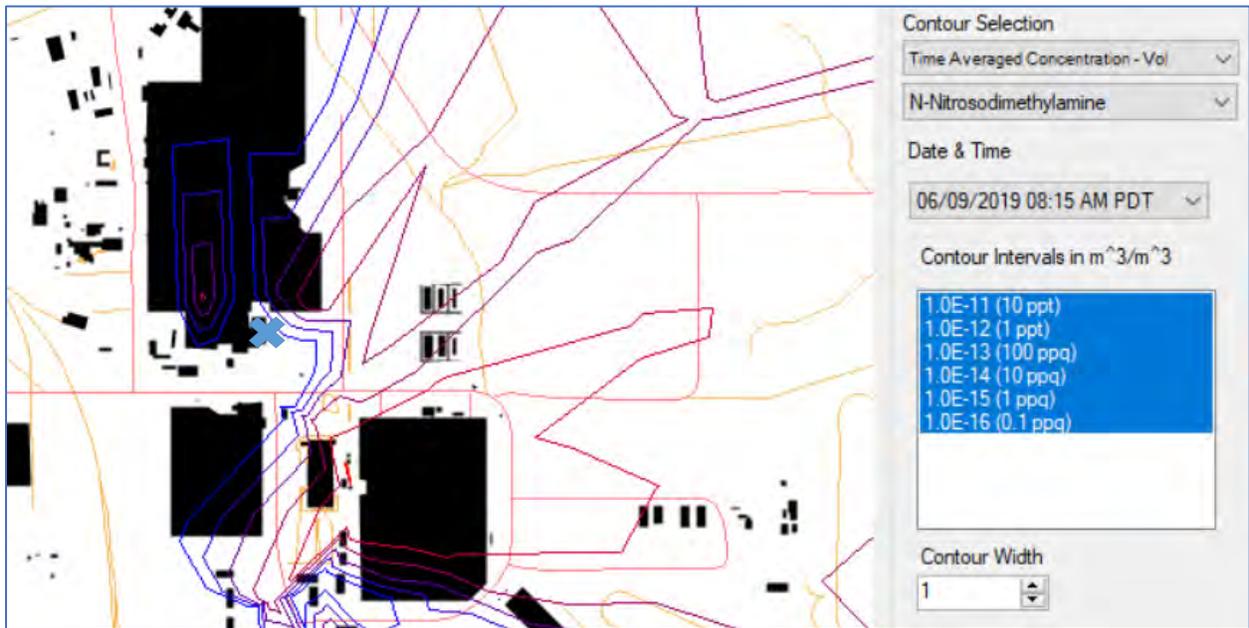
The model results indicate that all COPCs were well below their OEL at the receptor sites, based on estimated emission rates and scaling from the modeled ammonia concentrations. The COPC with the largest concentration in the AW and A-Farm headspaces relative to its OEL (NDMA) was modeled to show bounding concentrations of COPCs at the receptor sites (see Figures 5 and 6). The highest concentration of NDMA predicted at the receptor locations was 2.5 orders of magnitude below its OEL, which demonstrates that the worker breather space was safe relative to all COPCs.

Figure 5. APGEMS-TF Modeling of Combined Release from A-Farm PBFs and AW-Stack at time of 242A Evaporator Vapor Event, Predicted NDMA Concentration outdoors at AOP-015 Location is below 1 ppq (5.5 orders of magnitude below its OEL)

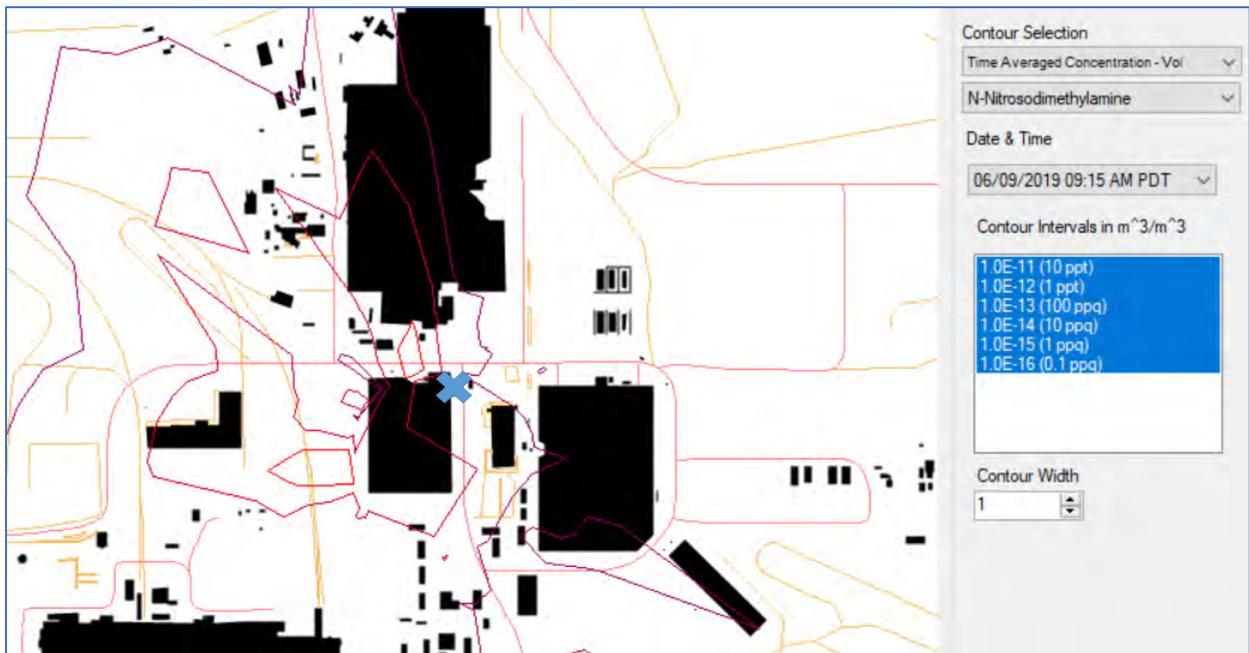
Figure 6. APGEMS-TF Modeling of Combined Release from A-Farm PBFs and AW-Stack at time of MO-818 Vapor Event, Predicted NDMA Concentration at this AOP-015 Location is Between 1 ppt and 0.1 ppt (2.5 orders of magnitude below its OEL)

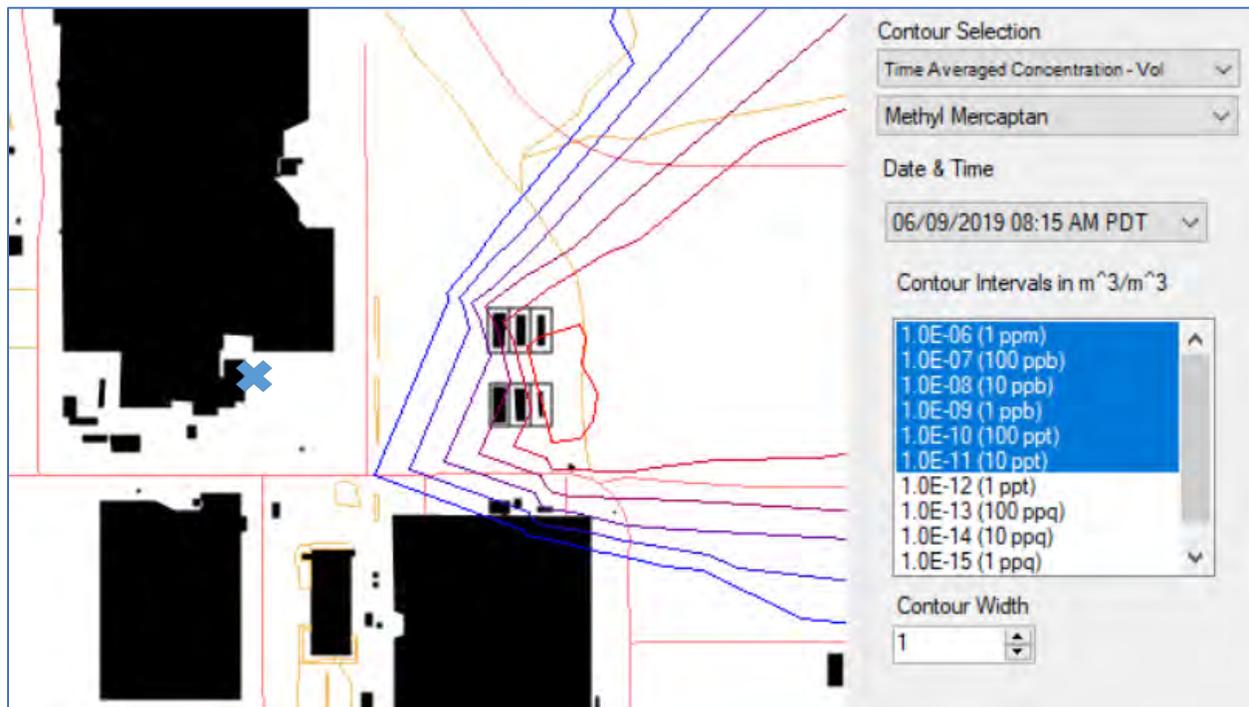
Contour lines in Figure 7 indicate that meteorological conditions alone do not implicate the 2607E12 sewer system as the source of 242A odor event. It should be noted that the wind speeds were light and variable at the time (3.7 mph average), and that at these low wind speeds winds can change direction or swirl during breaks in the wind.

Figure 7. APGEMS Modeling of 2607E12 Sewer System, 242A Evaporator AOP-15 Location is Outside the Predicted Sewer Plume

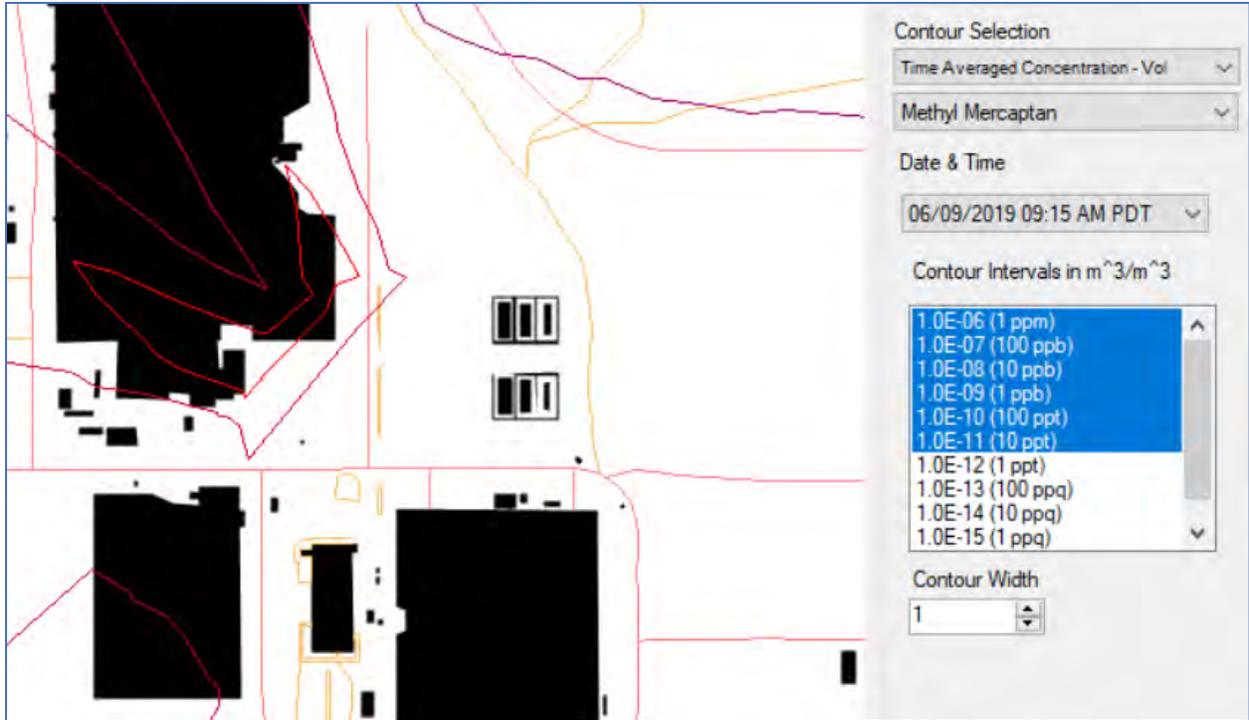
Contour lines in Figure 8 indicate that plume from 2607E12 sewer did encompass MO-818 at the time of the AOP-015 event, but not at the highest concentration contour (i.e., center of the plume). Again it should be noted that the average wind speed at the time was very low (2.7 mph) and the phenomenon of local wind direction change and swirling applies. Although the wind direction was not coming from the sewer at the time, the plume was broad enough to suggest that sewer gases could reach the MO-818 event location.

Figure 8. APGEMS Modeling of 2607E12 Sewer System, Methyl Mercaptan Concentrations are Arbitrary. The MO-818 AOP-015 Location is Inside the Predicted Sewer Plume but not within the Highest Concentration Contour
