C-67 Event Investigation Reports (Redacted) EIR-2023-037 (05/31/2023)

Washington River Protection Solutions
INDUSTRIAL HYGIENE EVENT INVESTIGATION REPORT

Event Title: <p style="text-align: center;">TFC-OPS-OPER-C-67 Response 242A Evaporator AMU</p>	PER Number: <p style="text-align: center;">N/A</p>
IHIR Number: <p style="text-align: center;">IHIR-00069</p>

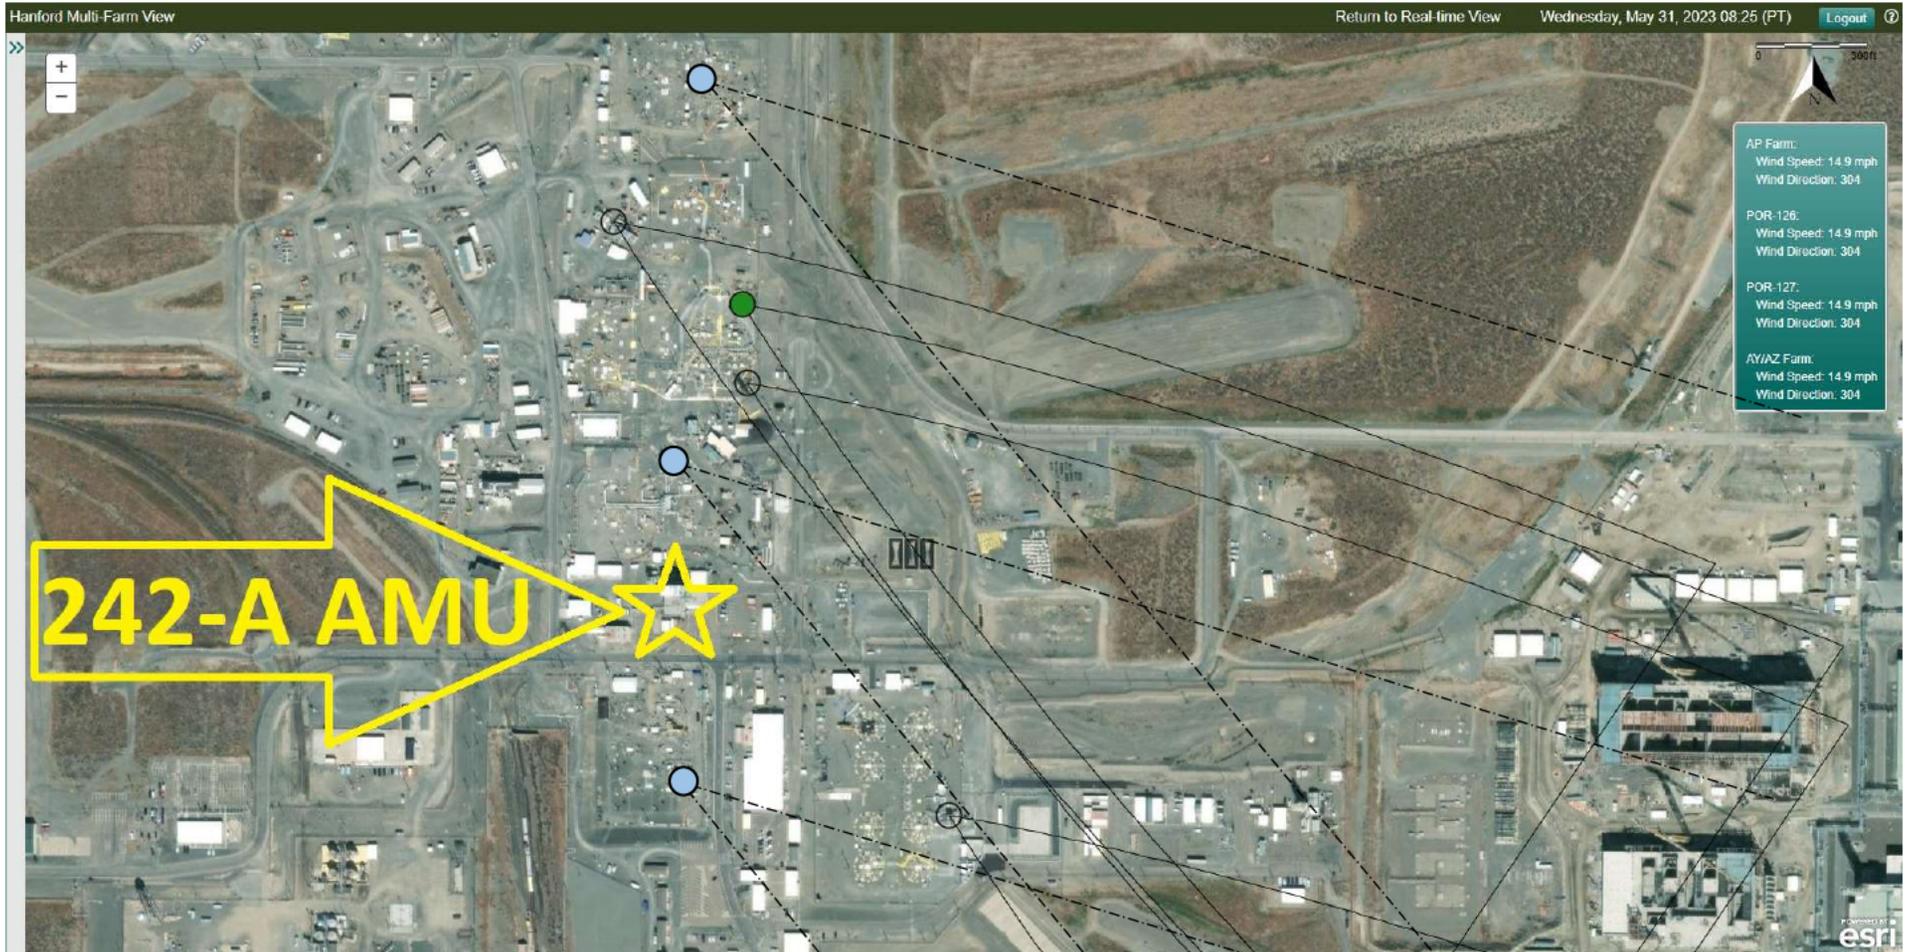
Figure 1. 200-East Area (with 241-AW, 241-AP, 241-AN, 241-AY/AZ, 241-AX, 241-A Farm projected plume models) at 0825 05/31/2023 from Data Fusion and Advisory System (DFAS) application, powered by SmartSite™

NOTE: 241-AN, 241-A, 241-AW Farm Exhausters are not connected to the DFAS; however, an approximate exhauster plume was added for each based on other modeled plumes.

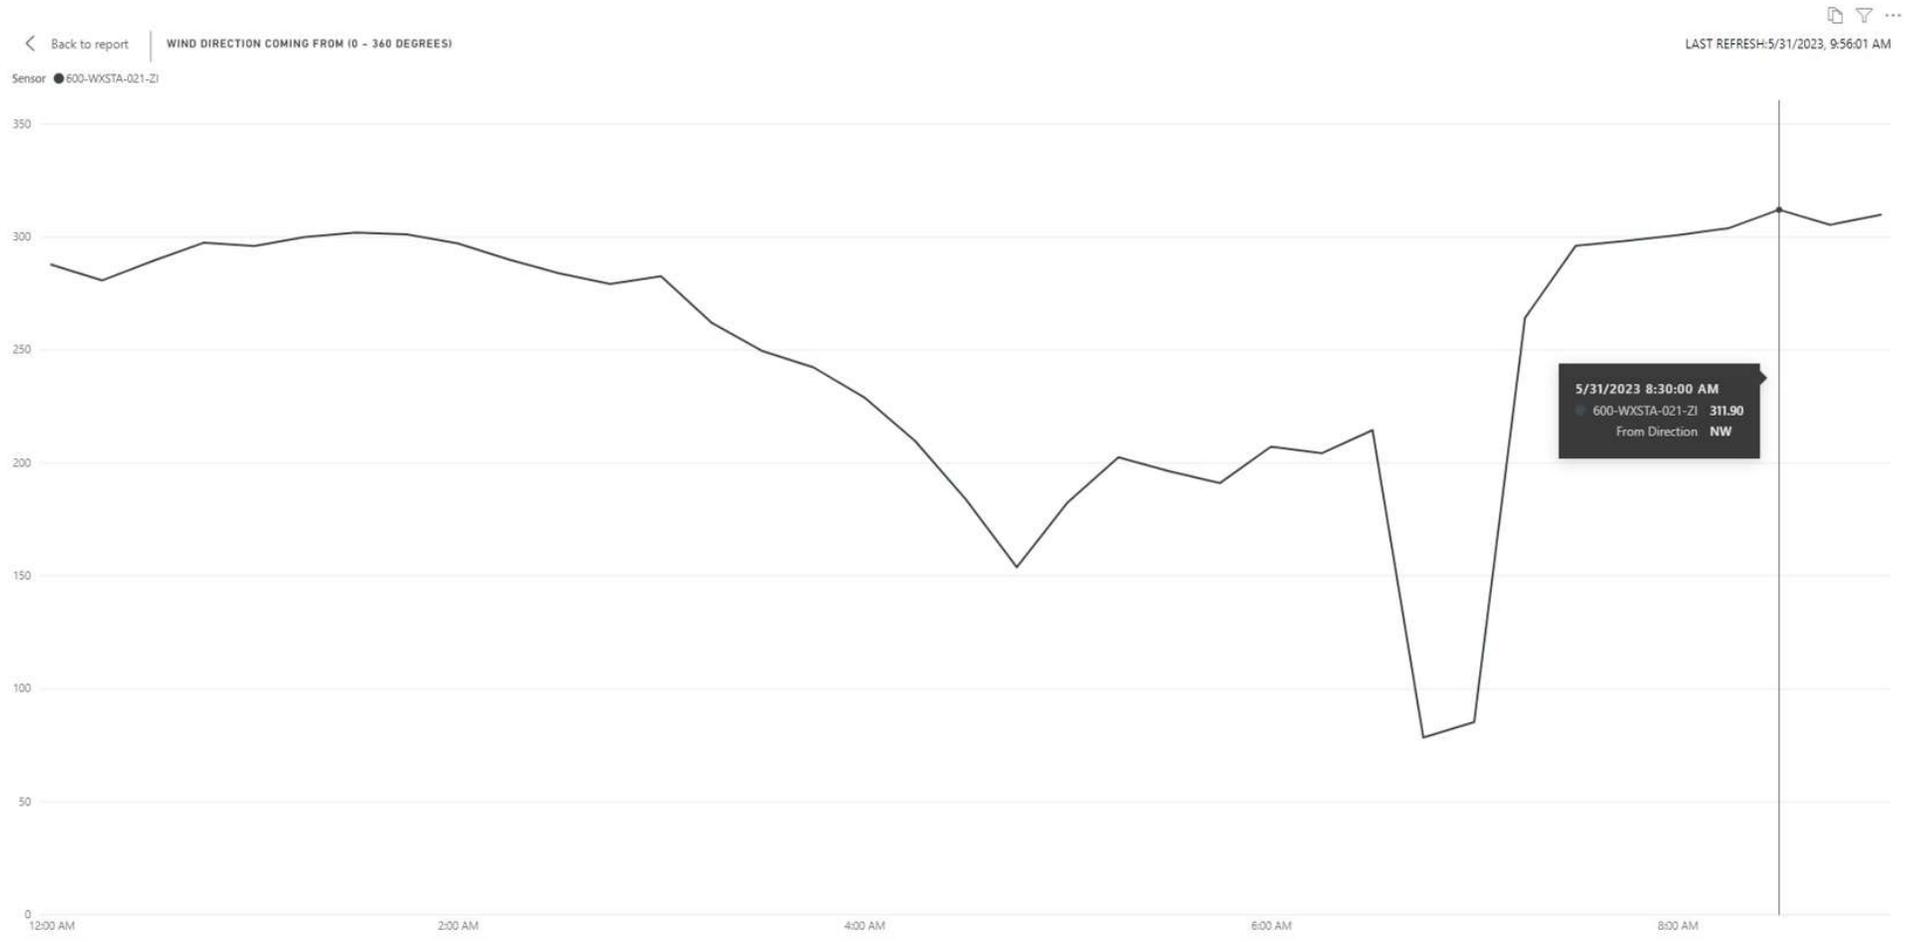
Figure 2. DFAS application, powered by SmartSite™ Weather Data (wind direction) from 0830 05/31/2023.

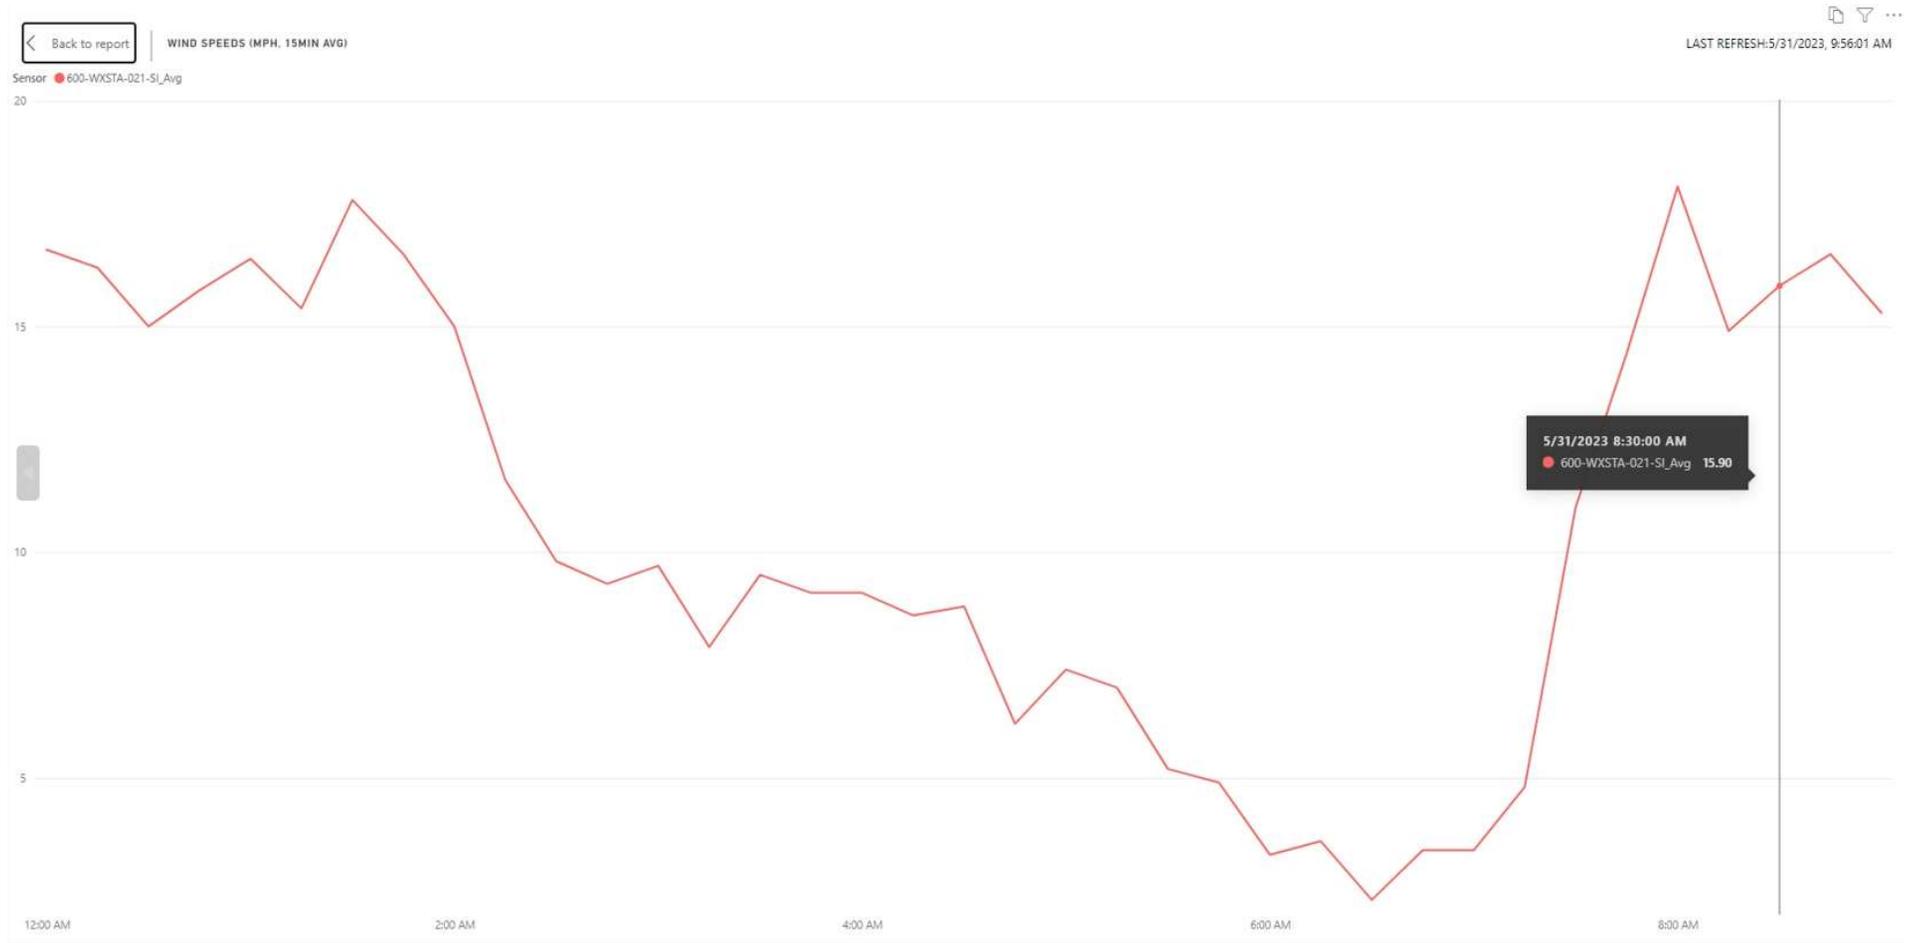
Figure 3. DFAS application, powered powered by SmartSite™ Weather Data (wind speed) from 0830 05/31/2023.

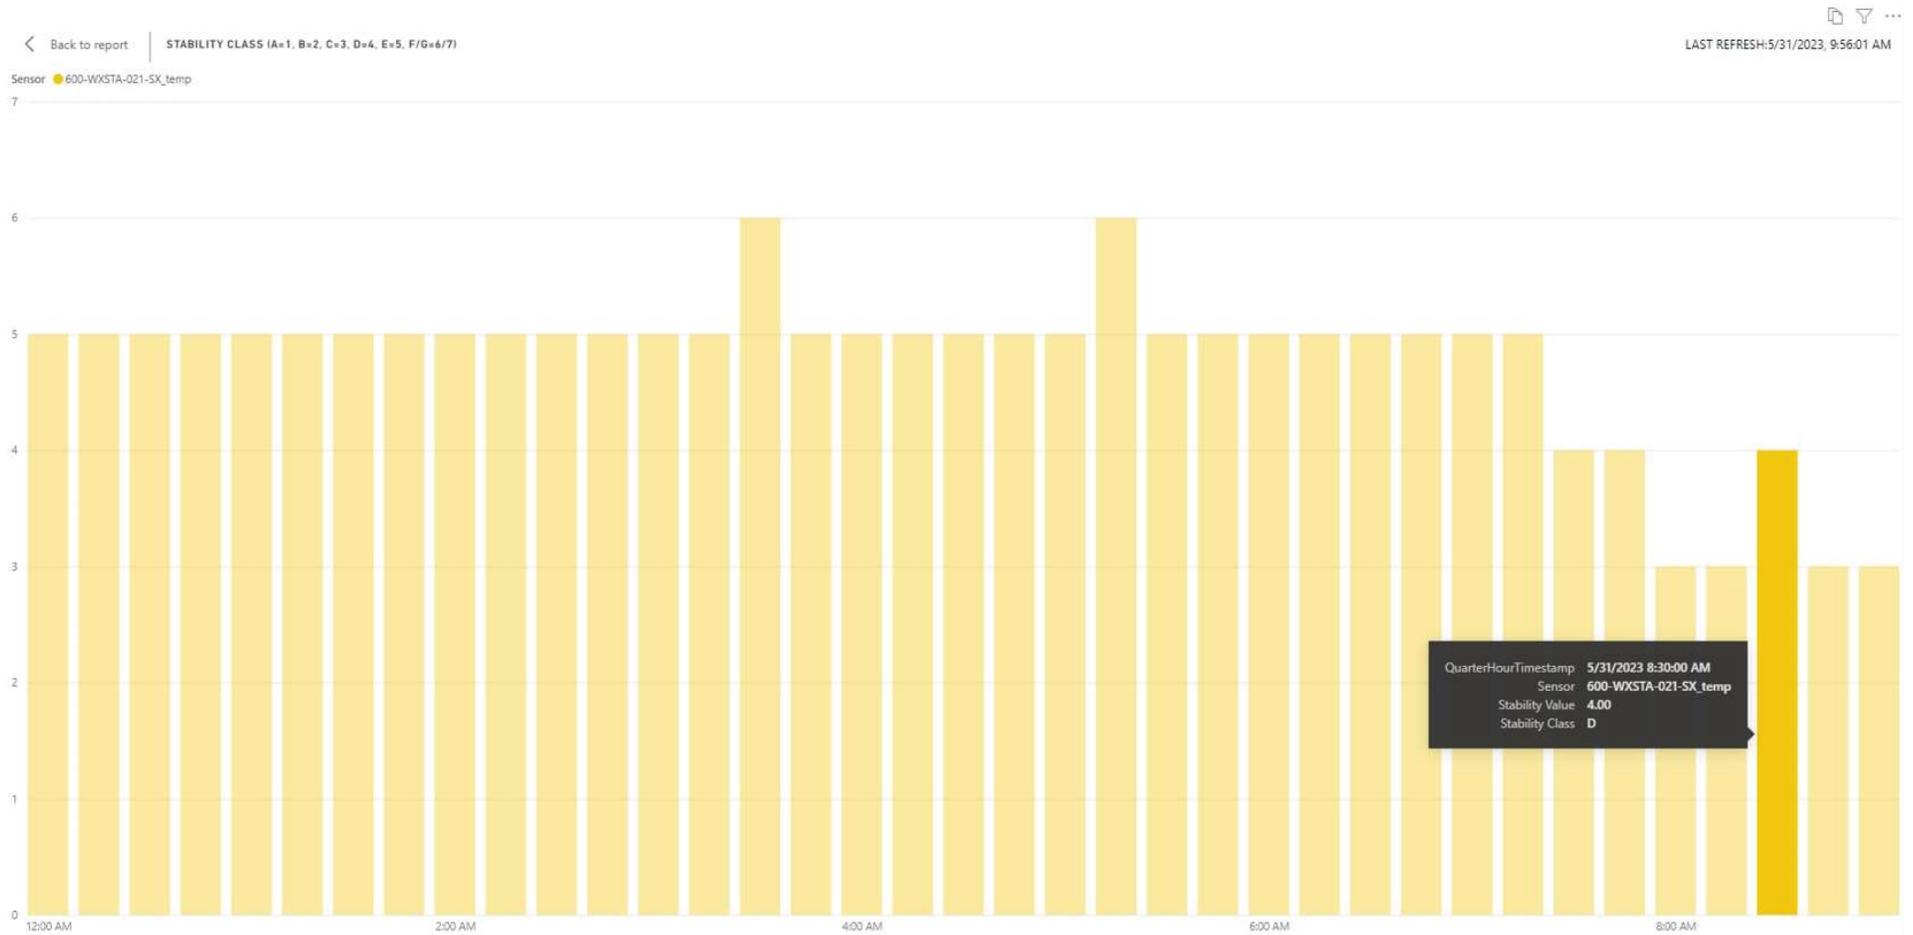
Figure 4. DFAS application, powered by SmartSite™ Weather Data (stability class) from 0830 05/31/2023.

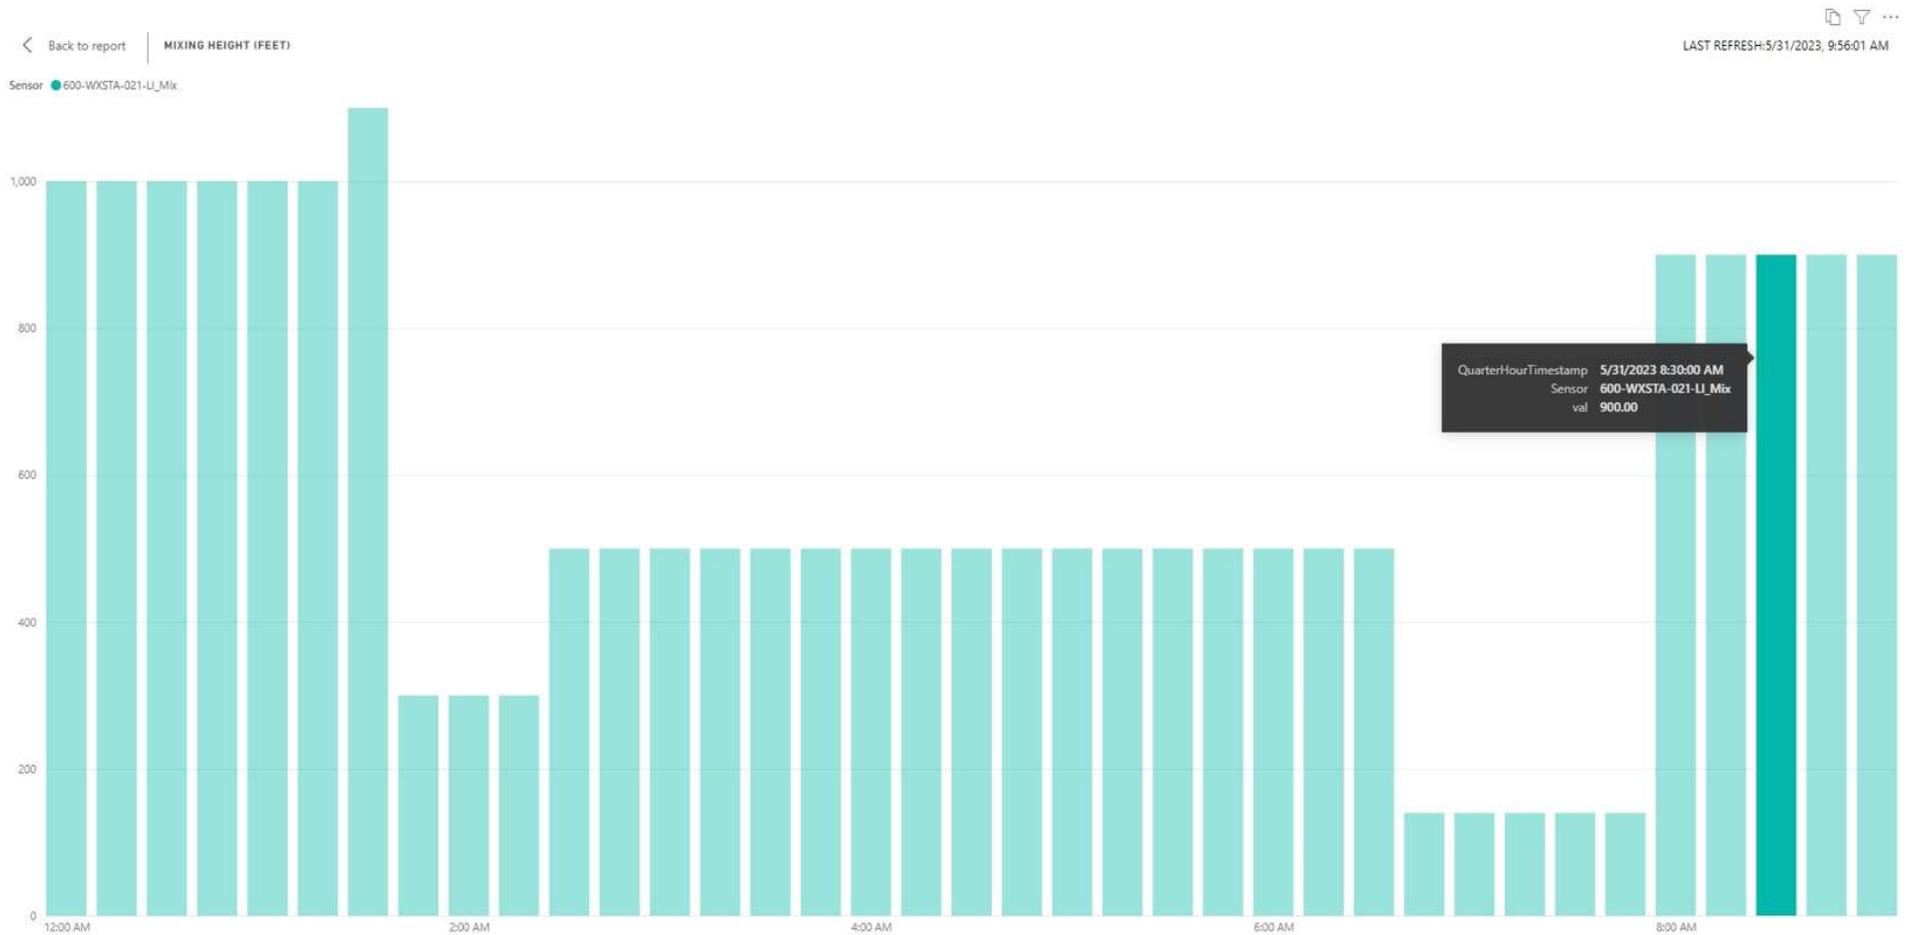
Figure 5. DFAS application, powered by SmartSite™ Weather Data (mixing height) from 0830 05/31/2023.

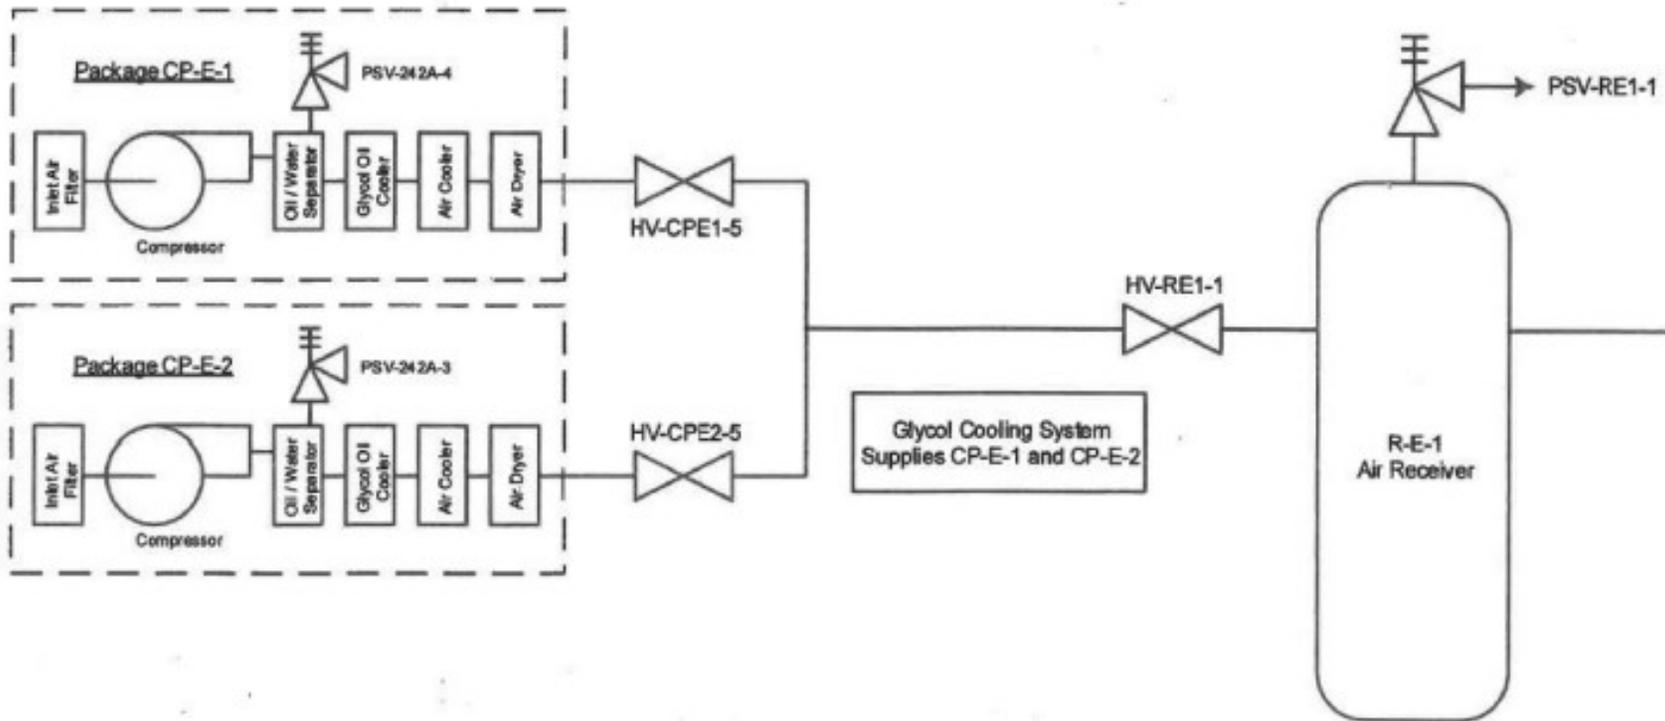
Figure 8. Simplified Schematic Showing the Air Compressors Connection to the Compressed Air System

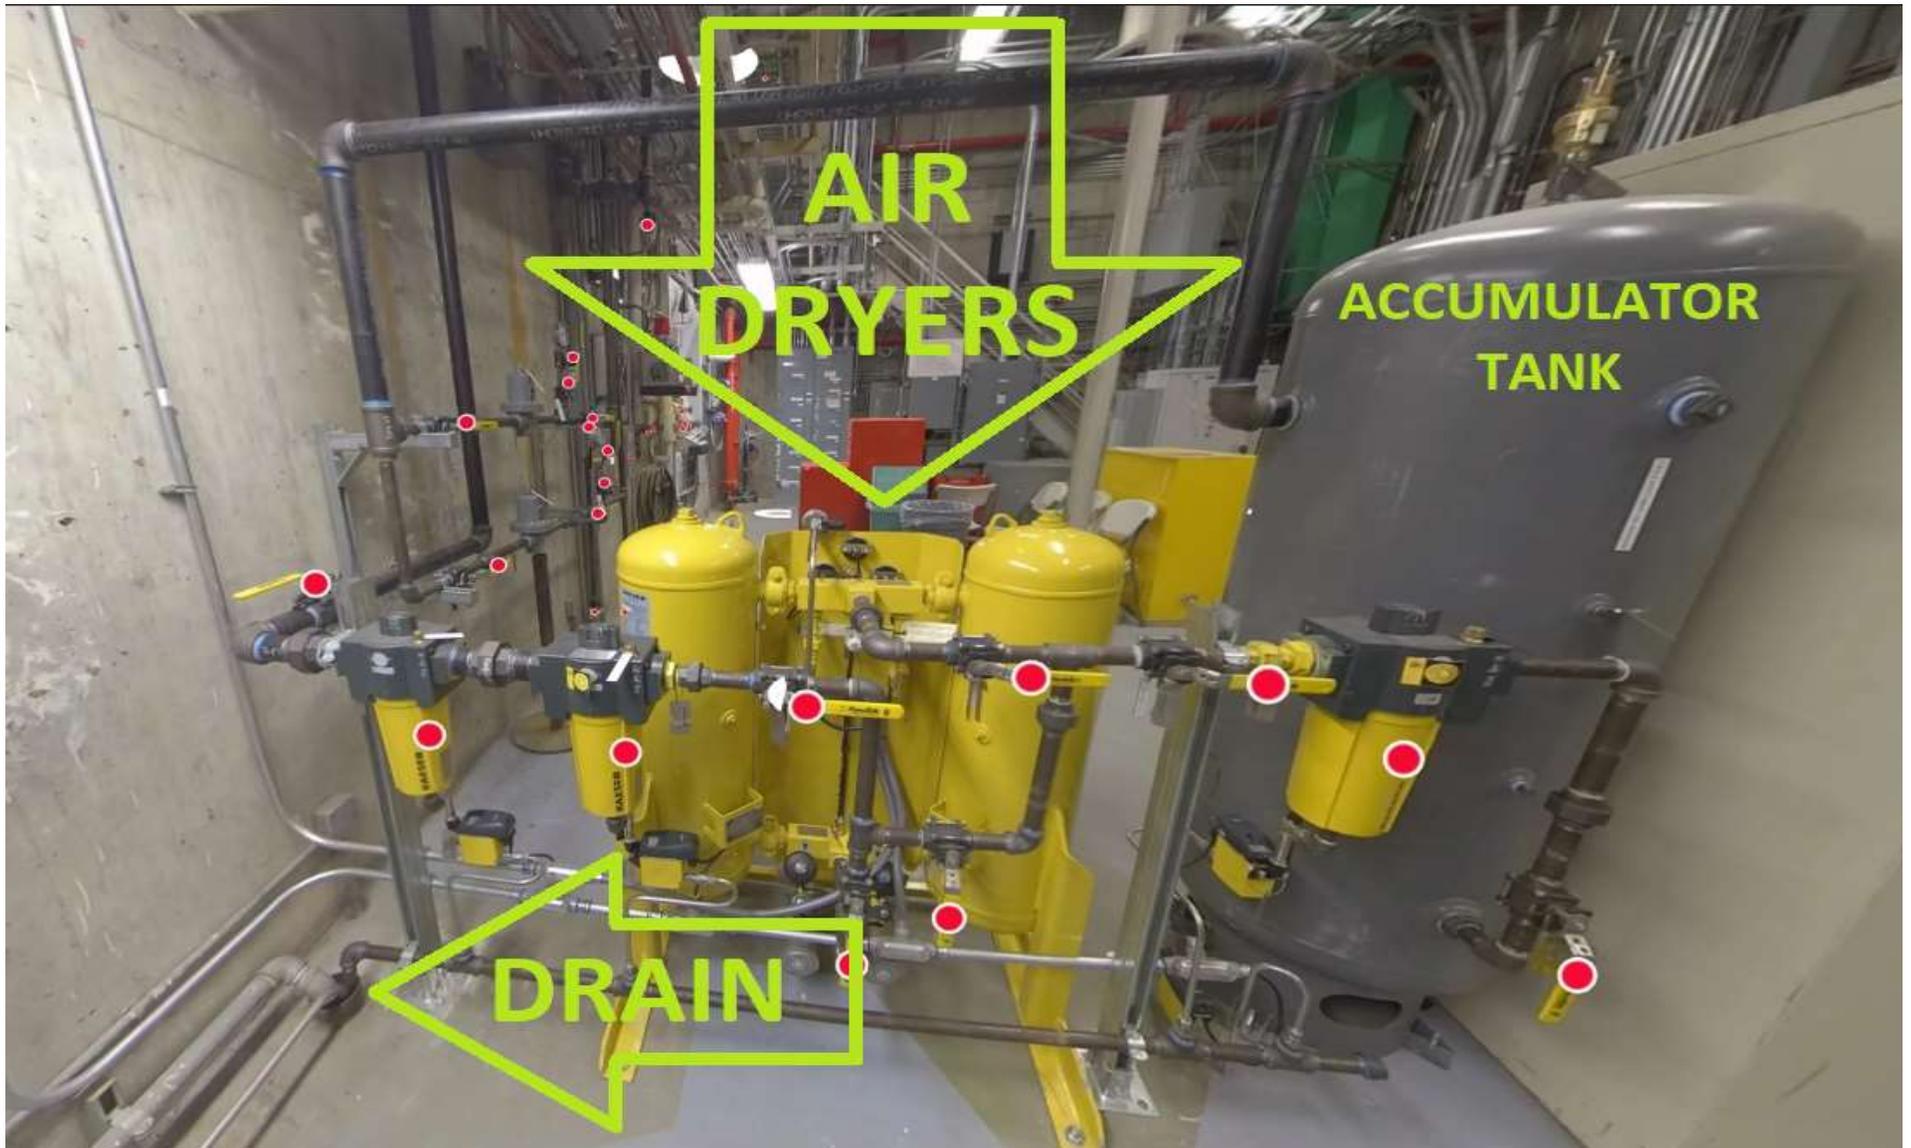
Figure 9. 242-A Service Air Dryer System Overview

The KAESER KAD115-C Air Dryer System consists of a regenerative desiccant dryer (DR-E-1) with a dry air receiver (ECN-715202, RPP-RPT-62735). The air dryer (DR-E-1) is a dual tank air dryer that dries the air in one desiccant tank by adsorbing moisture on the desiccant, while the other tank's desiccant is regenerating utilizing purge air to evaporate the water on the desiccant. The Air Dryer System is set to cycle between these tanks every 10 minutes (KAESER Compressors®, n.d.; PMID-BAS-5606). The air dryer (DR-E-1) is a pressure-swing regenerative desiccant compressed air dryer, with a working pressure range of 60-150 psig (RPP-RPT-62735). The Air Dryer System supplies the 242-A building with pressurized dry air which is needed to support various Evaporator building equipment (PMID-BAS-5606).

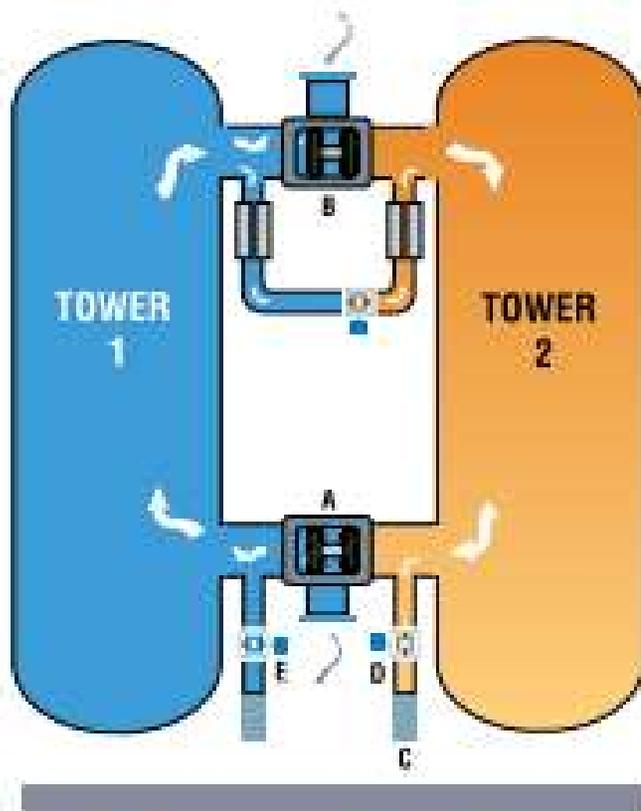
- A Inlet valve
- B Outlet valve
- C Muffler
- D & E Purge valves

Figure 10. KAESER Compressors® Desiccant Dryer Diagram

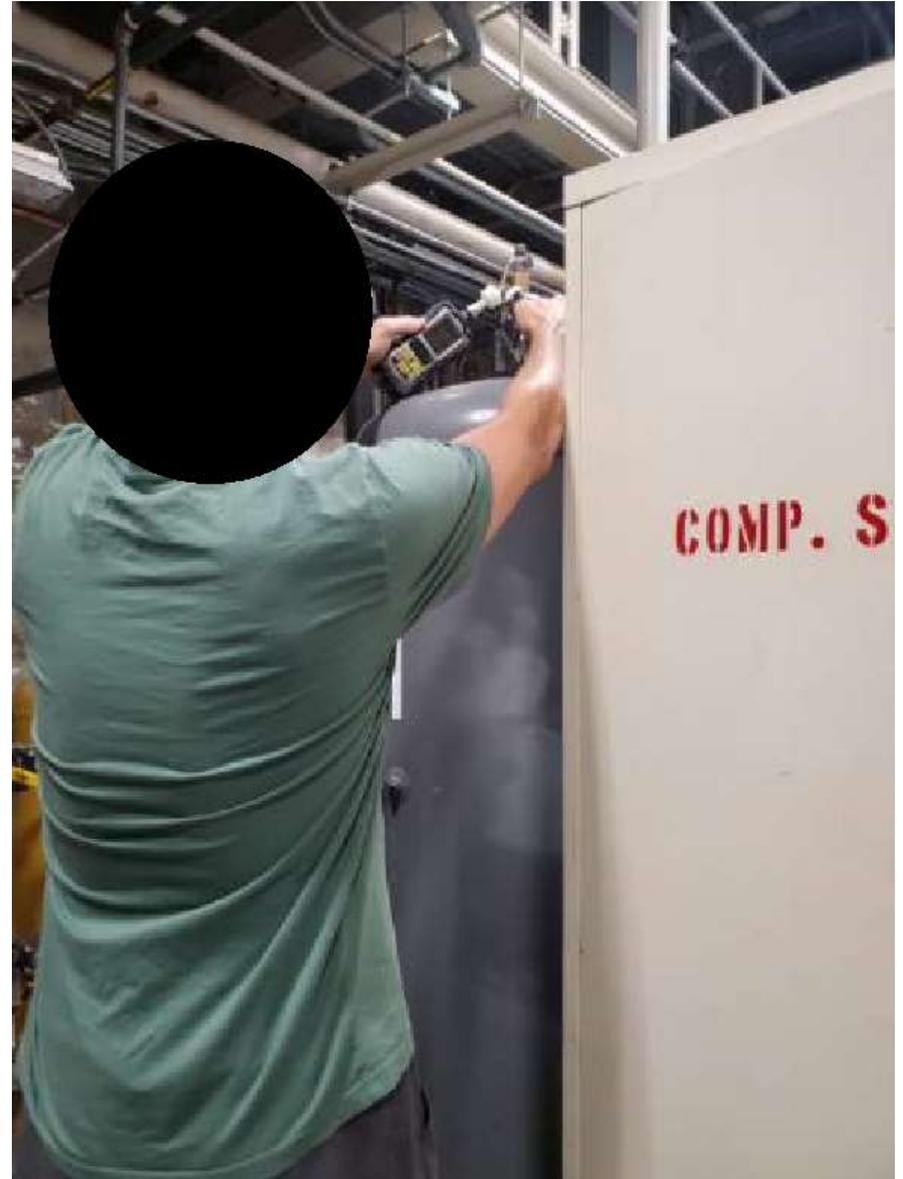
Figure 13. IHT Monitoring Accumulator Tank PRV.

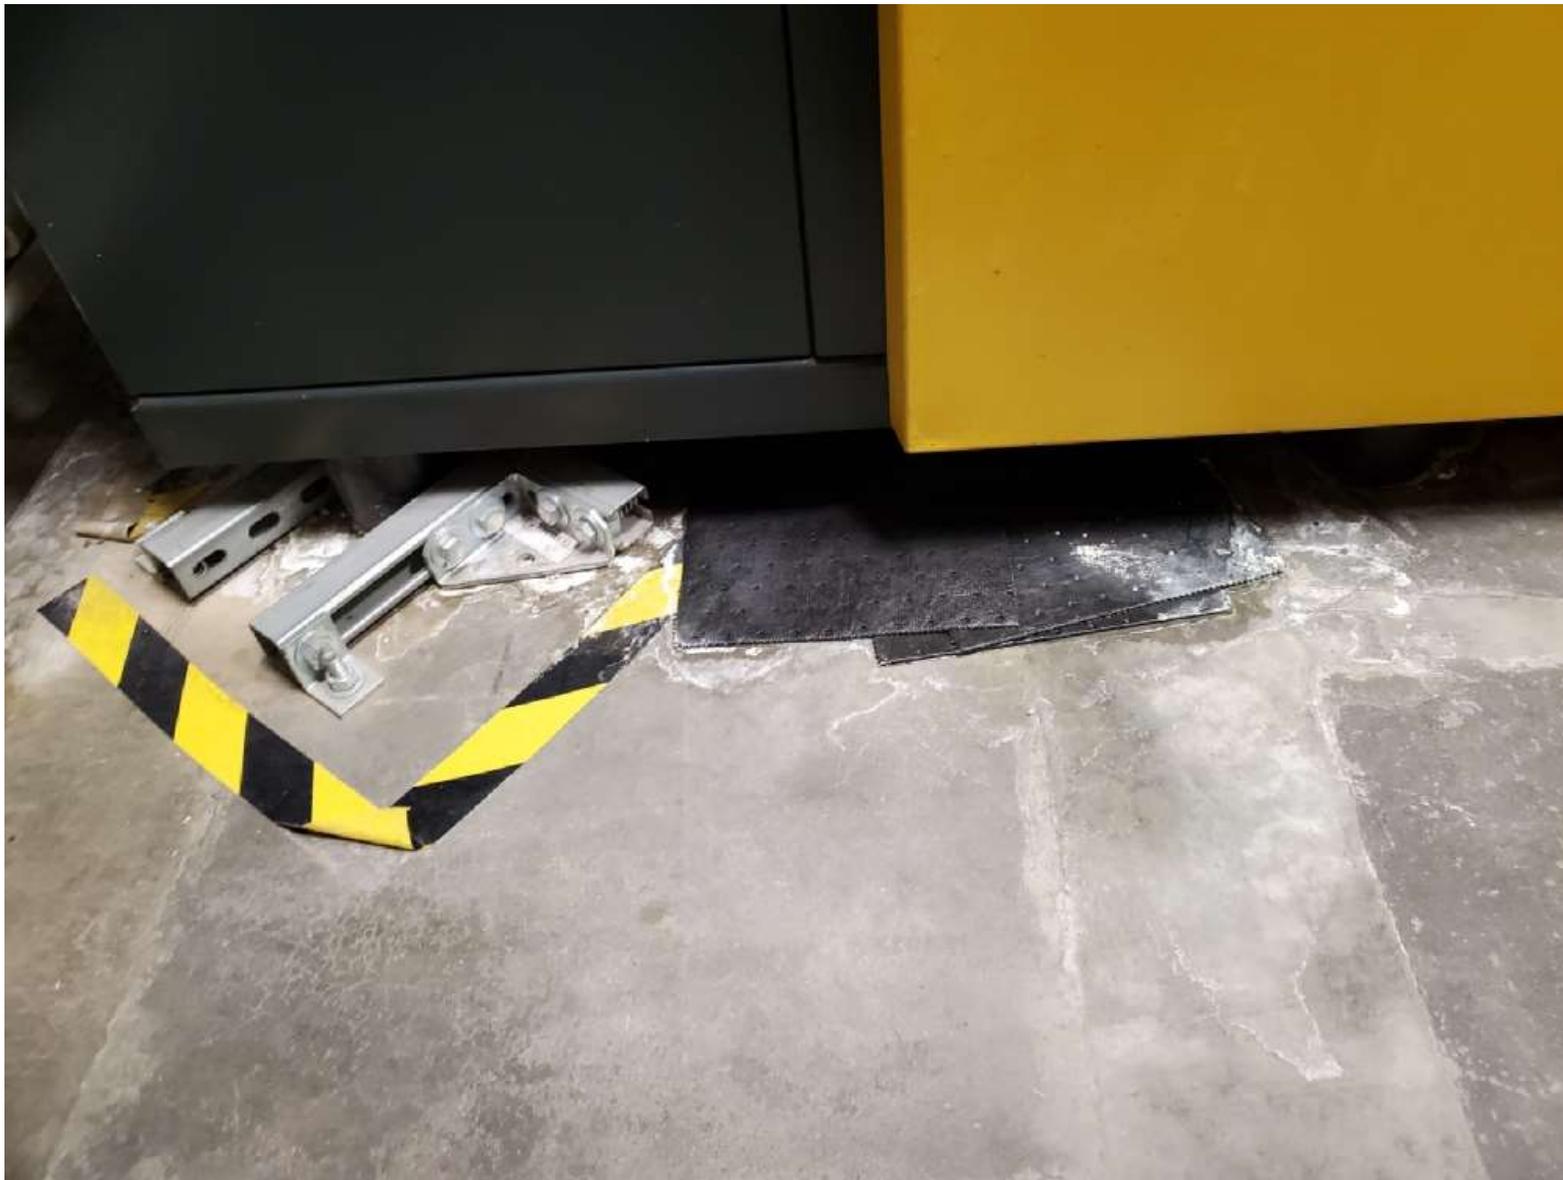
Figure 32. Puddle and Absorbent Mats Under Air Compressor.

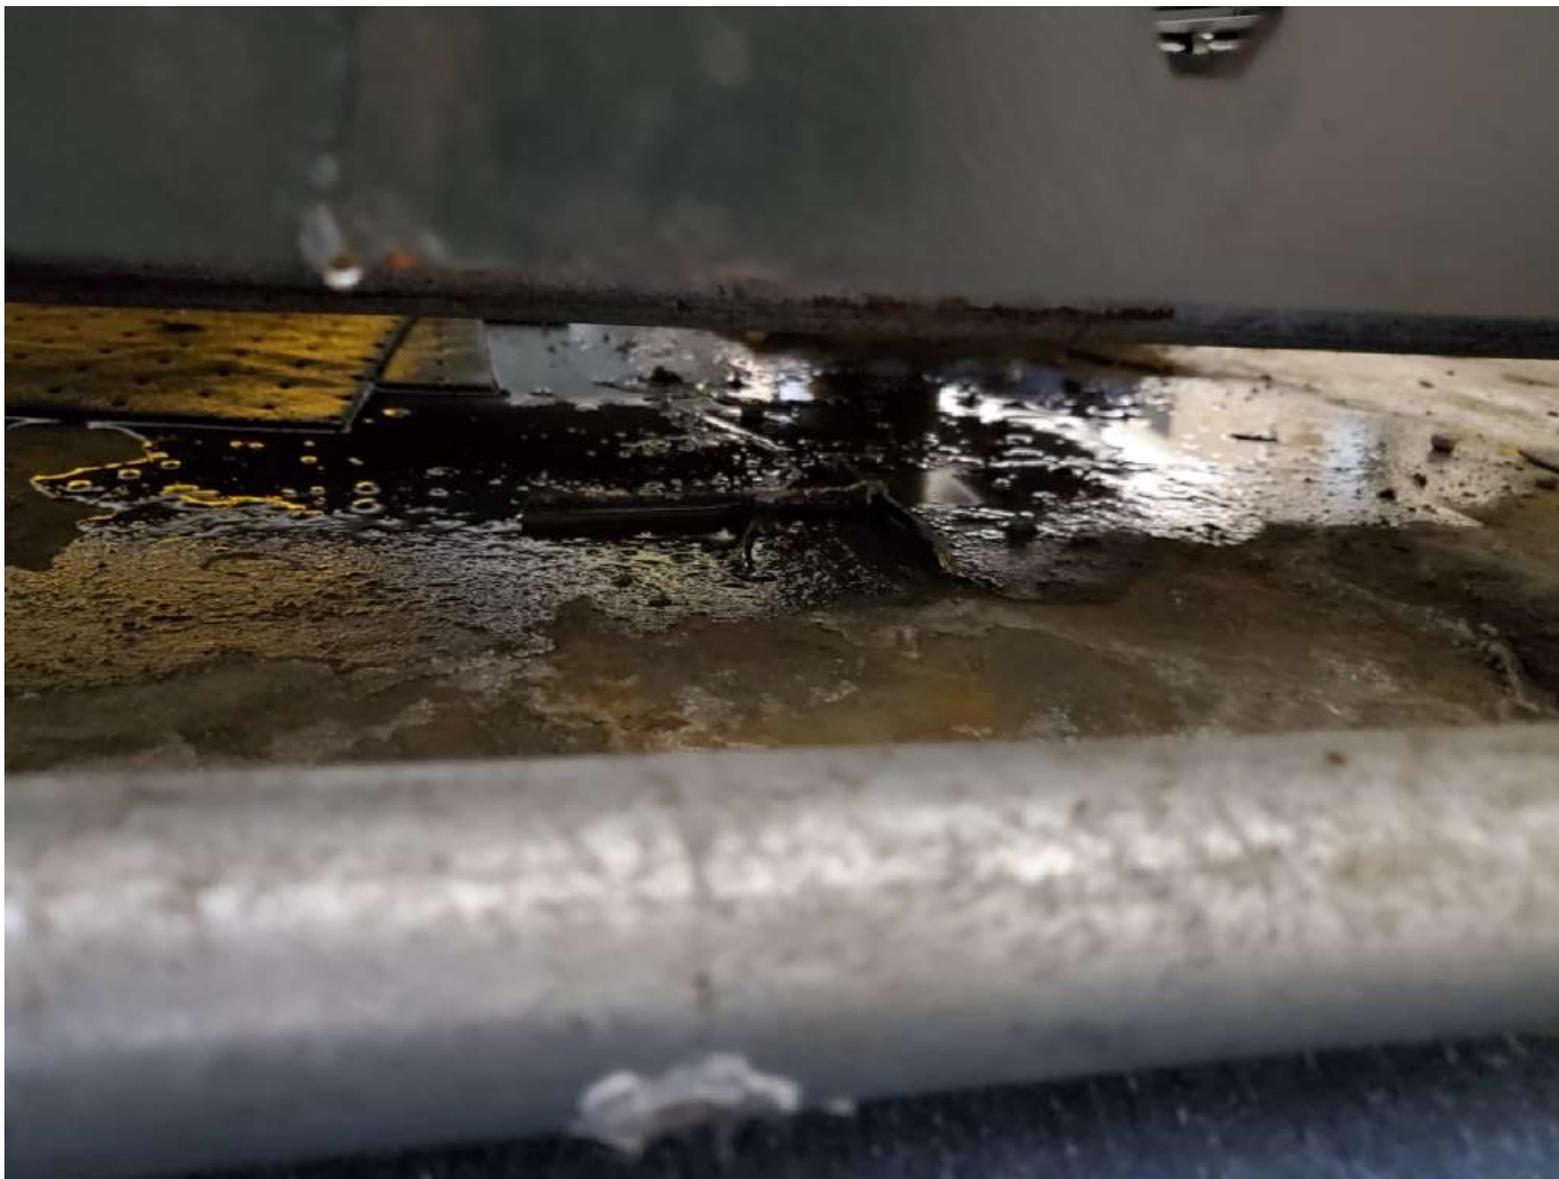
Figure 33. Puddle under Air Compressor.

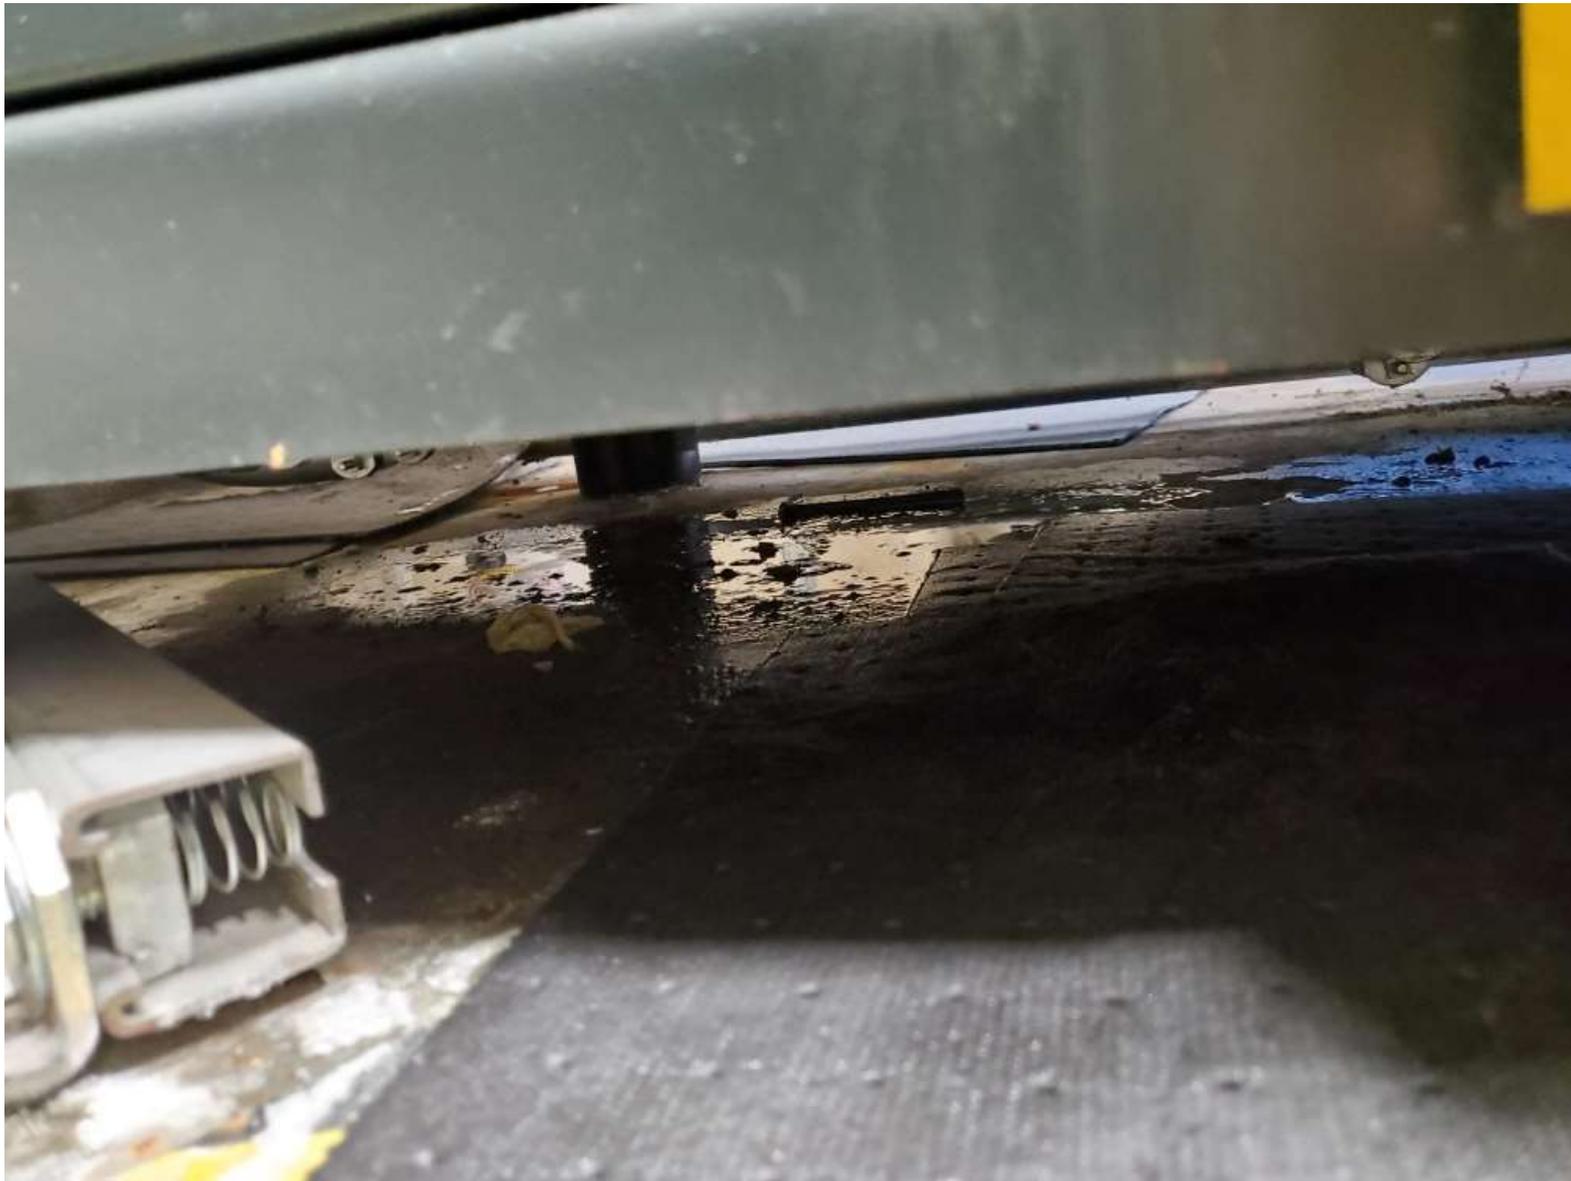
Figure 34. Puddle under Air Compressor.

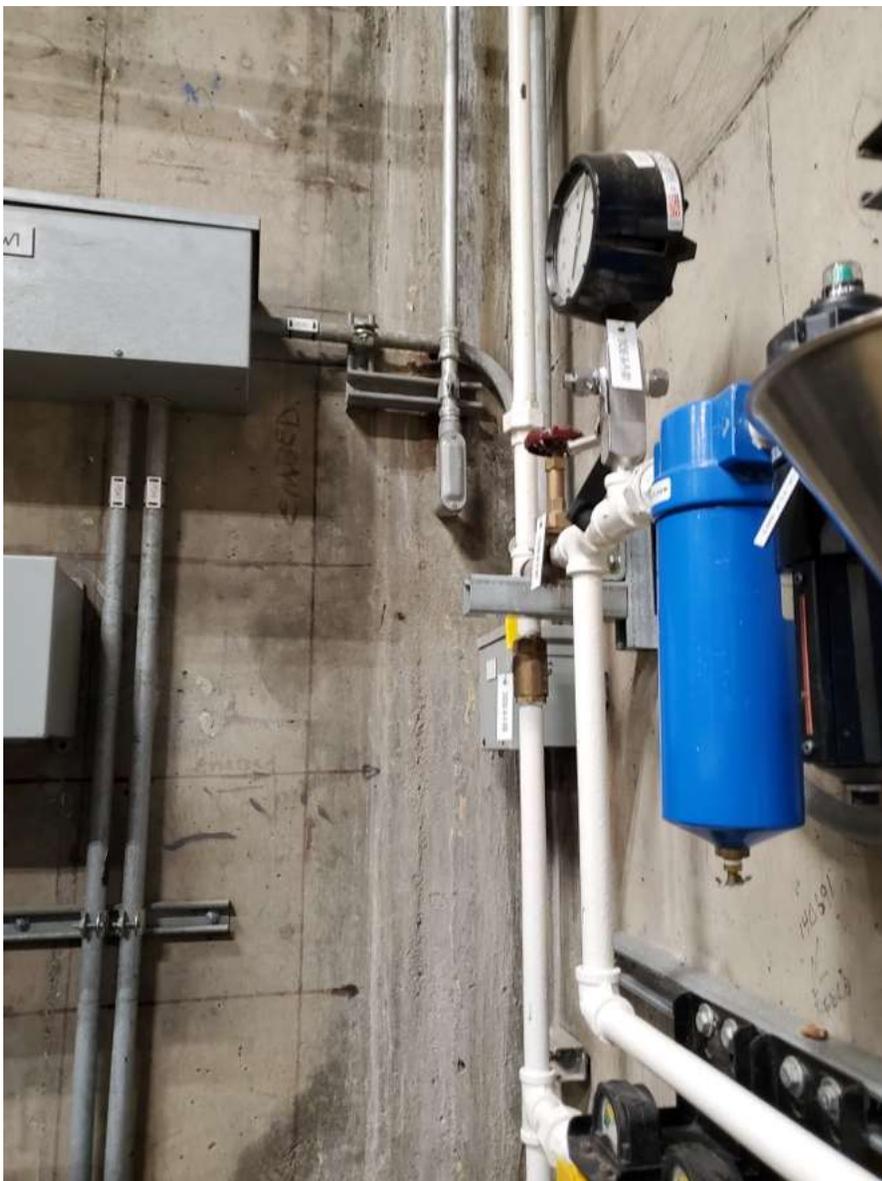
Figure 35. Wall Residue.

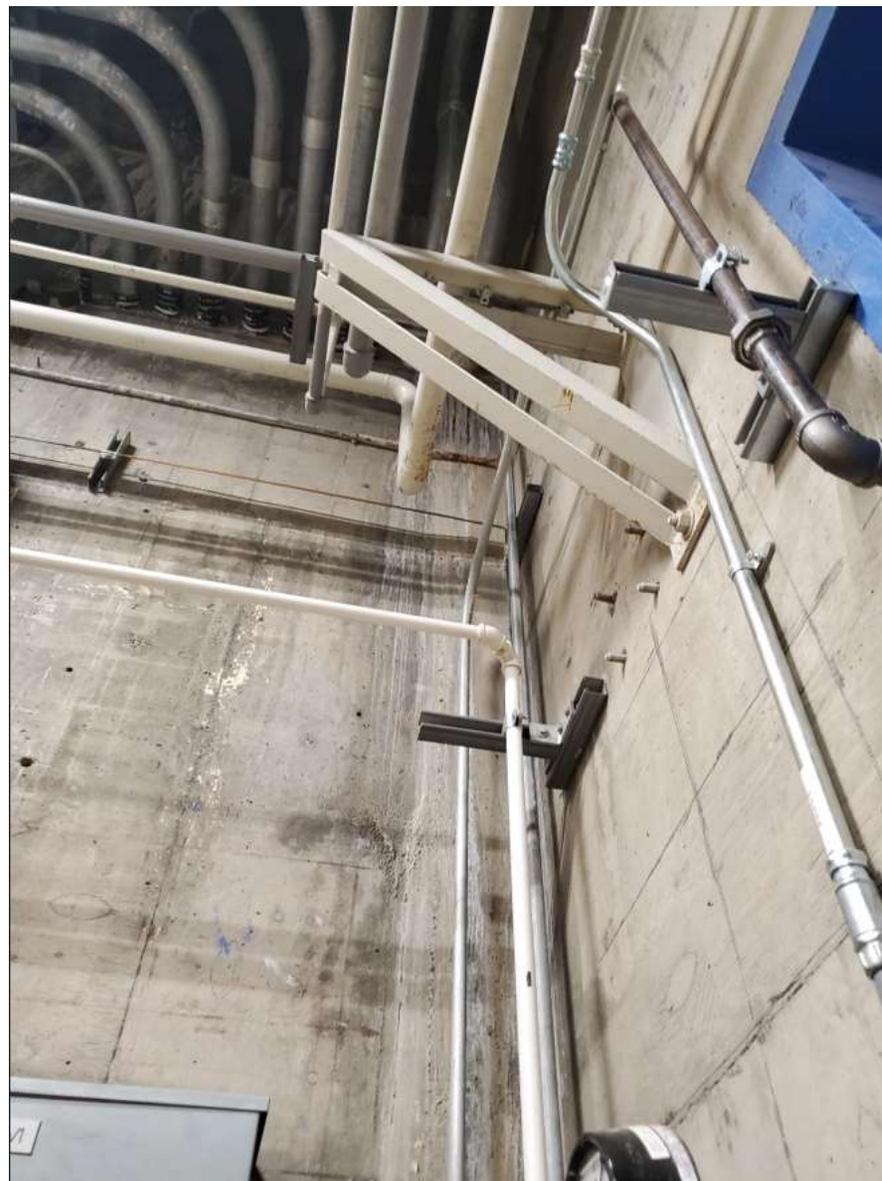
Figure 36. Wall Residue.

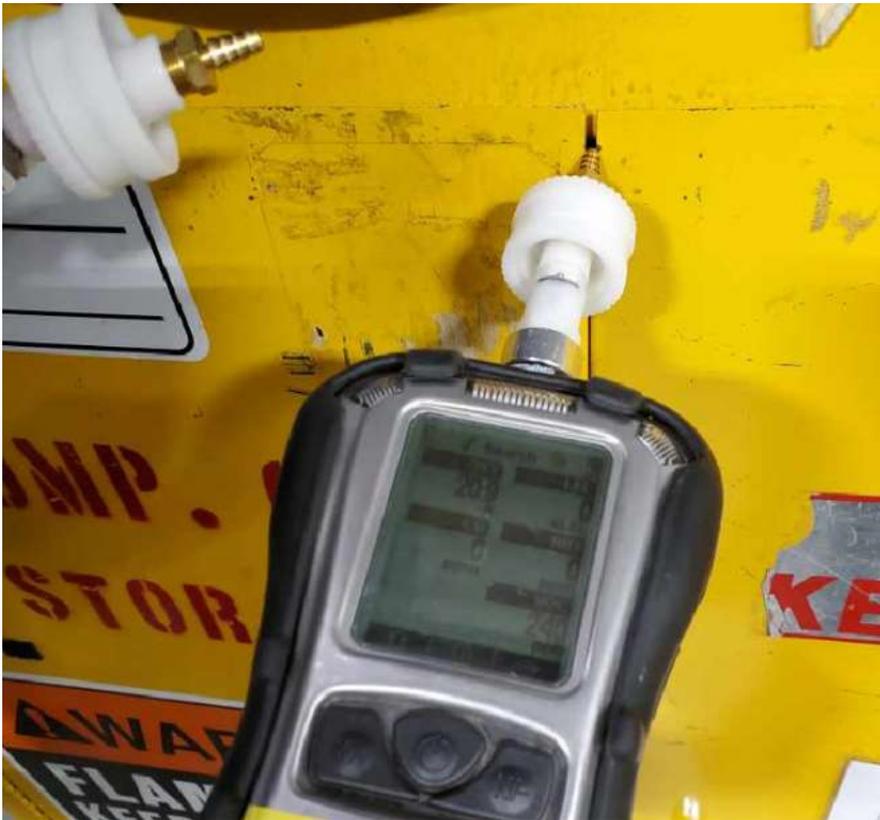
Figure 39. DRI Readings at Flammable Materials Cabinet Threshold.

- Hydrogen Sulfide- Less than detectable (< 0.1 ppm)
 - Ammonia- Less than detectable (< 1 ppm)
 - VOCs- 0.500 ppm at glycol container
 - VOCs- 0.240 ppm at flam cabinet
