C-67 Event Investigation Reports (Redacted) EIR-2023-047 (06/20/2023)

Project: Production Operations Date: 6/20/2023

Area/Building/Location: 200E/242A/AMU Approximate Time of Event: 1239 hours

Event Title: TFC-OPS-OPER-C-67 Response 242A Evaporator AMU	PER Number: N/A
	IHIR Number: IHIR-00075

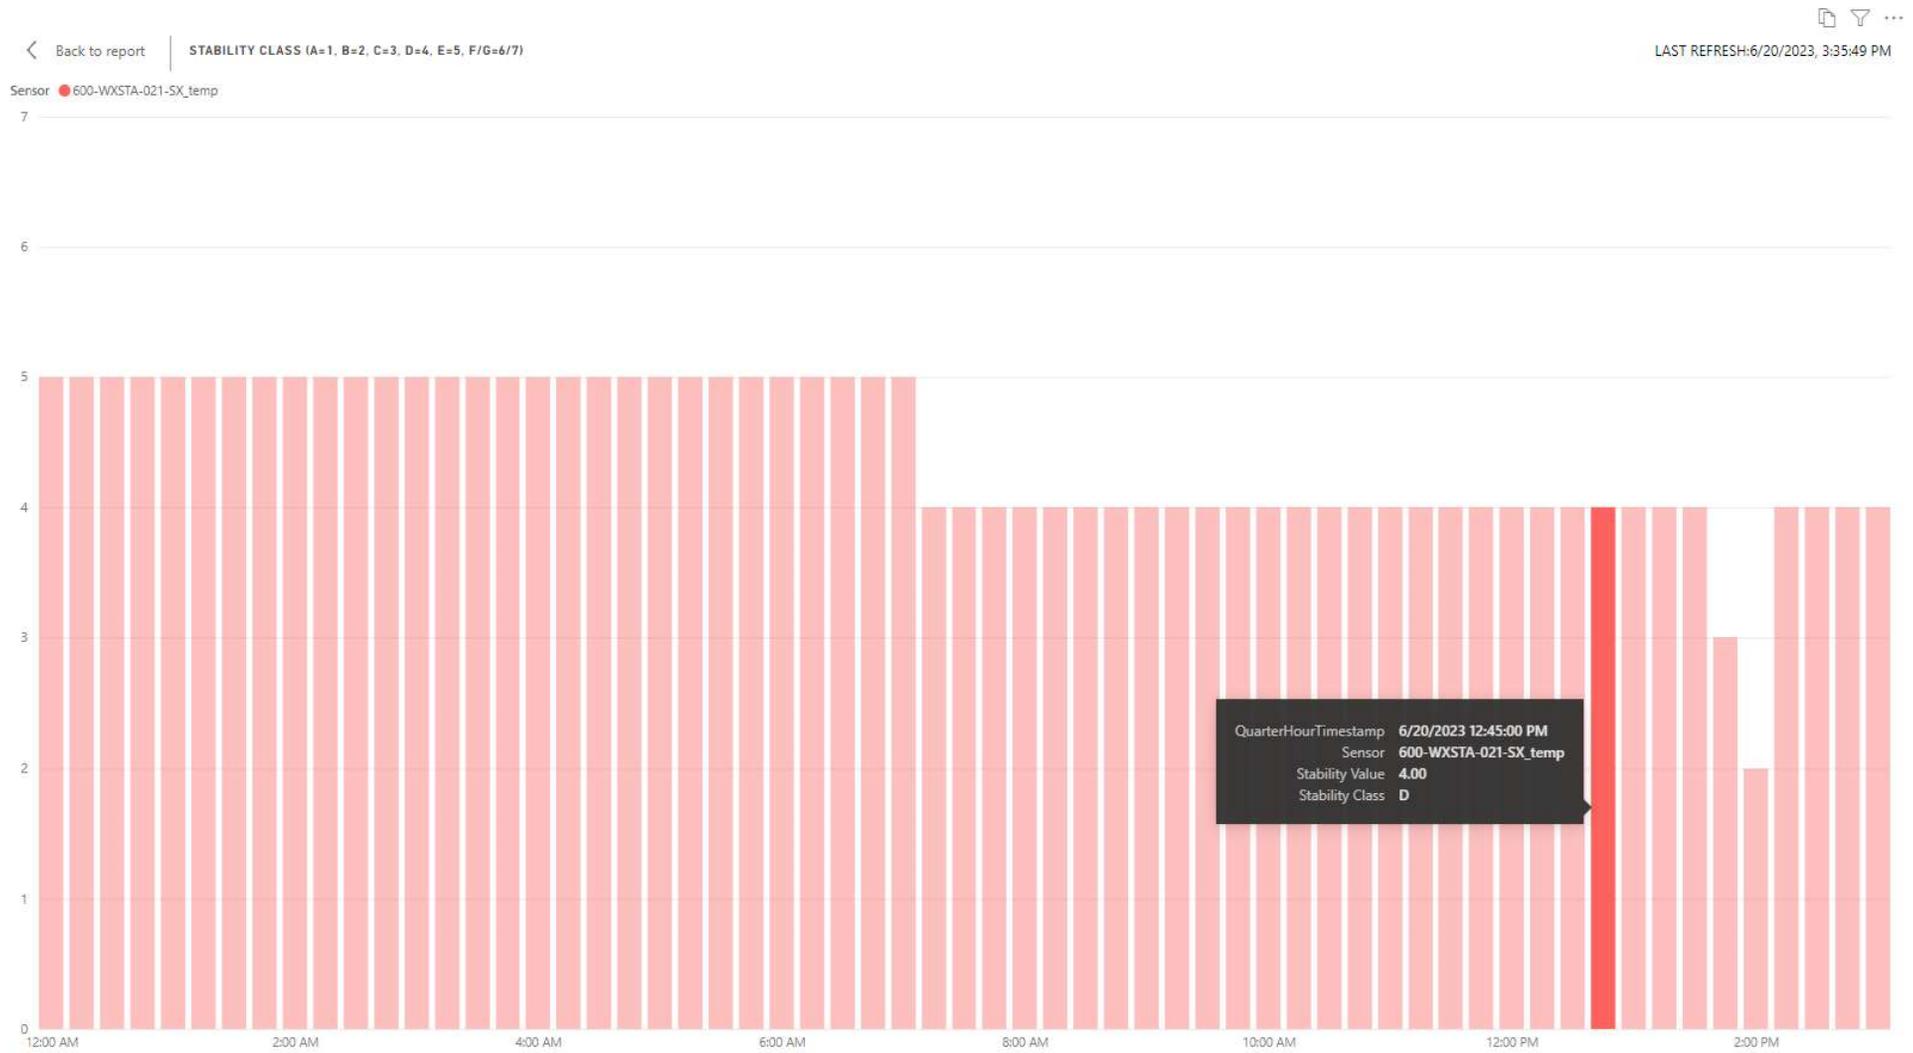
Figure 7. DFAS application, powered by SmartSite™ Weather Data (stability class) from 1245 06/20/2023.

- Wind Speed: 11.5 mph
- Wind Direction: 159° (out of South Southeast)
- Mixing Height: 1500 feet above grade
- Stability Class: D (neutral conditions)

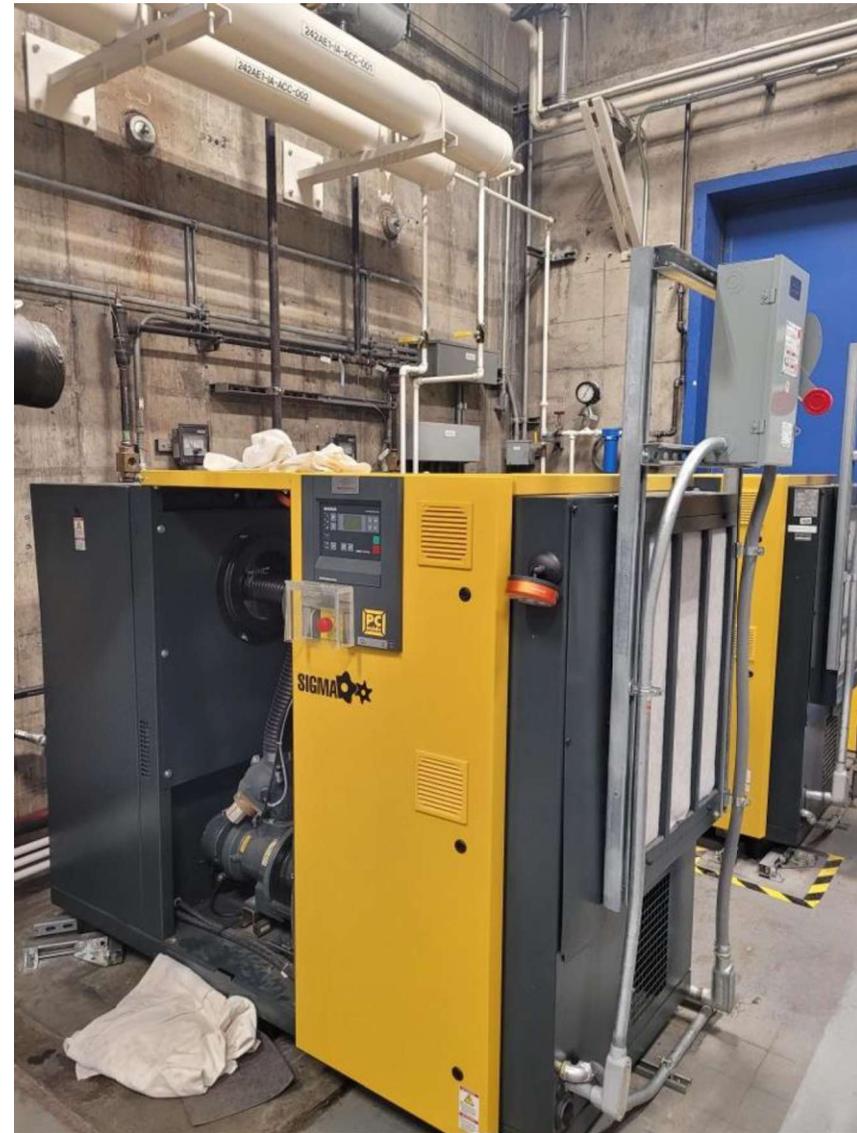
Figure 14. AMU Air Compressor Maintenance ongoing.

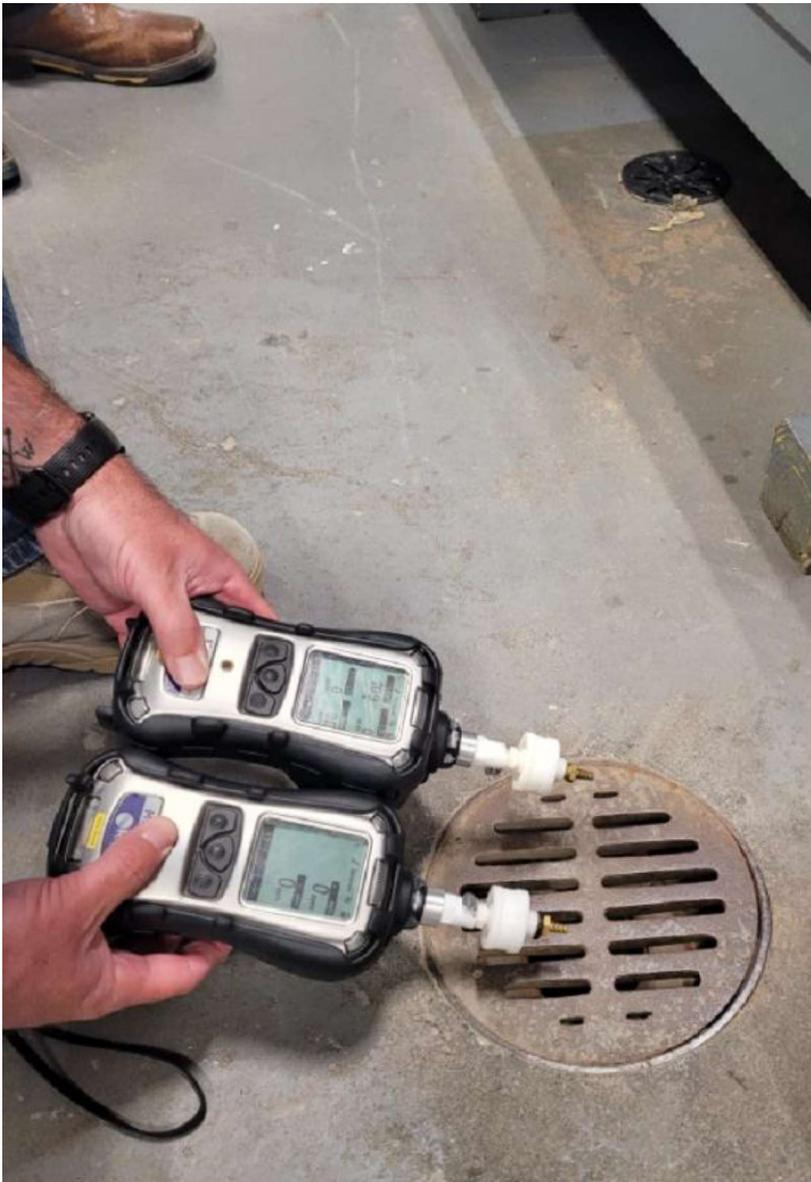
Figure 15. IHT Monitoring 242-A AMU Drain.

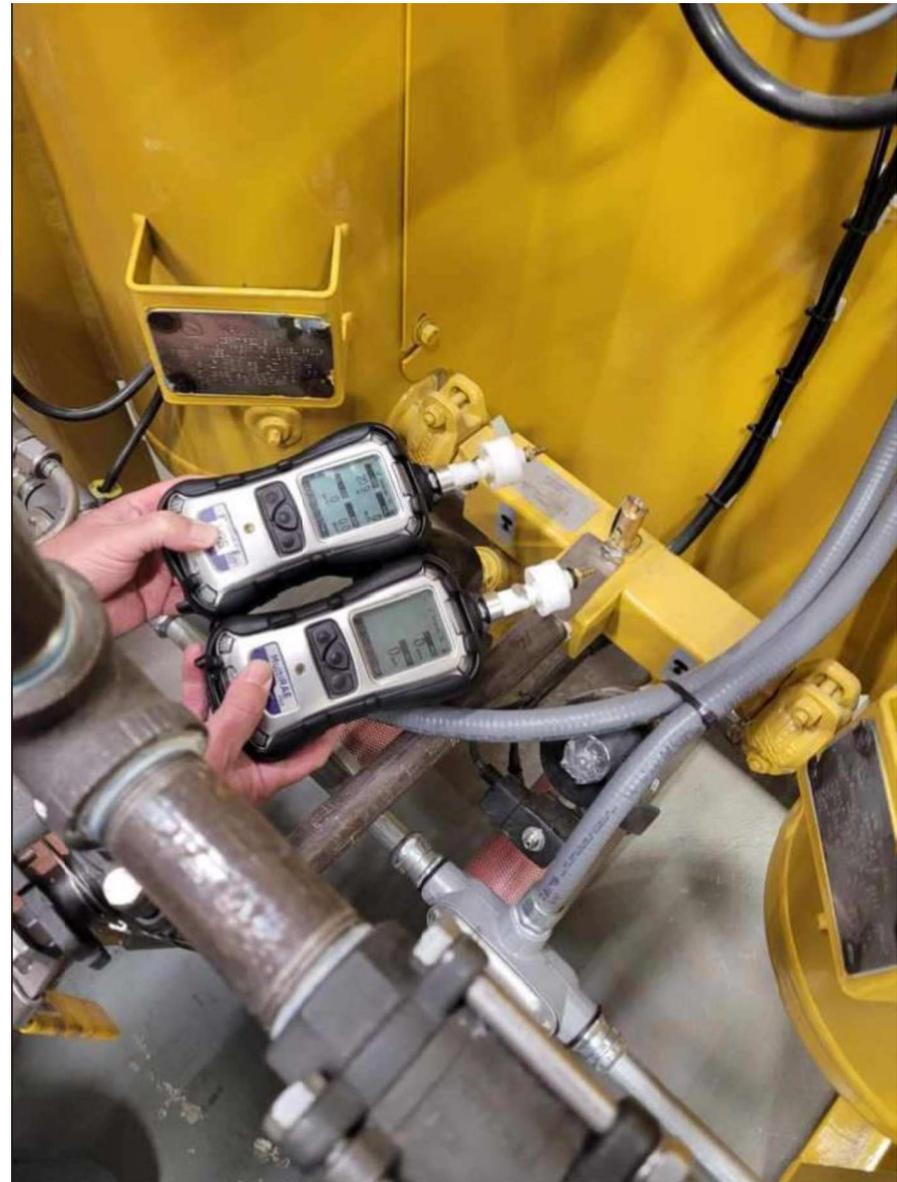
(1) IH personnel performing TFC-OPS-OPER-C-67 Response Actions noted a definitive sulfur smell, consistent with the Affected Workers' odor descriptors, when the Air-Dryer purge valve (PSV-DREL-1)

released. The Air Dryer System supplies the 242-A building with pressurized dry air, which is needed to support various Evaporator building equipment, and is set to cycle between dual tanks every 10 minutes. Similarly, HMIS Riggers reported experiencing "rotten egg" odors in the 242A AMU Room on 05/31/2023 that were coincident with activation of an air dryer pop-off valve. IH personnel performing odor investigation and TFC-OPS-OPER-C-67 response actions for the 05/31/2023 event occurrence also noted a brief "rotten-egg" odor every time the air dryer relief valve activated, which occurred about 4 times during field response actions.

Figure 16. IHT Monitoring Air-Dryer Purge Valve.

- Evaluate the 242A Evaporator AMU Room's KAESER KAD115-C Air Dryer System operability/effectiveness.
- Communicate the expected conditions encountered during the 242A Evaporator AMU Room's KAESER KAD115-C Air Dryer System Purge Valve release to the 242A Evaporator Facility Personnel.

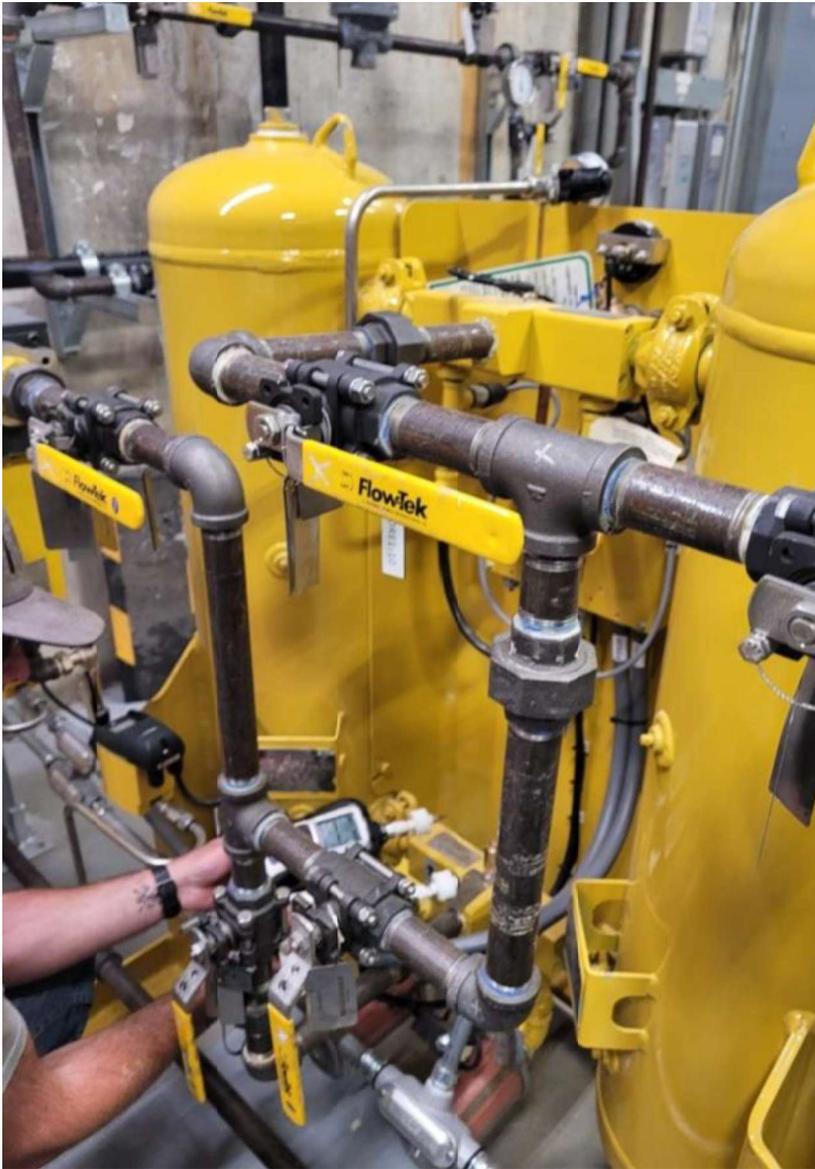
Figure 17. IHT Monitoring Air-Dryer Purge Valve.

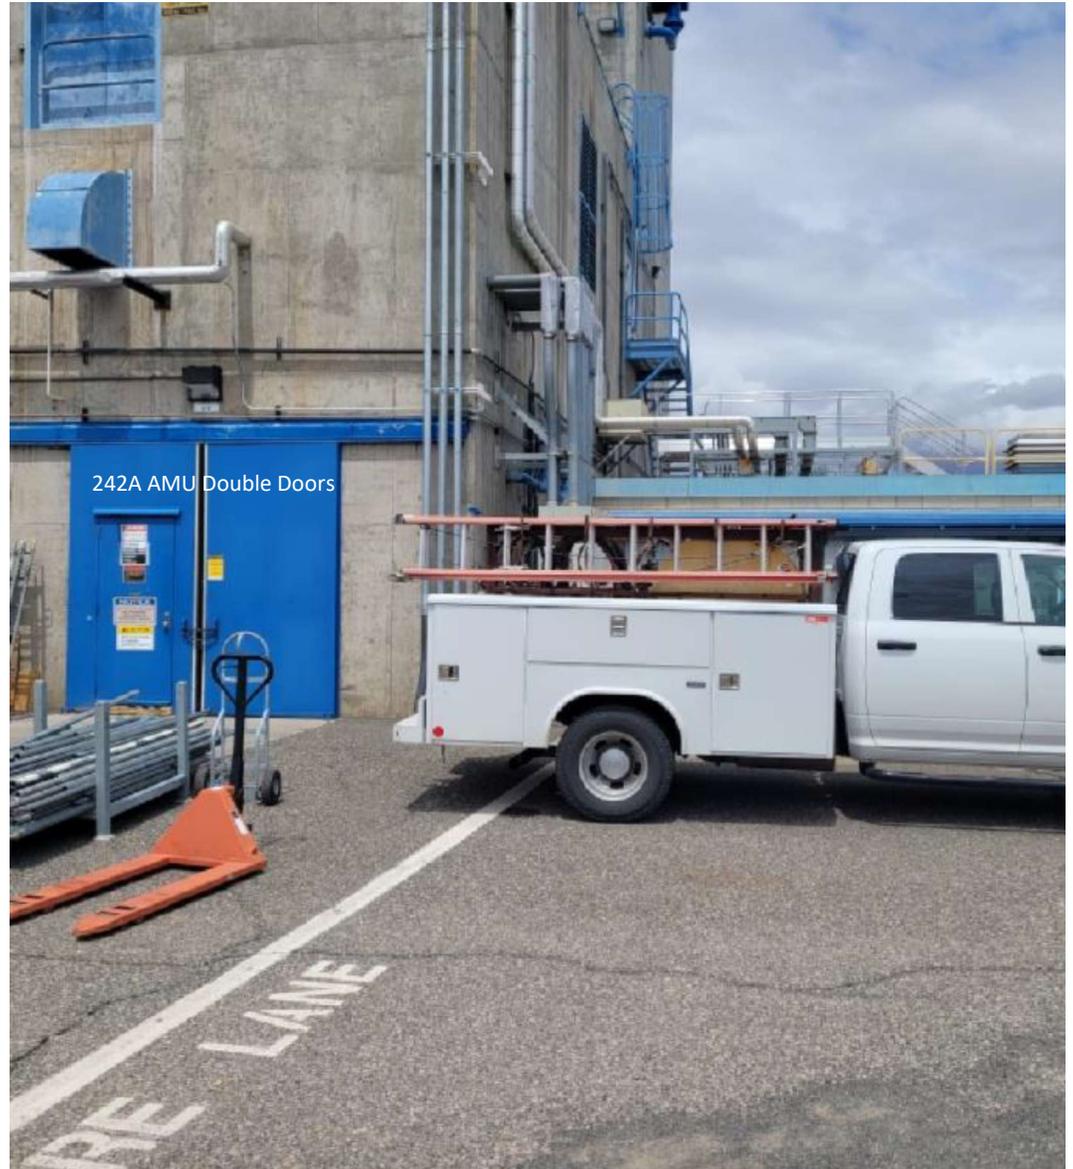
Figure 18. Vehicle idling outside of 242-A AMU exterior doors.
