# **C-67 Event Investigation Reports (Redacted) EIR-2024-028 C-67 (03/27/2024)**

3. **Investigation Title:** Odor Event at 2025EA

4. **Investigation Report Number:** EIR-2024-028

7. **Area / Building / Location:** 200E/2025EA/LUNCHROOM

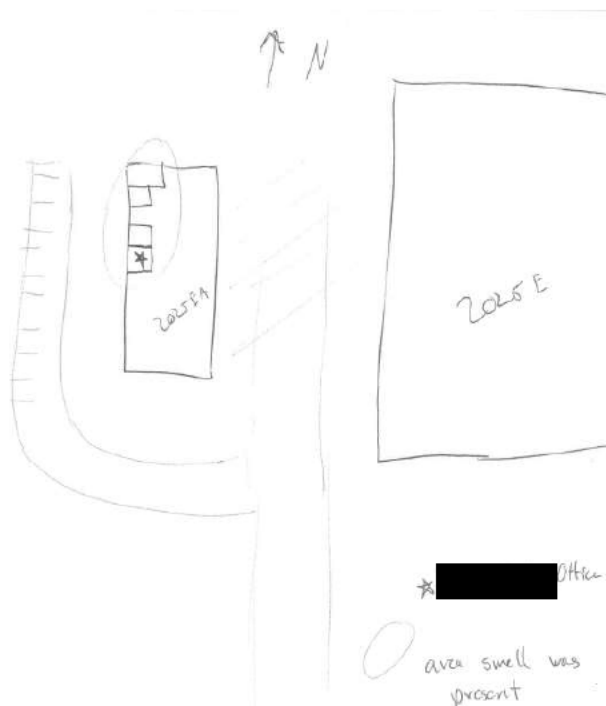
Figure 6. Affected Worker's OVRC Map.

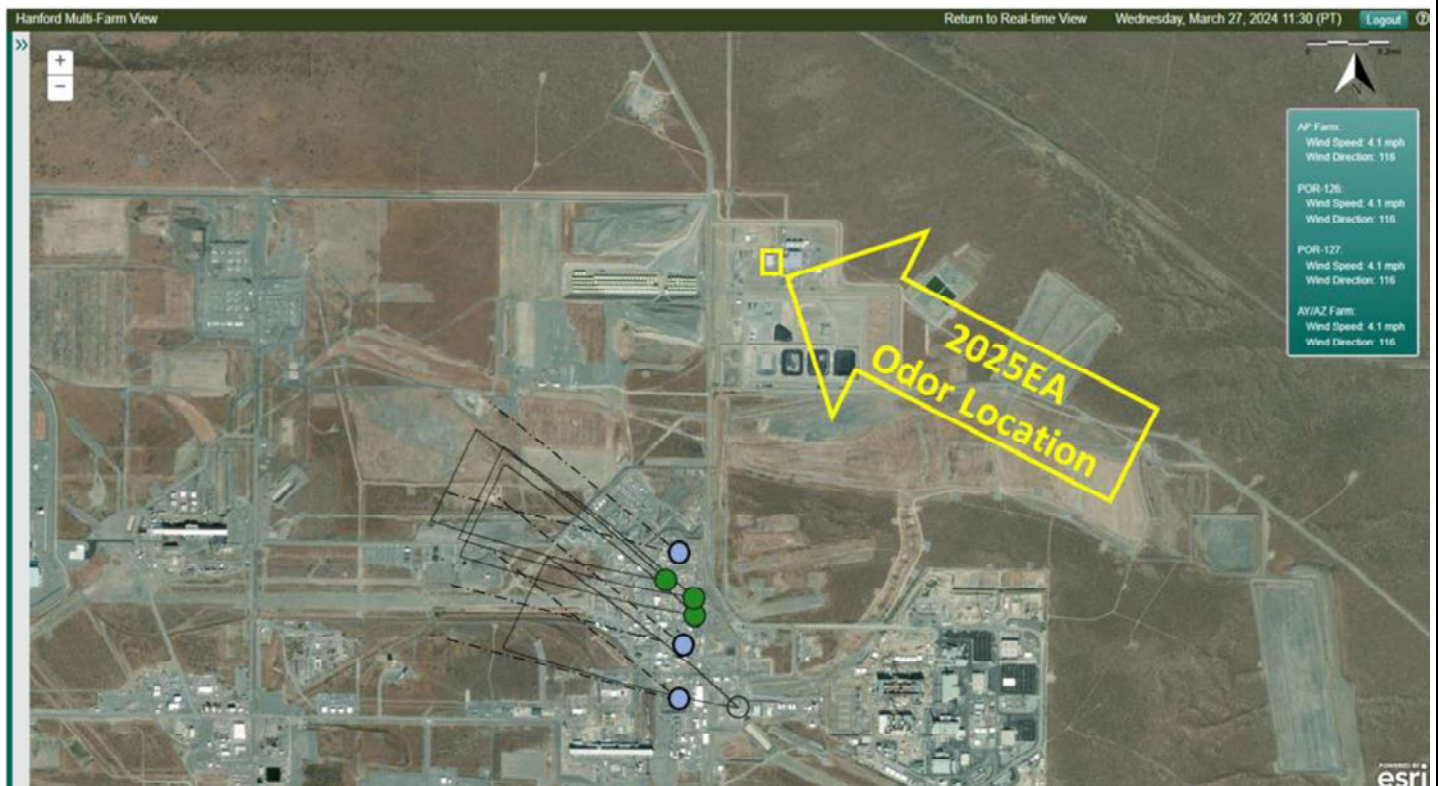
Figure 7. 200-East Area (with 241-AW, 241-AP, 241-AN, 241-AY/AZ, 241-AX, 241-A Farm projected plume models) at 1130 03/27/2024 from Data Fusion and Advisory System (DFAS) application, powered by SmartSite™.

NOTE: 241-AN, 241-A, 241-AW Farm Exhausters are not connected to the DFAS; however, an approximate exhauster plume was added for each based on other modeled plumes.

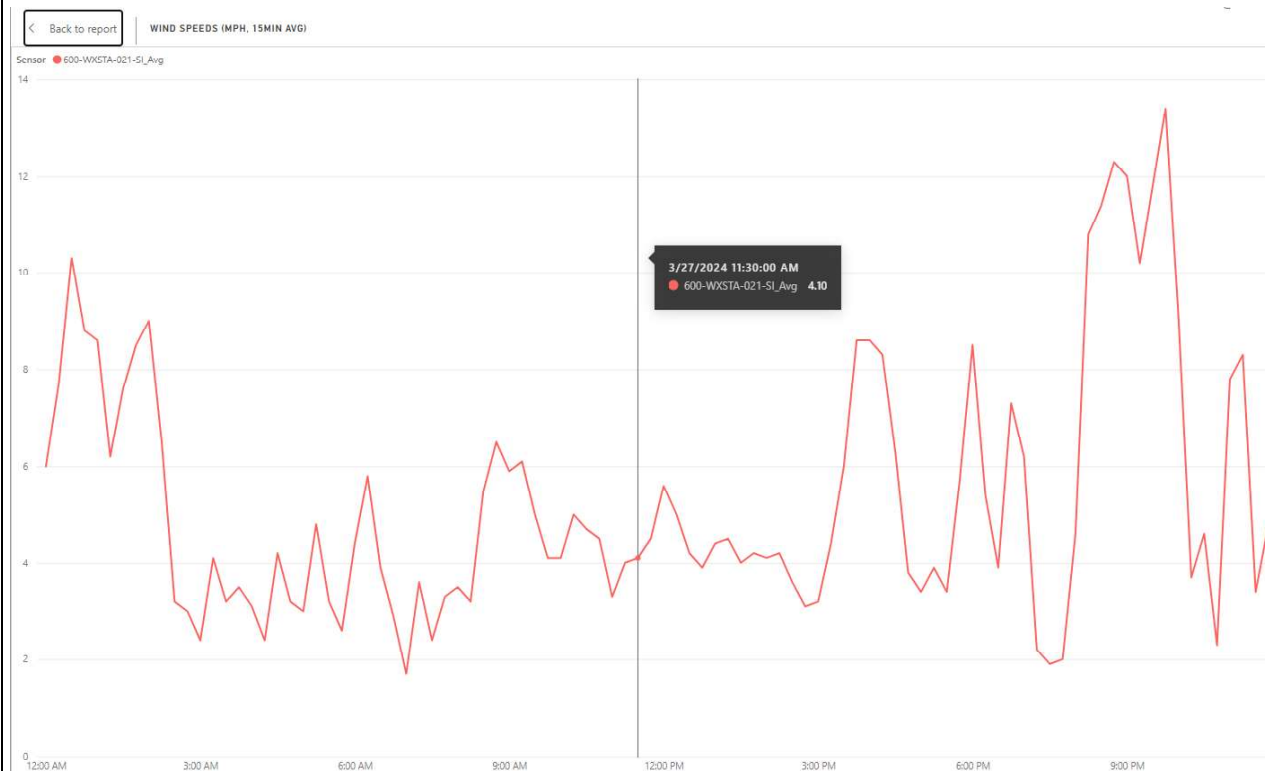
Figure 9. DFAS application, powered by SmartSite™ Weather Data (wind speed) from 1130 03/27/2024.
