# **C-67 Event Investigation Reports (Redacted) EIR-2024-066 C-67 (08/20/2024)**

3. Investigation Title: C-67 Odors at 242-S

4. Investigation Report Number: EIR-2024-066

7. Area / Building / Location: 200W/242S Evaporator Roof

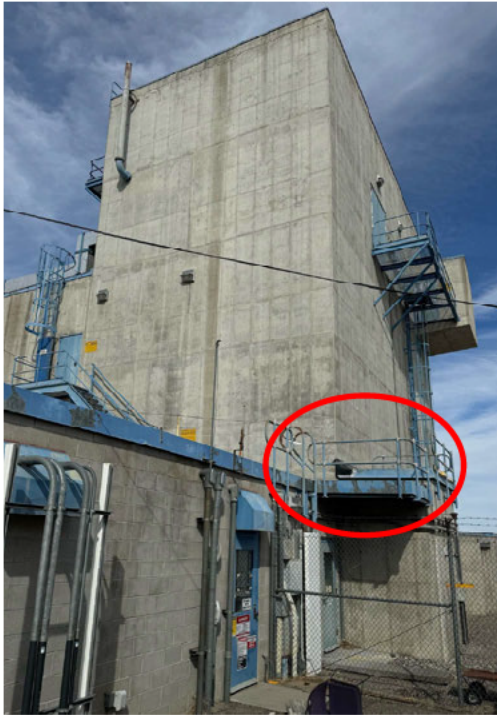
Picture 1-Location on 242S Evaporator Roof

The 242S Evaporator is located at 241-S-Farm in the 200 West Area of the Hanford site. The odor was smelled while the workers were on the 242S Evaporator roof when the IX column hatch was opened.

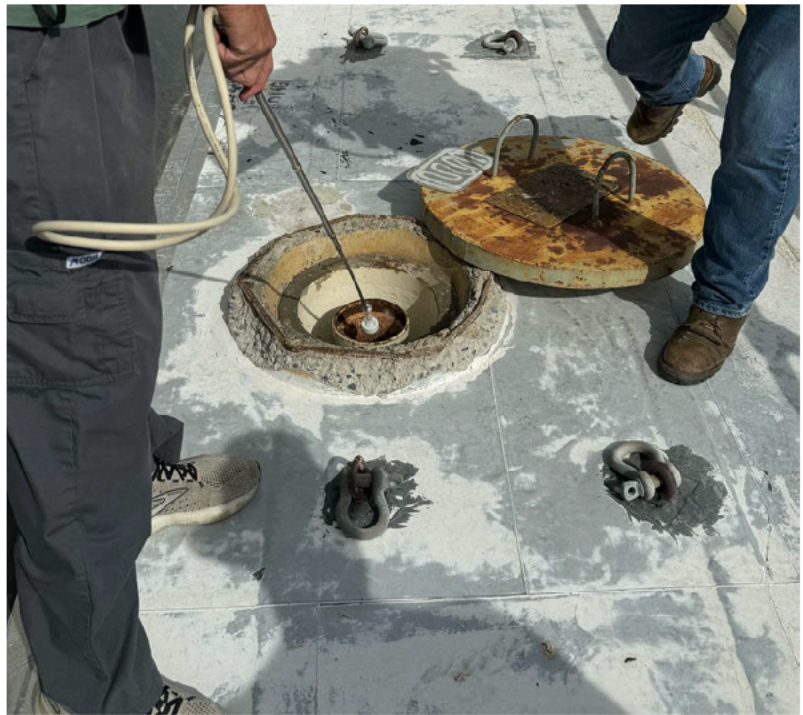
Picture 2-IHT Monitoring of Open Lid and Pipe Chamber

At approximately 1335 hours, the hatch was again opened (valve remained closed) and the IHT performed direct reading instrument (DRI) monitoring directly above the open chamber (see Pictures 1 & 2).

- o Ammonia - 6 parts per million (ppm)
- o Volatile Organic Compounds (VOCs) - 330 parts per billion (ppb)

The IHT reported that the ammonia levels dissipated to 0 ppm quickly after the peak reading. The IHT took readings of the Breathing Zone (BZ) of the NCO and the RCT. There were no detectable levels of ammonia or VOCs in the BZ.

Operations has requested that Industrial Hygiene create a sampling plan to further investigate what is causing the odors in the pipe chamber.

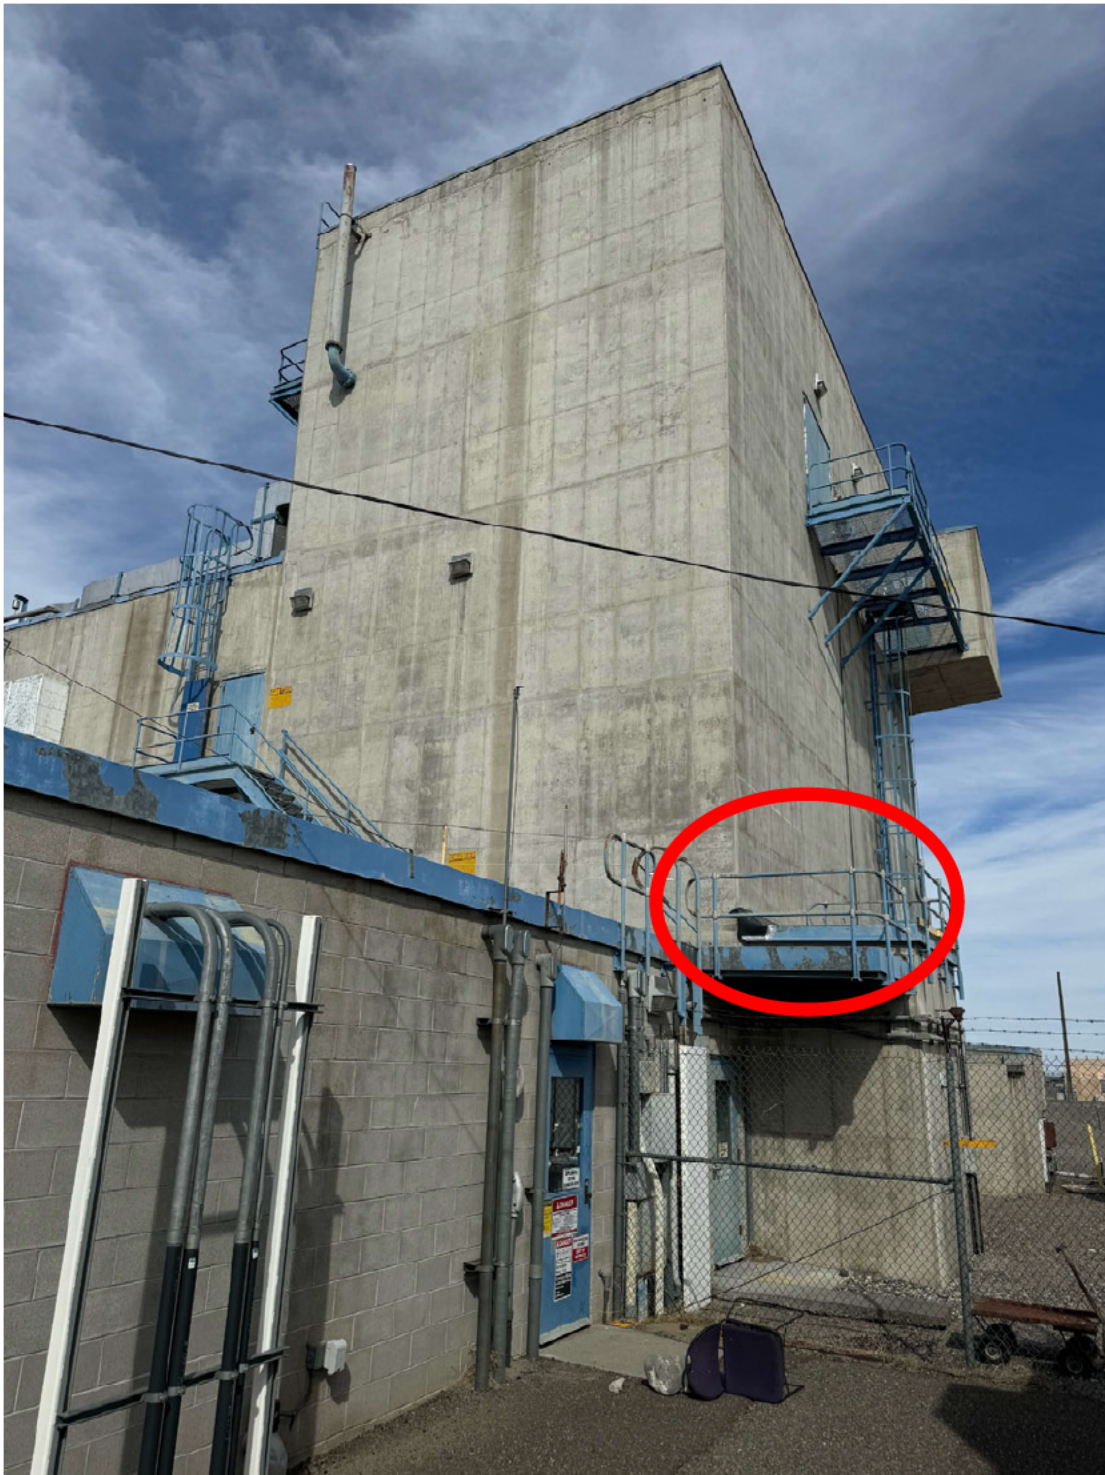
Figure 1. 242S Evaporator south side roof where odor event occurred.

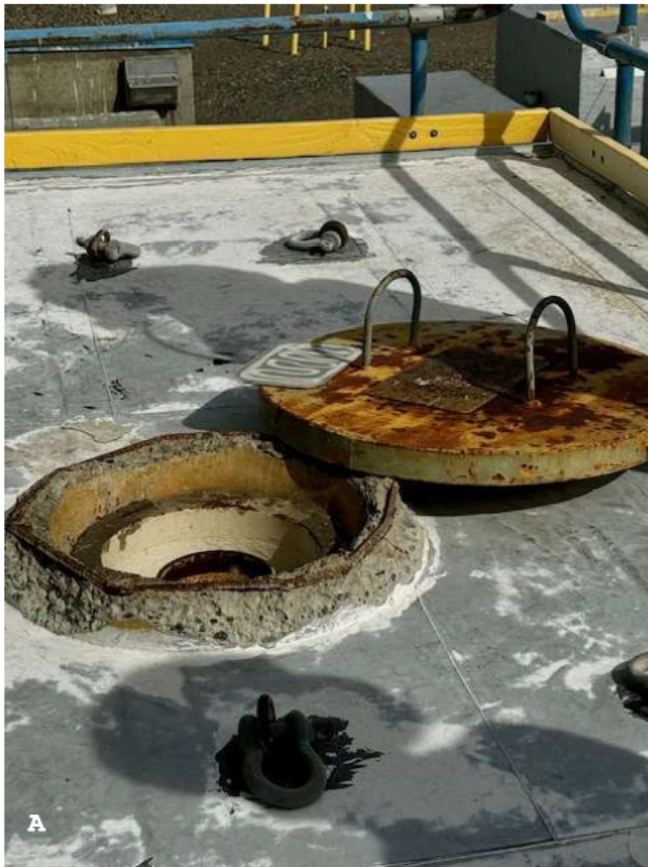
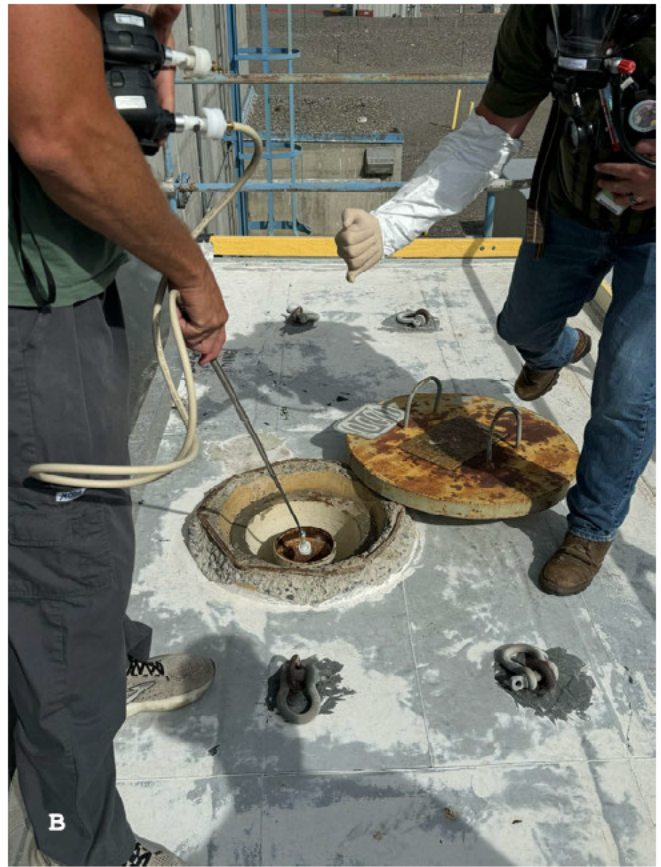
DRI monitoring at 242S rooftop pipe chamber with lid open and valve in closed position. No odors noted by Response Team at the general building area or on the roof at the time of monitoring.

Figure 2. Photographs showing open lid and pipe chamber (A) and IHT monitoring (B).

Based on the facts that there was no odor detected prior to opening the lid of the pipe chamber, that the odor was detected once the chamber was opened, and increased with the opening of the valve, and dissipated with the closure of the valve, it can be concluded that the source of the odor was the pipe chamber. Further investigation of the contents of the pipe chamber and connected systems in 242S is recommended.
