Hanford Tank Waste Operations & Closure
EVENT REPORT FORM

1. Project: Facility Maintenance 2. Report Date: 10/9/2025
3. Investigation Title: C-67 Response at MO-531
4. Investigation Report Number: EIR-2026-001
5. Responsible Manager: [REDACTED]
6. Event Investigator: [REDACTED]
7. Area / Building / Location: MO-531
8. Date and Approximate Time of Event: Date: 10/7/2025 Time (military): 1258 hours
9. Associated Action Request (AR) Number: ITDC-AR-2026-0072
10. Associated Occurrence Report Number (if applicable): NA
11. Event Learning Meeting Held: Yes [] or No [X] Date: _____ Time (military): _____

INDUSTRIAL HYGIENE EVENT INVESTIGATION REPORT (IHIR)

Event Title: TFC-OPS-OPER-C-67 Response at MO531	IHIR Number: IHIR-00126
	IHEI Number: N/A

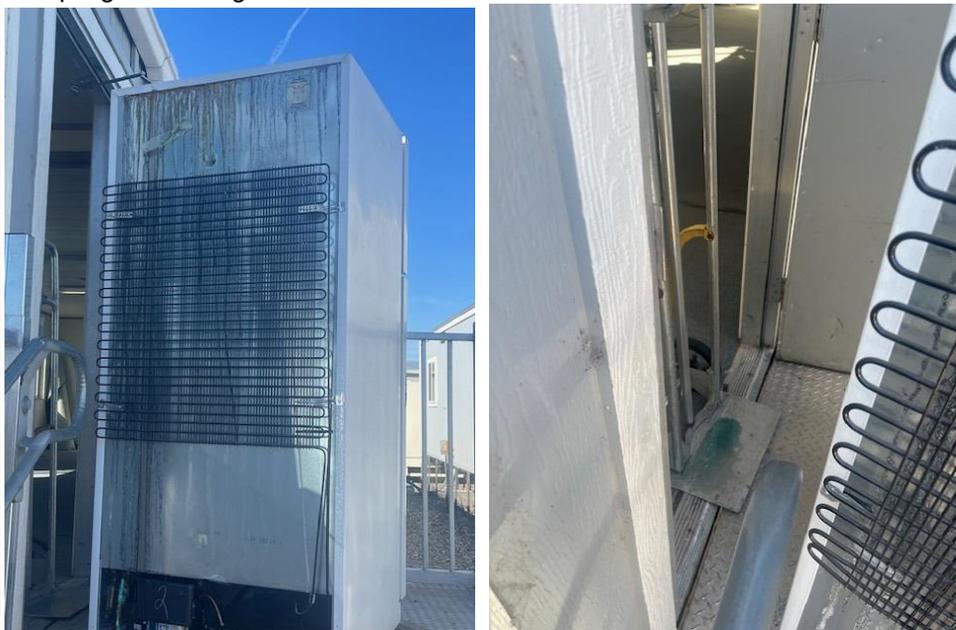
Upon arrival, the response team identified that blue liquid was leaking from the back of the refrigerator, creating a puddle on the hand truck, as pictured below:

No odors were detected by facilities IH or OFS level 3 IH manager outside MO531. After monitoring their way in, responding personnel monitored the interior of MO531, including the puddle of liquid on the floor behind the hand truck. All readings remained below the detection limit. PO IHTs reported detecting "refrigerant" odors inside the building, near the puddle of liquid. Upon departing MO531, the IHTs were instructed to perform a post use function test on their instruments. All instruments passed at 1425. Results are summarized below:

Following response actions, the CSM determined the leaked refrigerant did not meet the criteria to enter TF-AOP-11. DFLAW IH and CSM discussed the contents of the spill, and the residual liquid was determined to be non-hazardous and able to be cleaned up with GHA controls (i.e., disposable gloves, safety glasses with side shields, and absorbent pads). CSM, facilities IH, and the central planning work control manager discussed follow-up actions and determined clean-up met the criteria for performing housekeeping under the H2C Authorized Level 4 Activity List.

IH concludes the source of the odor is likely the leaked refrigerant. IHT monitoring did not indicate any vapors were present at or above regulatory limits at the time of response. The leaked refrigerant will be cleaned up as a level 4 activity.

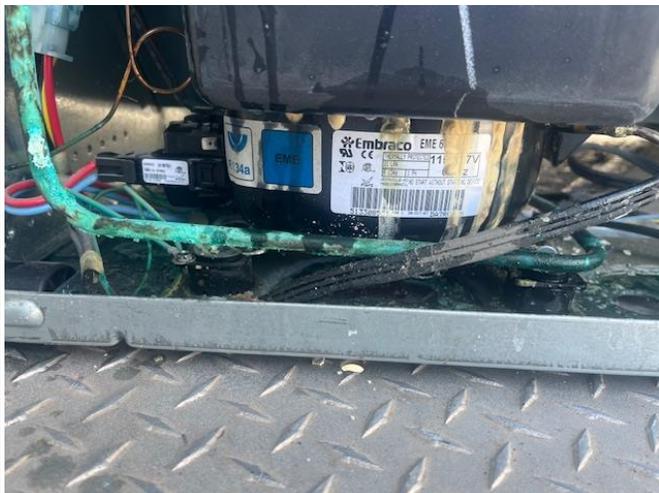
- 1416 Facilities IH notifies PO IH that all readings at the puddle were below the detection limit.
Facilities IH notifies PO IH that the tag has been located, and the refrigerator contains R134A refrigerant.

The refrigerant was identified as R134A by the tag on the back of the refrigerator, pictured below:
