Hanford Tank Waste Operations & Closure (H2C)  
**EVENT REPORT FORM**

1. Project: West Area Construction 2. Report Date: 08/10/2026  
3. Title: TFC-OPS-OPER-C-67 Response at MO655  
4. Investigation Report Number (if applicable): EIR-2026-055 5. Revision: 0  
6. Responsible Manager: [REDACTED]  
7. Event Investigator: [REDACTED]  
8. Area/Building/Location: 200W/MO655  
9. Date and Approximate Time of Event: Date: 08/05/2026 Time: (military) 0815  
10. Associated Action Request (AR) Number: ITDC-AR-2026-2397  
11. Occurrence Report Number (if applicable): N/A  
12. Event Learning Meeting Held: Yes [ ] or No [X] Date: N/A Time: (military) N/A

**Attachment 1: Industrial Hygiene Event Investigation Report (IHIR) #IHIR-00144, "TFC-OPS-OPER-C-67 at MO-655"**

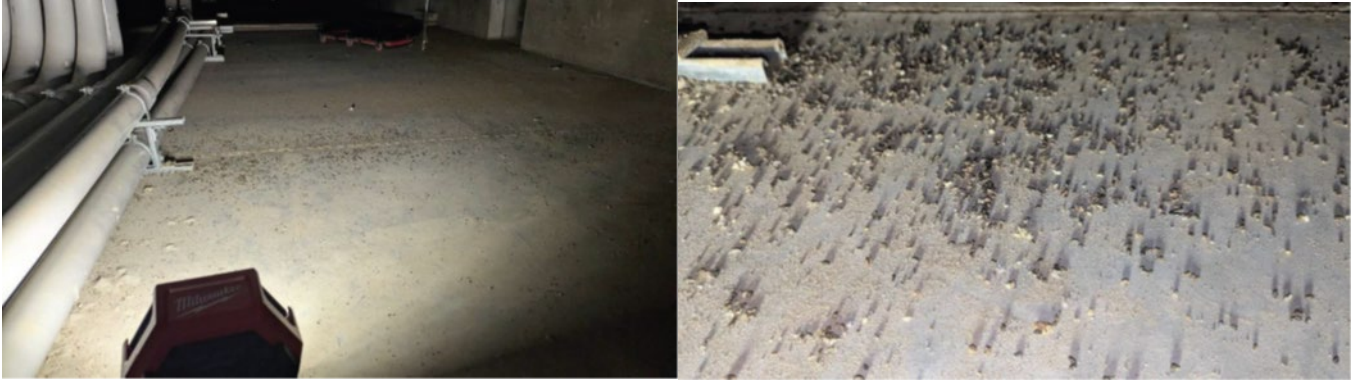
To summarize the conclusions of the Industrial Hygiene Event Report, IHIR-00144, *TFC-OPS-OPER-C-67 at MO-655* (Attachment 1): When responders arrived at building MO-655, no odor was detected in the accessible areas. The building has a crawl space with poor ventilation where the odor had been reported. Personnel entering the crawl space did not smell an odor, though rodent droppings were present (see photos below).

Industrial Hygiene Technicians (IHT) monitored the area including the crawl space and found no abnormal readings. Although the location is near SY Tank Farm, monitoring results indicated it is unlikely the odor originated from Tank Farm Vapors. The most likely source of the faint ammonia-like odor was rodent urine in the poorly ventilated crawl space.

Communication regarding the recent discovery of rodent droppings in the crawl space is being shared across the Industrial Hygiene (IH) department. Response teams have been reminded to stay vigilant and adaptable during investigations, and to pause and reassess whenever they encounter unexpected conditions. At this time, no additional actions are required beyond reinforcing these practices and maintaining ongoing awareness.

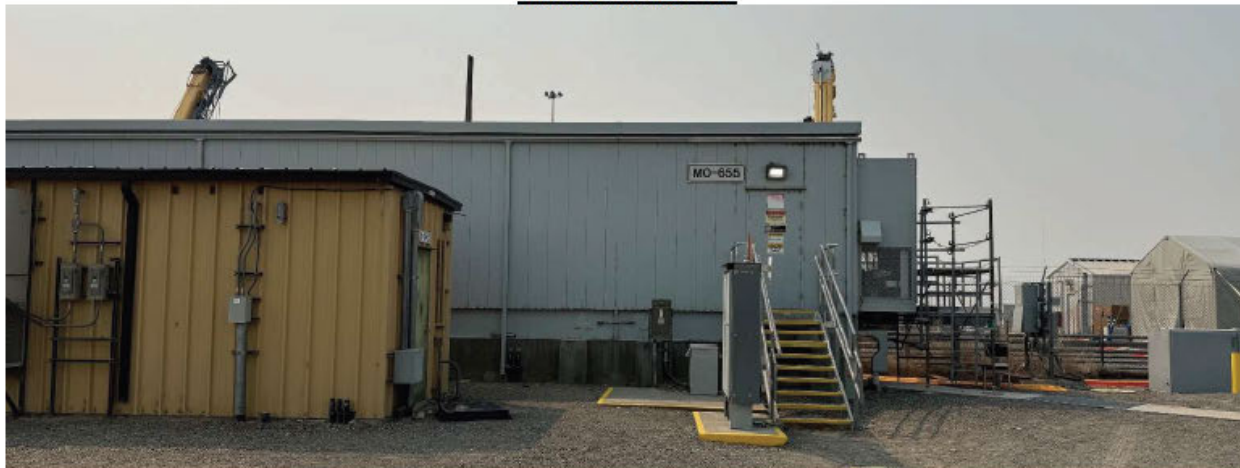
Upon arrival at the event scene, no odor was observed by personnel in the perimeter of MO-655 or the general access areas inside MO-655. The ventilation in MO-655 was operational, however, the area where the odor was reported was a separate air space. MO-655 is a prefabricated building with a concrete slab and below floor crawl space (approximately 3 feet high, 14 feet wide, and 30 feet long) with electrical and communication wires and conduit. The area accessed is a non-permit required confined space with two access hatchways, one on either end of the trailer. There is no ventilation, other than natural ventilation, of the crawl space where the odor was observed which creates a stagnant environment. There are no water or sewer utilities for the building. No chemicals were being used in the space at the time of the reported odor. Personnel that entered the space where the odor was reported did not observe a present odor. Rodent droppings were observed throughout the crawl space, but there were no signs of any obvious rodent nests or infestation.

Exterior of MO-655

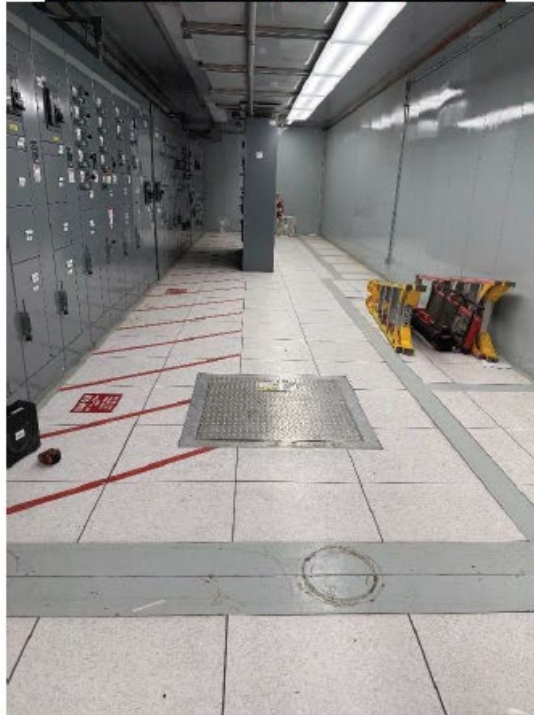
Interior of MO-655 and Access Hatchway

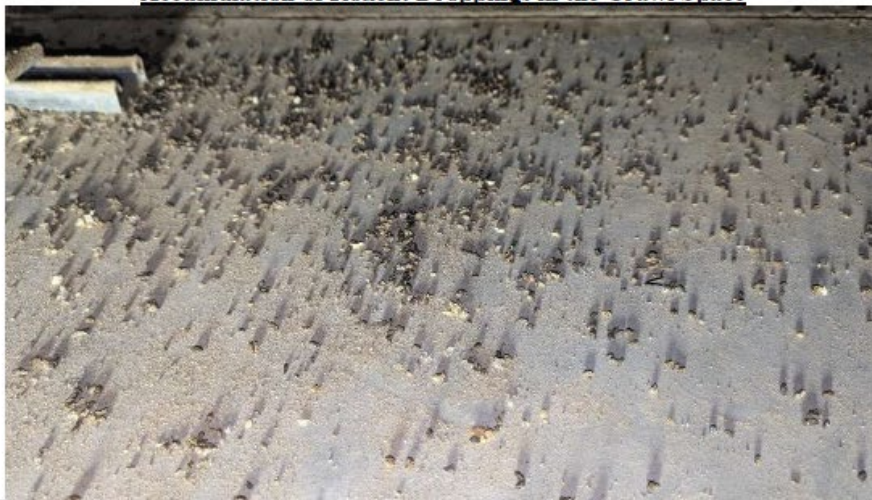
Accumulation of Rodent Droppings in the Crawl Space

Although the location of the reported odor is close in proximity to SY Tank Farm, it is not likely that the reported odor was due to a tank vapor event based on the findings of the work location. It is more likely that the faint ammonia-like odor smelled was due to rodent urine within the crawl space and lack of ventilation. DRI monitoring performed during response actions did not indicate further action is necessary to protect worker safety and health. As a result, the area was released from restricted access and work was allowed to continue. If the odor is recurring during future work activities, cleaning of the space to eliminate the biological contamination could be completed, although not required to proceed.
