Hanford Tank Waste Operations & Closure (H2C)  
**EVENT REPORT FORM**

1. Project: Field Crew Operations 2. Report Date: 08/11/2026  
3. Title: C-67 Response at 271AW1 Change Tent  
4. Investigation Report Number (if applicable): EIR-2026-053 5. Revision: 0  
6. Responsible Manager: [REDACTED]  
7. Event Investigator: [REDACTED]  
8. Area/Building/Location: 200E/271-AW1 Change Tent  
9. Date and Approximate Time of Event: Date: 07/30/2026 Time: (military) 0705 hours  
10. Associated Action Request (AR) Number: ITDC-AR-2026-2432  
11. Occurrence Report Number (if applicable): N/A  
12. Event Learning Meeting Held: Yes [ ] or No [x] Date: N/A Time: (military) N/A

## INDUSTRIAL HYGIENE EVENT INVESTIGATION REPORT (IHIR)

Event Title:  
TFC-OPS-OPER-C-67 Response 217-AW1 Change Tent.

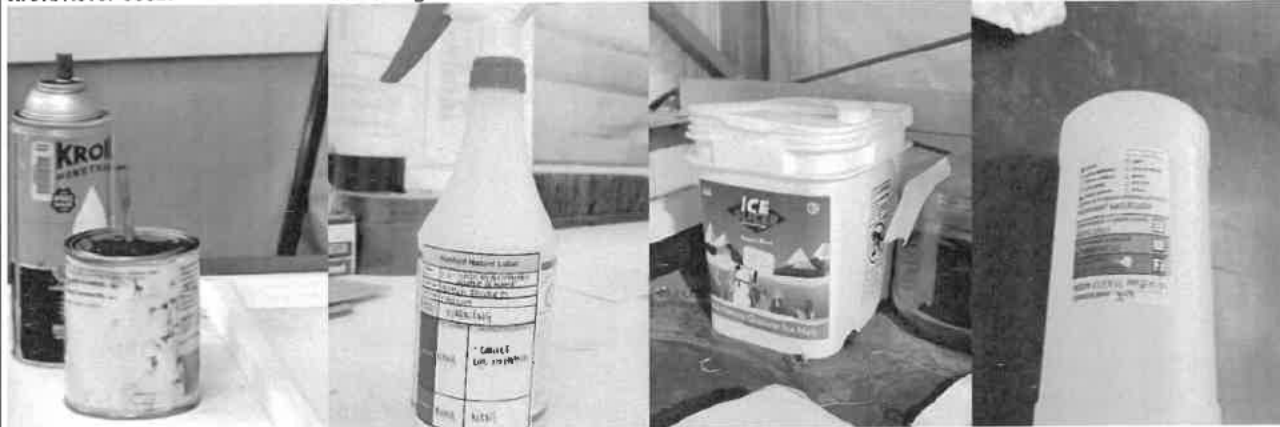
### Chemicals

Kroil/Never-seez?

Lemon Hg

Ice-melt

Zep (anti-bacterial cleaner w/lemon)

Chemicals found within the facility were inconsistent with the odor profile of "rubber" and "musty". Some housekeeping improvements were identified and communicated with the AZ team for correction and were verified corrected.

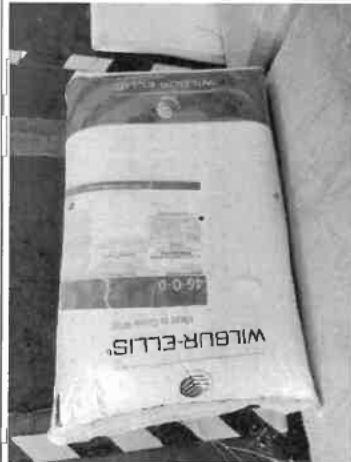
Fertilizer used as ice melt.

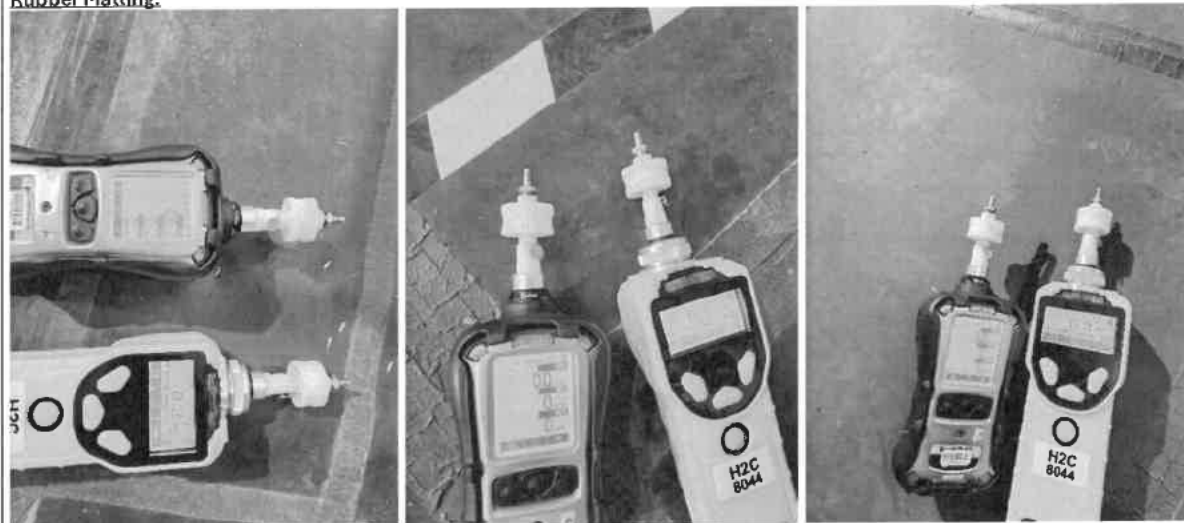
#### Rubber Matting:

The 217-AW1 tent is a temporary structure outfitted with rubber mat flooring, which was installed to replace the previous wooden flooring that had degraded due to moisture intrusion, rot, and mold growth. Rubber flooring is known to exhibit increased off-gassing under elevated temperatures. Ventilation conditions may also influence odor intensity; although the tent is typically cooled by three HVAC units, only two were operational at the time of the incident.

Odor descriptors provided by the affected workers are inconsistent with Tank Vapors. The 217-AW1 tent is a temporary structure with a floor made of rubber matting. The structure was previously constructed with wooden flooring that was susceptible to rot and mold growth from water intrusion resulting from direct contact with the ground. The prior flooring was replaced in sections and overlayed with rubber matting within the last year. Off gassing of the rubber flooring has the potential to increase during warmer temperatures. Ventilation may play a role in odor intensity. The tent is cooled via three HVAC units. At the time of the occurrence only two of the units were in operation.
