# EVENT INVESTIGATION REPORT

EIR-2016-024

Investigation of 702-AZ Room 105 AOP-015 Entry

PER No. WRPS-PER-2016-0908

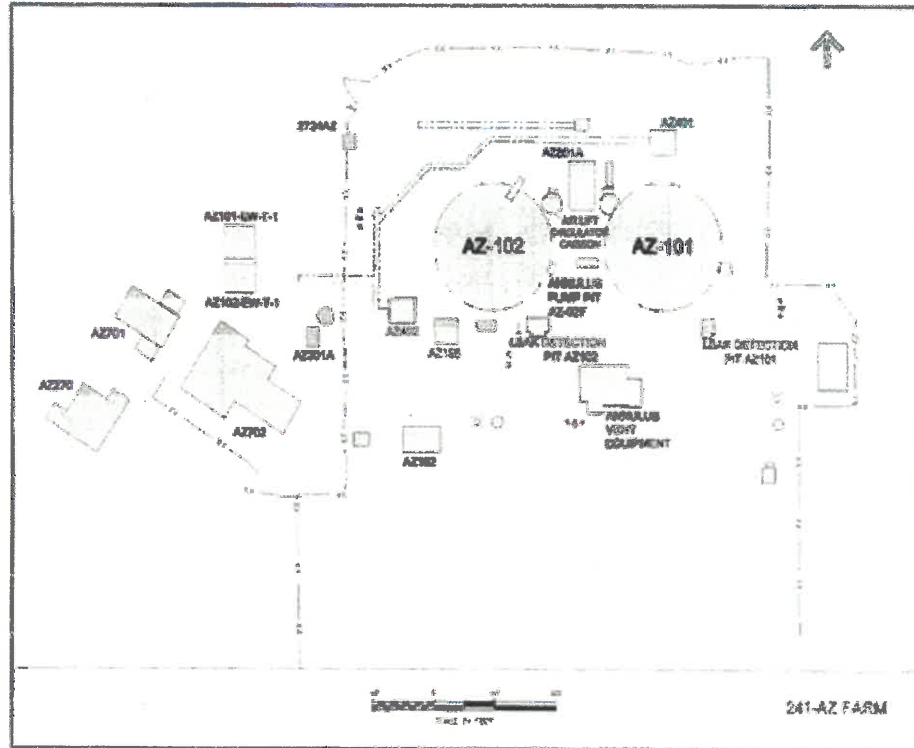
Attachment 1  
Odor Response Cards

- Date and time odor was noticed 5/4/16
- Your name and the work you were performing PAPER CHANGING
- Location of odors (mark area on map and wind direction) A 702AZ ROOM 105 PRIMARY FLOOR
- Name(s) of others in or near the affected area \_\_\_\_\_
- Was an IHT present? Yes
- Describe the odor  Sweet  Sour  Musty  Earthy  Metallic  Smoky  Rotten  Onion  
 Cleaning Solution  Ammonia  Other: \_\_\_\_\_
- Possible Source CAN FILTER
- Your symptoms (if any)  Headache  Dizziness/Light-Headed  Nausea  Cough  
 Fatigue/Drowsiness/Weakness  Sore/Burning Throat  Difficulty Breathing  
 Watery/Irritated Eyes/Trouble with Vision  Tingling/Numbness/Paralysis  Rash/Itching  
 Other: NOT CURRENTLY SHOWING ANY
