EVENT INVESTIGATION REPORT

**Investigation of TY Farm AOP-015 Entry
Event Investigation Report 2019-013**

4/9/2019

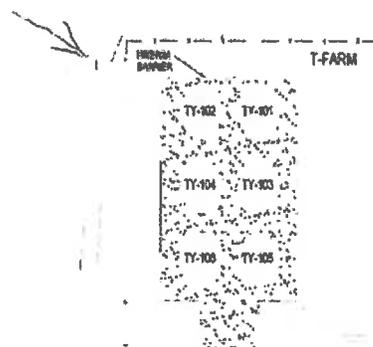
241-TY FARM

- Date and time odor was noticed 3/19/19 1300
- Your name and the work you were performing _____
- Location of odors (mark area on map and wind direction) _____
- Name(s) of others in or near the affected area _____
- Was an IHT present? No
- Describe the odor Sweet Sour Musty Earthy Metallic Smoky Rotten Onion
 Cleaning Solution Ammonia Other: Rusty
- Possible Source ?
- Your symptoms (if any) Headache Dizziness/Light-Headed Nausea Cough
 Fatigue/Drowsiness/Weakness Sore/Burning Throat Difficulty Breathing
 Watery/Irritated Eyes/Trouble with Vision Tingling/Numbness/Paralysis Rash/Itching
 Other: NONE

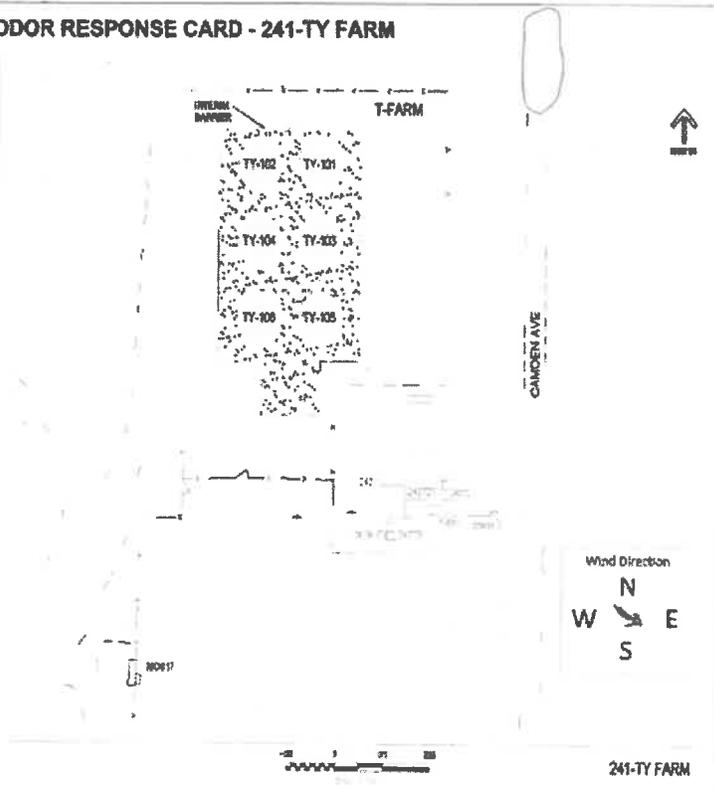
- Date and time odor was noticed 3/19/19 13:00
- Your name and the work you were performing [REDACTED]
- Location of odors (mark area on map and wind direction)
- Name(s) of others in or near the affected area [REDACTED]
- Was an IHT present? Yes
- Describe the odor Sweet Sour Musty Earthy Metallic Smoky Rotten Onion
 Cleaning Solution Ammonia Other: _____
- Possible Source _____
- Your symptoms (if any) Headache Dizziness/Light-Headed Nausea Cough
 Fatigue/Drowsiness/Weakness Sore/Burning Throat Difficulty Breathing
 Watery/Irritated Eyes/Trouble with Vision Tingling/Numbness/Paralysis Rash/Itching
 Other: _____

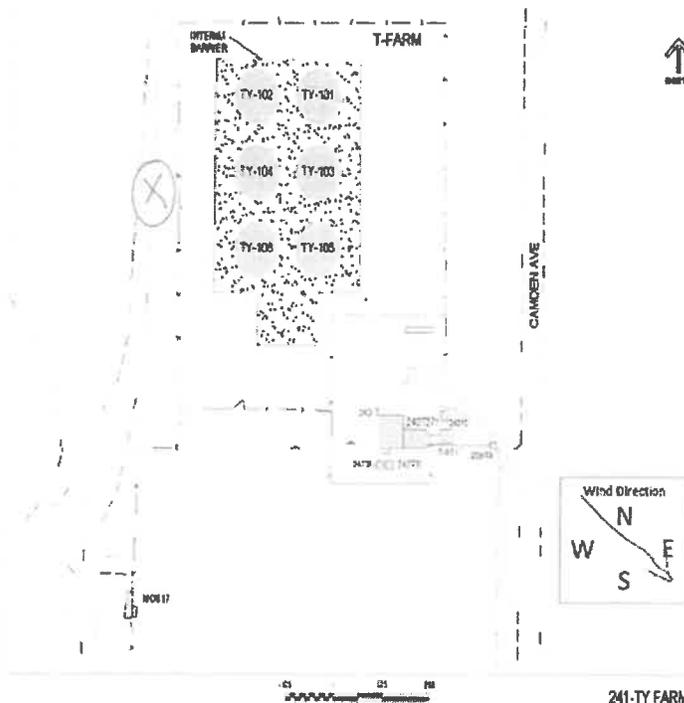
- Date and time odor was noticed 3/19 1:00 PM
- Your name and the work you were performing [REDACTED]
- Location of odors (mark area on map and wind direction)
- Name(s) of others in or near the affected area [REDACTED]
- Was an IHT present? N/O
- Describe the odor Sweet Sour Musty Earthy Metallic Smoky Rotten Onion
 Cleaning Solution Ammonia Other: Egg smell
- Possible Source fant
- Your symptoms (if any) Headache Dizziness/Light-Headed Nausea Cough
 Fatigue/Drowsiness/Weakness Sore/Burning Throat Difficulty Breathing
 Watery/Irritated Eyes/Trouble with Vision Tingling/Numbness/Paralysis Rash/Itching
 Other: Not at this time.
