EVENT INVESTIGATION REPORT

Event Investigation Report, EIR-2019-014 244A AOP-015 Entry EIR-2019-014

PER No. WRPS-PER-2019-0574

244A AOP-015 Entry

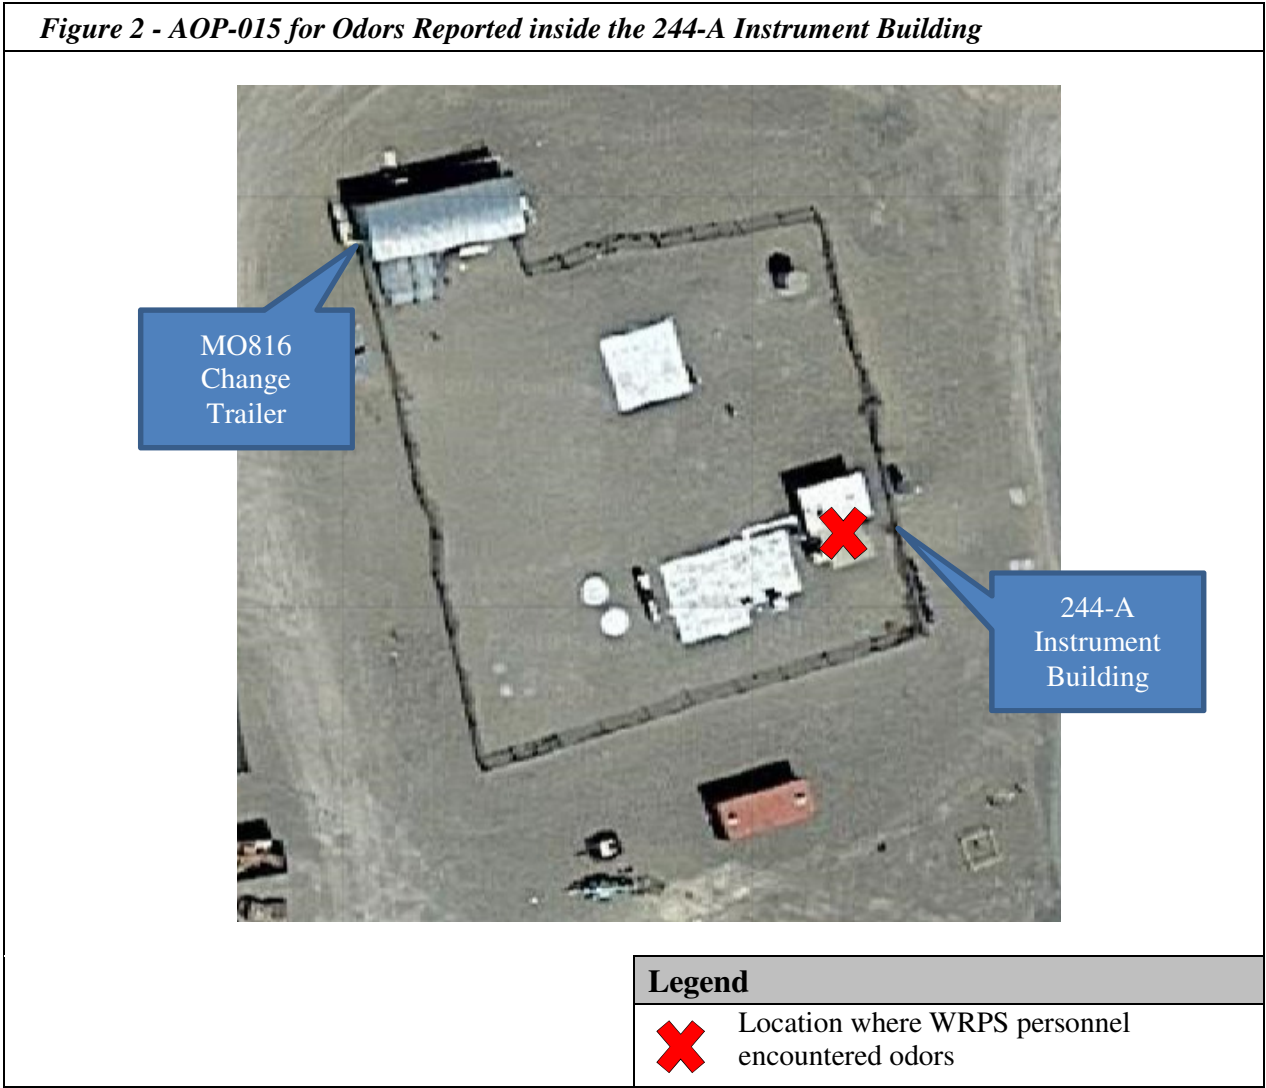
Source of the odors was undetermined although not expected to be tank waste related. The 244-A Instrument Building houses the 244-A Air Compressor, including controls and instrumentation, to supply instrument air to the 244-A catch tank dip tubes. It is located within a contamination area and sump level readings are to be taken quarterly. The building relies on passive ventilation. Location of the building is ~300 meters southwest of the nearest tank in AN Farm. At the time of the event, there were zero (0) waste disturbing or tank-intrusive activities occurring in the nearby tank farms. Wind directions were from the northwest traveling at 4 mph with barometric pressure readings at 29.3". The temperatures were above freezing and had been above freezing for several days which led to considerable ice and snow melt. The increase in moisture and warmer

temperatures may have attributed to the growth of mold or mildew. On March 26, 2019, at ~1400 hours the 244-A building was accessed and it was noted by personnel that there were no significant odors.
