AOP-015 Event Investigation Reports (Redacted) EIR-2019-049 12022019

“TF-AOP-015 Event at AX Farm”

EIR-2019-049

WRPS-PER-2019-2370

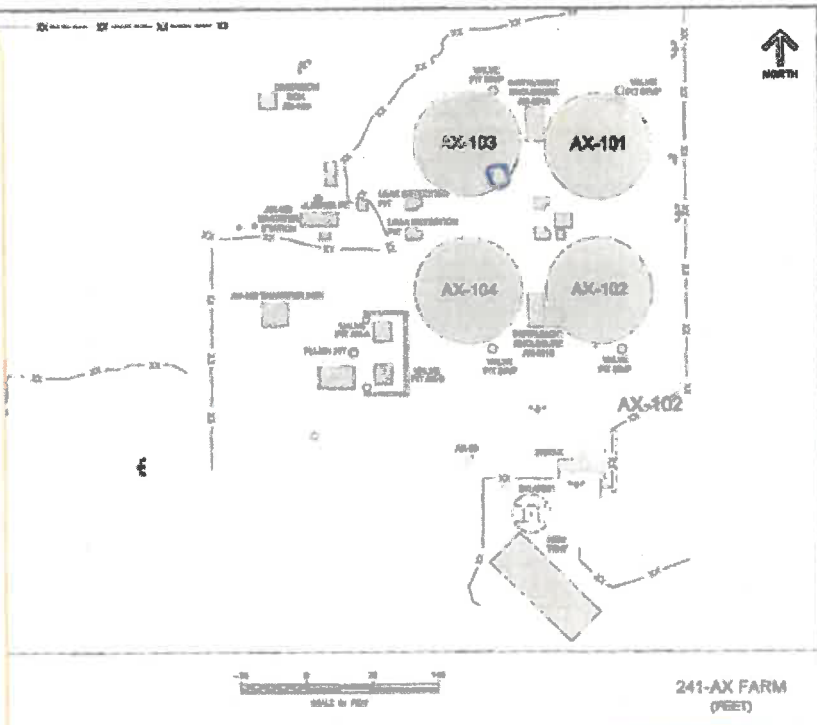
Odor Response Card

- Contact CSM, [redacted] complete below bulleted information and map. 9:20 am
 - Date and time odor was noticed Dec. 2, 2019 9:30 am
 - Your name and the work you were performing [redacted] Scaffolding
 - Location of odors (mark area on map and wind direction) AX 103
 - Name of others in or near the affected area [redacted]
 - Was an IHT present? NO
 - Describe the odor Sweet Sour Musty Earthy Metallic Smoky Rotten Onion Cleaning Solution Ammonia Other Burning Smell
 - Possible source 3A Riser
 - Your symptoms (if any) Headache Dizziness/Light-Headed Nausea Cough Fatigue/Drowsiness/Weakness Sore/Burning Throat Difficulty Breathing Watery/Irritated Eyes/Trouble with Vision Tingling/Numbness/Paralysis Rash/Itching Other _____
