Event Investigation Report

EIR-2018-010

"Investigation of SY Farm Emergency Shower AOP-015 Event"

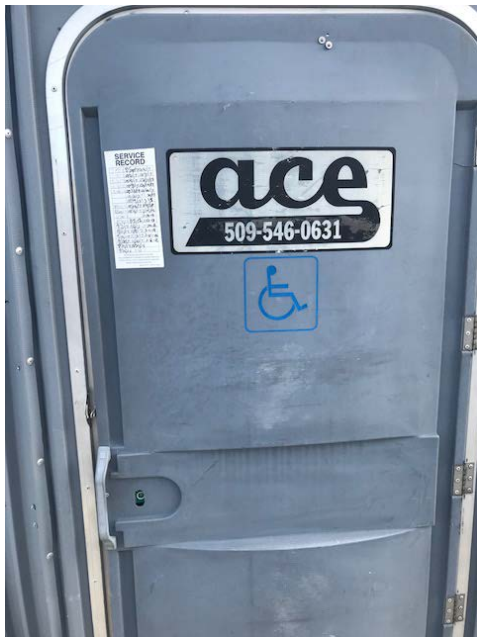
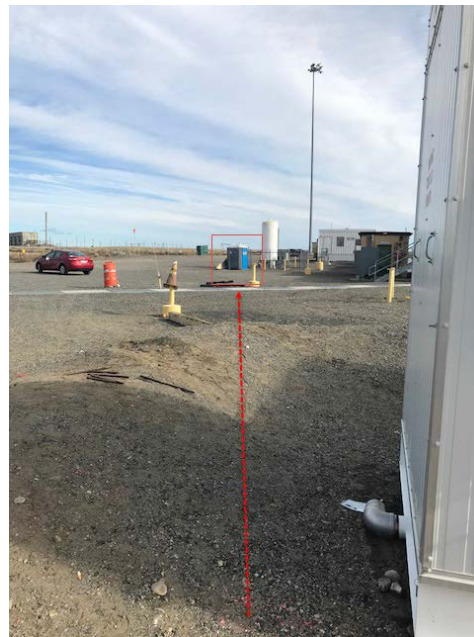
An additional potential source for the reported odor is the portable toilet located north of SY Farm in front of 272SY building, approximately 200 feet east/northeast of digging area and was serviced prior to the event on February 5, 2018. According to the local Ace representative the portable toilets are cleaned by two different methods. The toilet, tank and the unit is sprayed down with a mild soap detergent referred to as the deodorizer. The scent is marionberry and this deodorizer is what makes the water blue. A chemical called Scalex is sprayed in the urinal and is a diluted bleach descaler. No other work was taking place in the adjacent areas at the time of the event that could be considered as a potential source for the odor. The SY safety shower was drained and dumped immediately above its foundation on February 1, 2018. Maintenance confirmed that no chemicals or cleaning agents are used during this process.

SY portable toilet located north/northeast of electrical conduit dig site where odor was reported

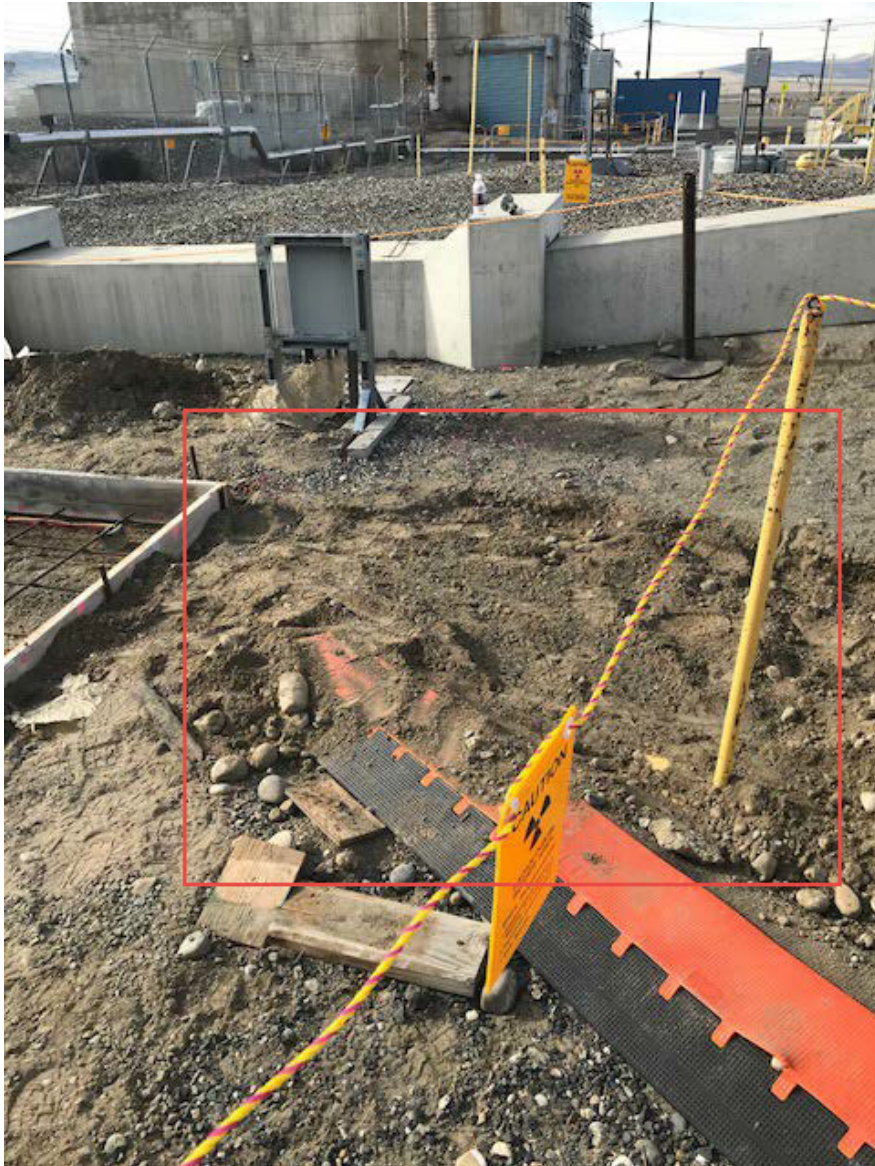
Attachment 1, Picture of area where FE&C employees smelled pine sol/lemony odor while hand digging a trench to lay the electrical conduit for the SY Safety shower, 1 page

On February 6, 2018 two Federal Engineers and Constructors (FE&C) employees, one electrician and one laborer, smelled a pine sol/lemony chemical odor while hand digging a trench to lay the electrical conduit for the SY Safety shower on the northwest corner of SY Farm exterior. The odor was detected at approximately 1020, employees immediately exited the area upon smelling the odor and returned to their office location in the 200E area, where they reported the odor to their Field Work Supervisor (FWS). The odor was reported to the Central Shift Office (CSO) at approximately 1040 by the employees' FWS. Personnel were asked by their FWS and the Central Shift Manager (CSM) if they wanted to seek medical attention, but both individuals reported having no symptoms and declined a medical evaluation.
