Hanford Tank Waste Operations & Closure (H2C)
EVENT REPORT FORM

1. Project: Operations Field Support 2. Report Date: 06/08/2026
3. Title: C-67 Odor Response at 272WA
4. Investigation Report Number (if applicable): EIR-2026-041 5. Revision: 0
6. Responsible Manager: [REDACTED]
7. Event Investigator: [REDACTED]
8. Area/Building/Location: 200W / 272WA Parking Lot
9. Date and Approximate Time of Event: Date: 05/18/2026 Time: (military) 1015 hours
10. Associated Action Request (AR) Number: ITDC-AR-2026-1873
11. Occurrence Report Number (if applicable): N/A
12. Event Learning Meeting Held: Yes [] or No [x] Date: N/A Time: (military) N/A

INDUSTRIAL HYGIENE EVENT INVESTIGATION REPORT (IHIR)

TFC-OPS-OPER-C-67 272WA Parking Lot

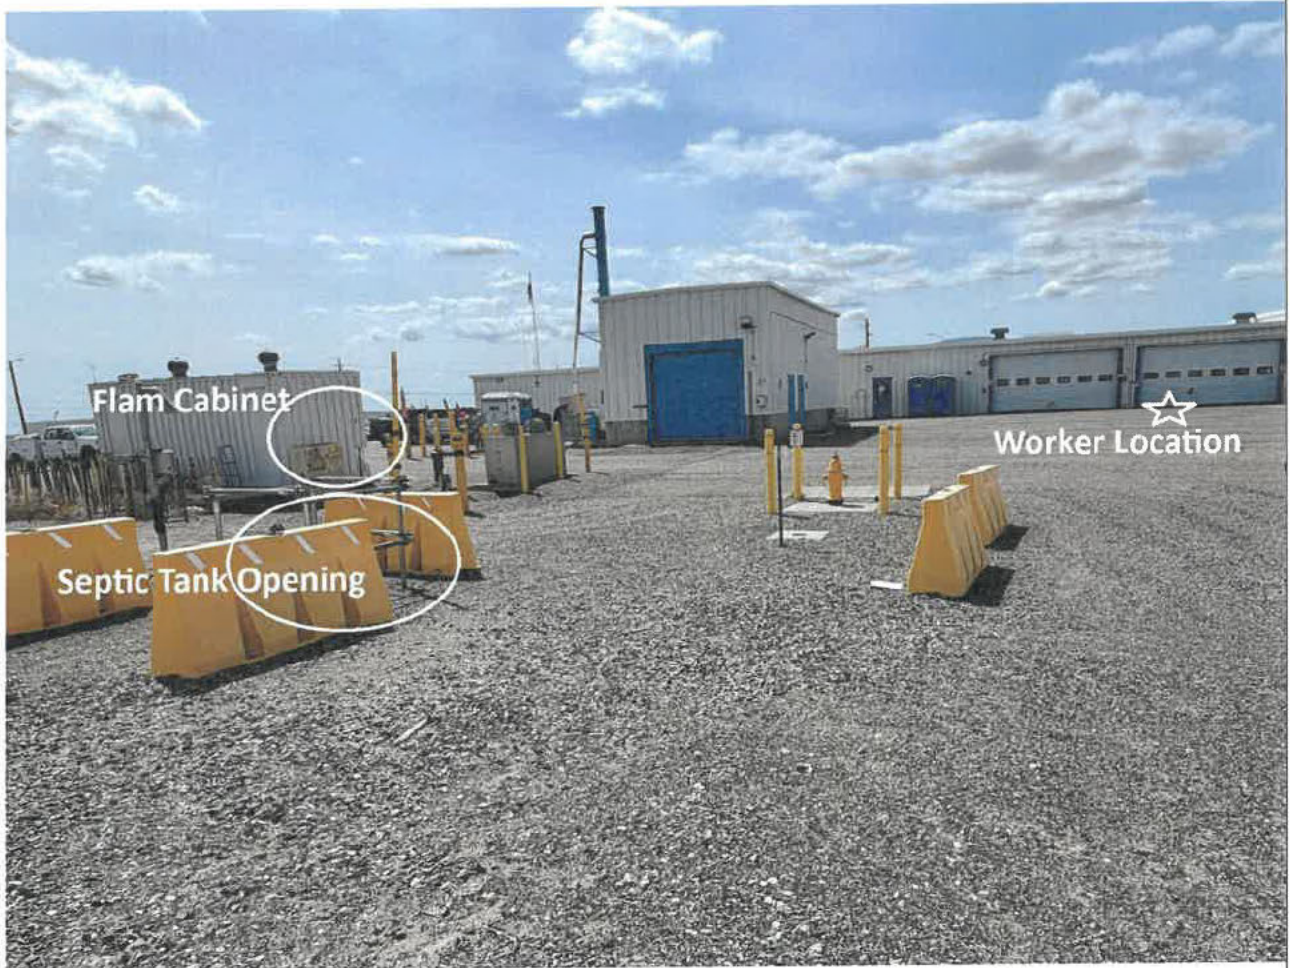
IHTs used DRI to monitor for ammonia, VOCs, LFL, and hydrogen sulfide at the 272WA parking lot and adjacent areas (see images below for locations). All readings were less than action limits, with no elevated readings observed. Instrumentation passed the post-use function check.

Perimeter area readings

NH₃: 0 ppm
VOCs: 0 ppm
Hydrogen Sulfide: 0 ppm
LFL: 0%
Oxygen: 20.9%

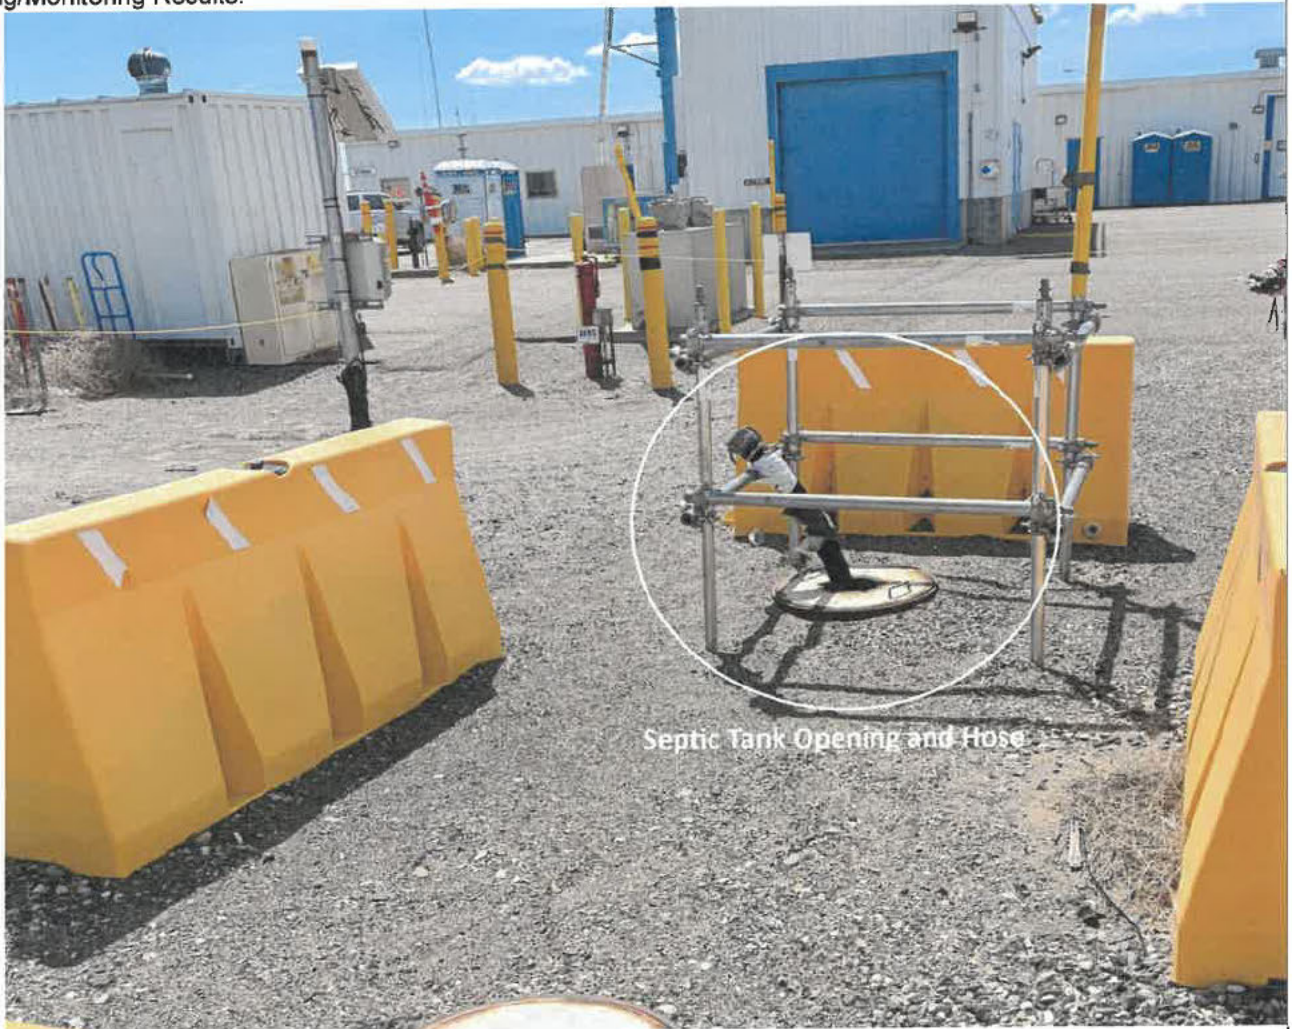
Septic Tank Opening and Hose

Septic tank opening and hose (area and source)

NH3: 0 ppm
VOCs: 0 ppm
Hydrogen Sulfide: 0 ppm
LFL: 0%
Oxygen: 20.9%

During their assessment, the Response Team found an open lid on a septic tank and an uncapped hose at the edge of the parking lot near the flammable cabinet. Measurements taken at the septic tank were below action limits.
